**HUMBOLDT STATE UNIVERSITY
JENKINS HALL**

SEISMIC EVALUATION

June 22, 2018

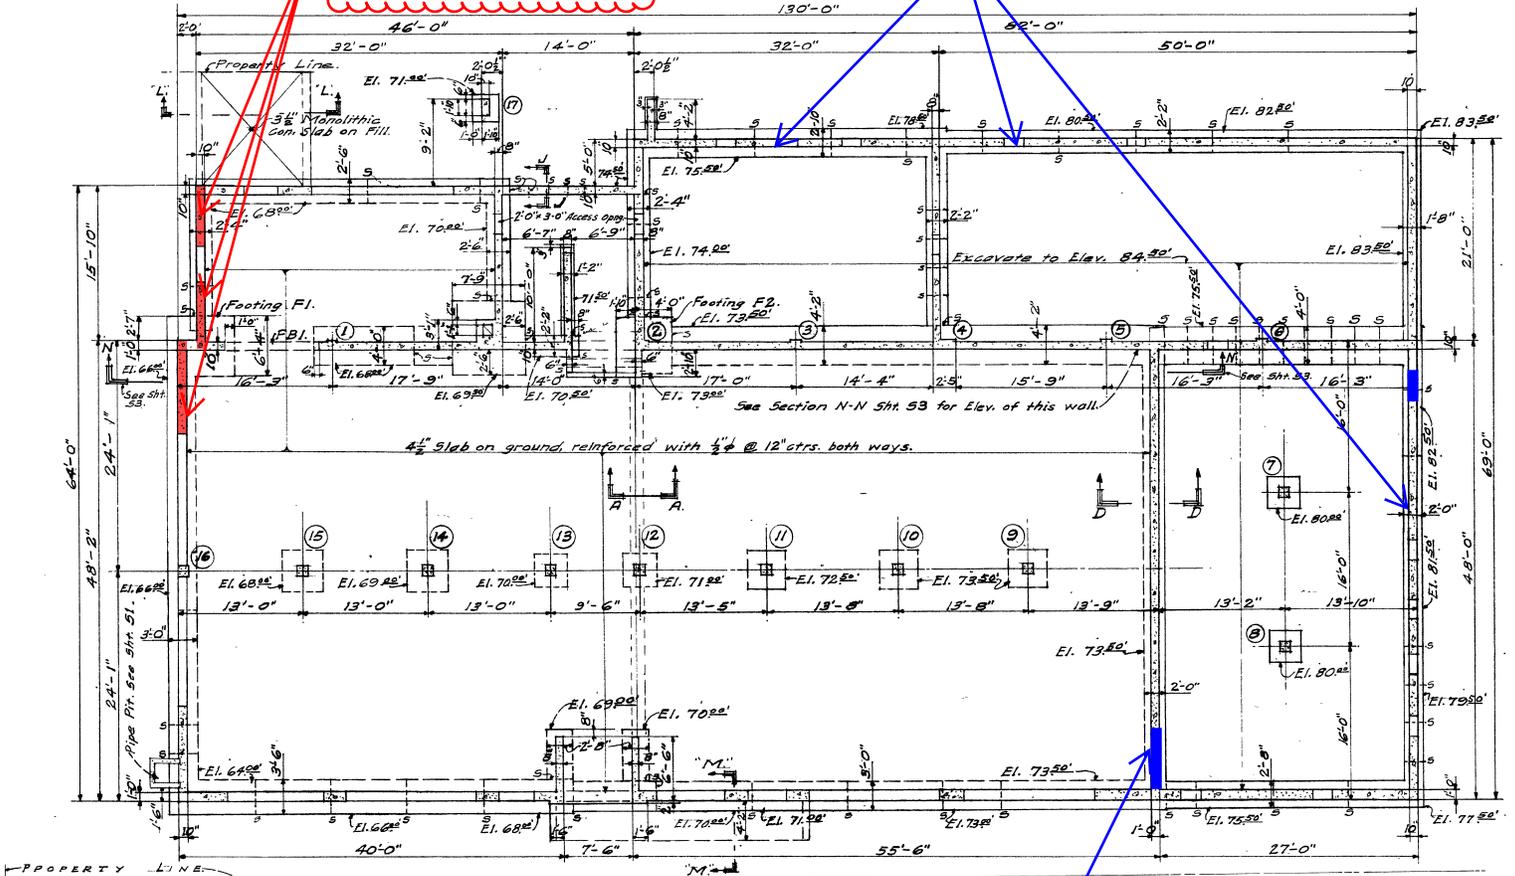
FOUNDATION PLAN
Scale 1/4" = 1'-0"

- Shear Walls: The existing perimeter concrete walls have many large window openings, and corresponding narrow shear wall piers. This is of most concern at the First Floor, along the west perimeter wall, where the existing narrow wall piers support two stories of seismic shear (as compared with the north, south and east walls, where large portions of the First Floor walls are solid subgrade basement walls). While only marginally overstressed, this location is the weak link in the seismic force resisting system, and should be considered for retrofit. Retrofit may consist of infilling portions of windows to provide more shear wall length, and/or thickening of existing shear wall piers.

EXISTING STEPPED FOOTINGS EXPOSED IN ROOMS PROPOSED FOR RENOVATION: CANNOT DEMO WITHOUT EXTENSIVE FOUNDATION SHORING, UNDERPINNING AND RECONSTRUCTION

WALL PIER DEFICIENCY: INCREASE SIZE FOR ADDED STRENGTH

Additionally, TT notes HSU’s proposal to renovate the existing raised First Floor areas that were originally (per the original building drawings) intended to be unoccupied and backfilled with dirt. HSU’s concept renovation drawings note that these areas will require demolition and removal of “concrete steps, sections of slab and exposed concrete areas.” It should be noted that the majority of the exposed perimeter concrete steps are likely part of the perimeter building foundation, and cannot be demolished without significant shoring/underpinning operations, and reconstruction of the foundations at a lower elevation.

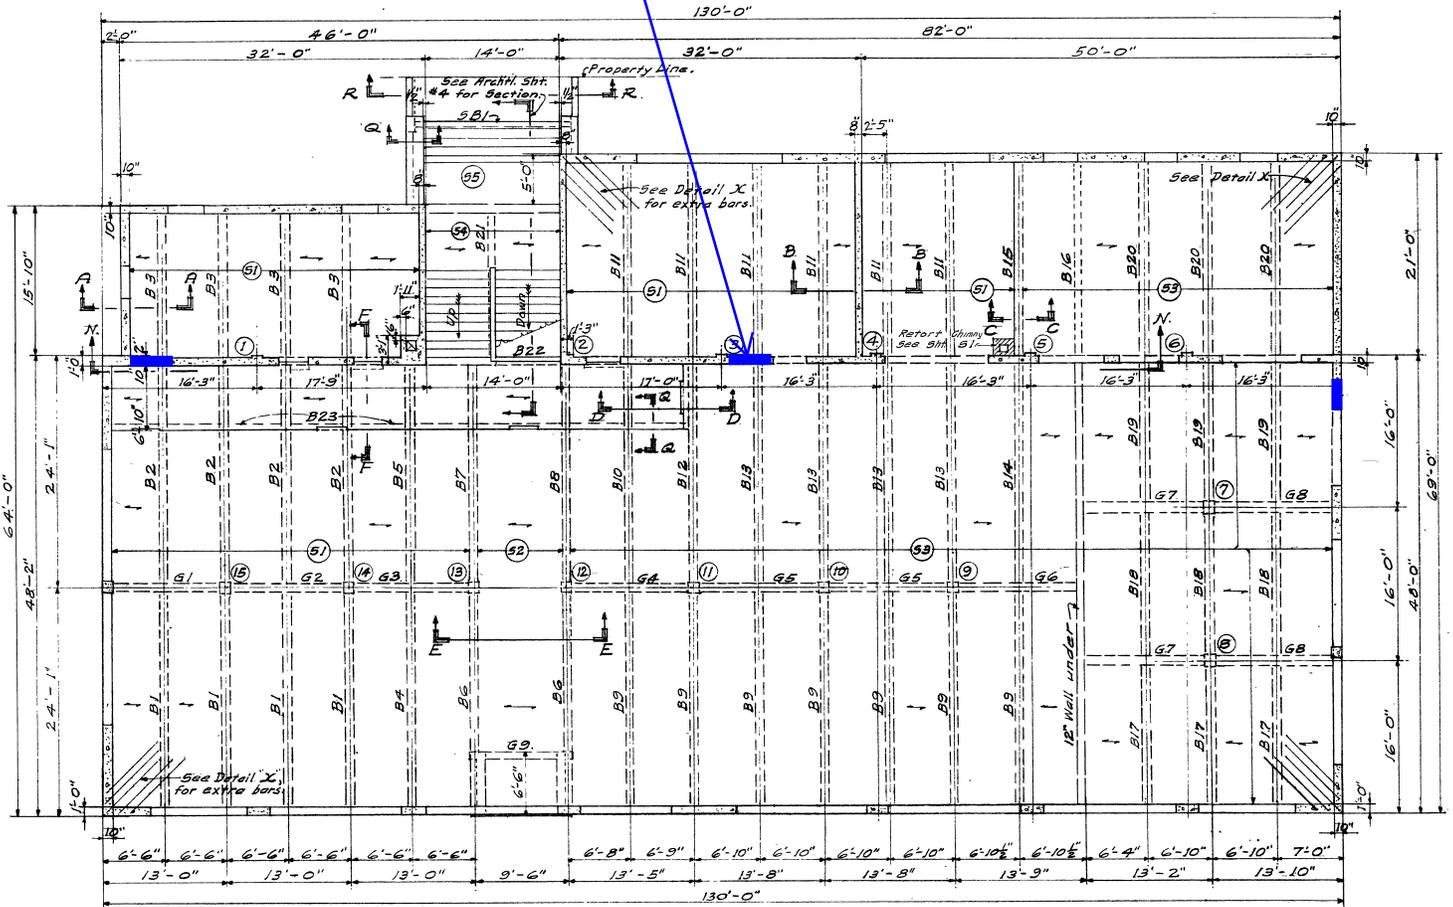
FLOOR FRAMING PLAN.
Scale $\frac{1}{4}'' = 1'-0''$

NO RETROFIT SCOPE AT THIS LEVEL

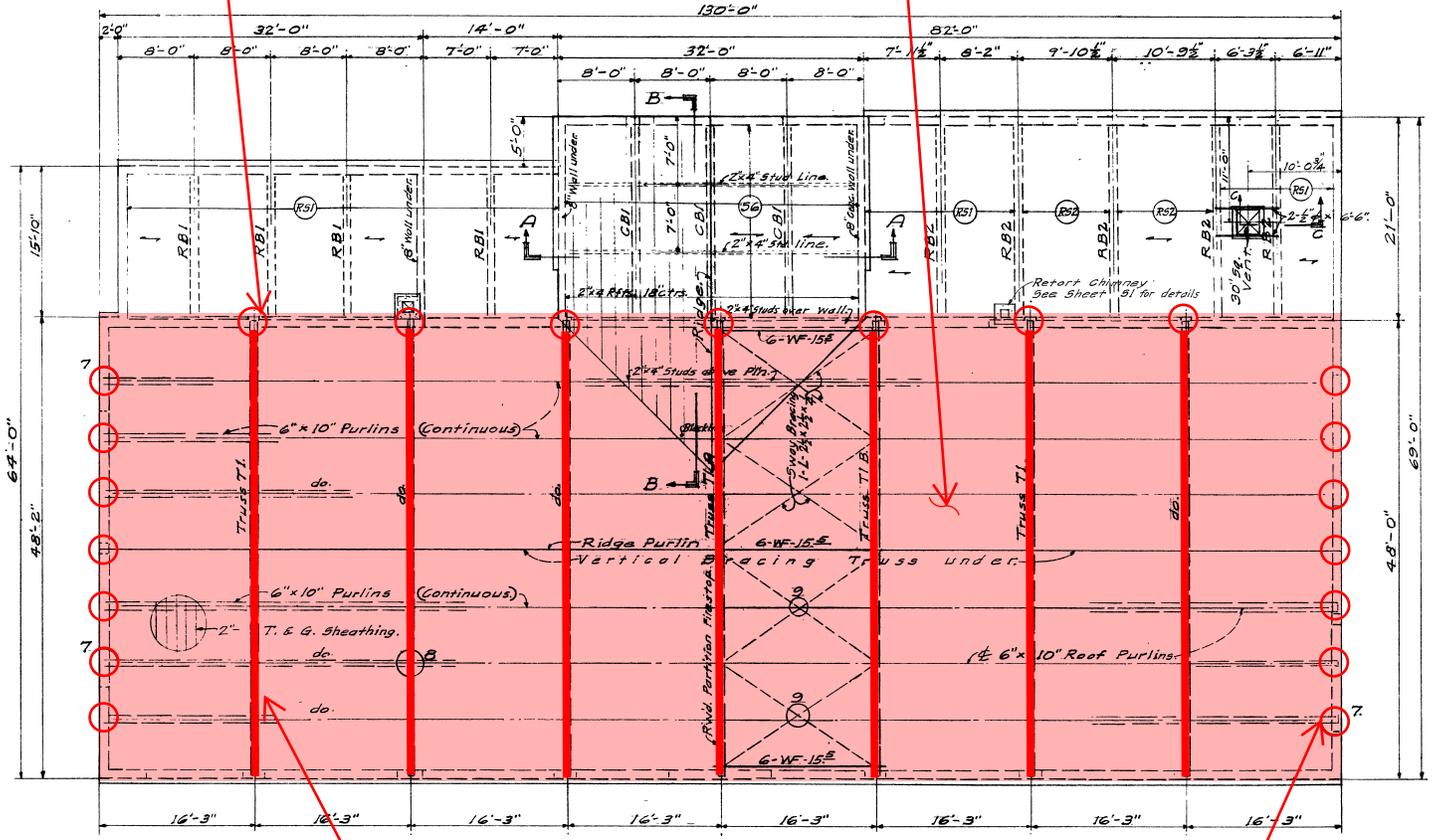
ROOF FRAMING PLAN.
 Scale: 1/8" = 1'-0"

- Wall-to-Roof Anchorage: During seismic events, heavy structural walls pull away from floor and roof diaphragms, and can be a potential collapse hazard if not adequately connected. This is a particular issue at flexible roof diaphragms (i.e. wood-framed or bare metal deck). For this building, the wall-to-roof anchorage connections are inadequate along the west and east building ends. Along the north and south sides of the building, the walls are well-anchored to the trusses, but the trusses are not adequately attached to the diaphragm. Both conditions should be prioritized for retrofit.

- Roof Diaphragm: Wood straight sheathing diaphragms have very low shear capacities, and are generally not used in modern seismic design; the diaphragm should be retrofitted by overlaying new plywood over the existing straight sheathing. Additionally, the wood and concrete diaphragms are not well tied together to transfer forces (primarily from the wood to concrete); new drag connections shall be provided.

DIAPHRAGM TIE DEFICIENCY:
 PROVIDE NEW CONNECTIONS BETWEEN
 WOOD AND CONCRETE DIAPHRAGMS,
 TYP AT EACH TRUSS LOCATION

DIAPHRAGM DEFICIENCY:
 STRENGTHEN DIAPHRAGM BY
 PROVIDING NEW PLYWOOD
 SHEATHING OVER EXISTING 2x
 STRAIGHT SHEATHING

WALL ANCHORAGE DEFICIENCY:
 STRENGTHEN CONNECTION OF WALL TO
 PURLIN, TYP AT EAST AND WEST WALLS

WALL ANCHORAGE DEFICIENCY:
 PROVIDE NEW BLOCKING TO CONNECT
 DIAPHRAGM TO TRUSS, TYP AT EACH TRUSS
