January 19, 2023

Subject: XPL277 Library Low Slope Roof Replacement – Asbestos and Lead Data Summary

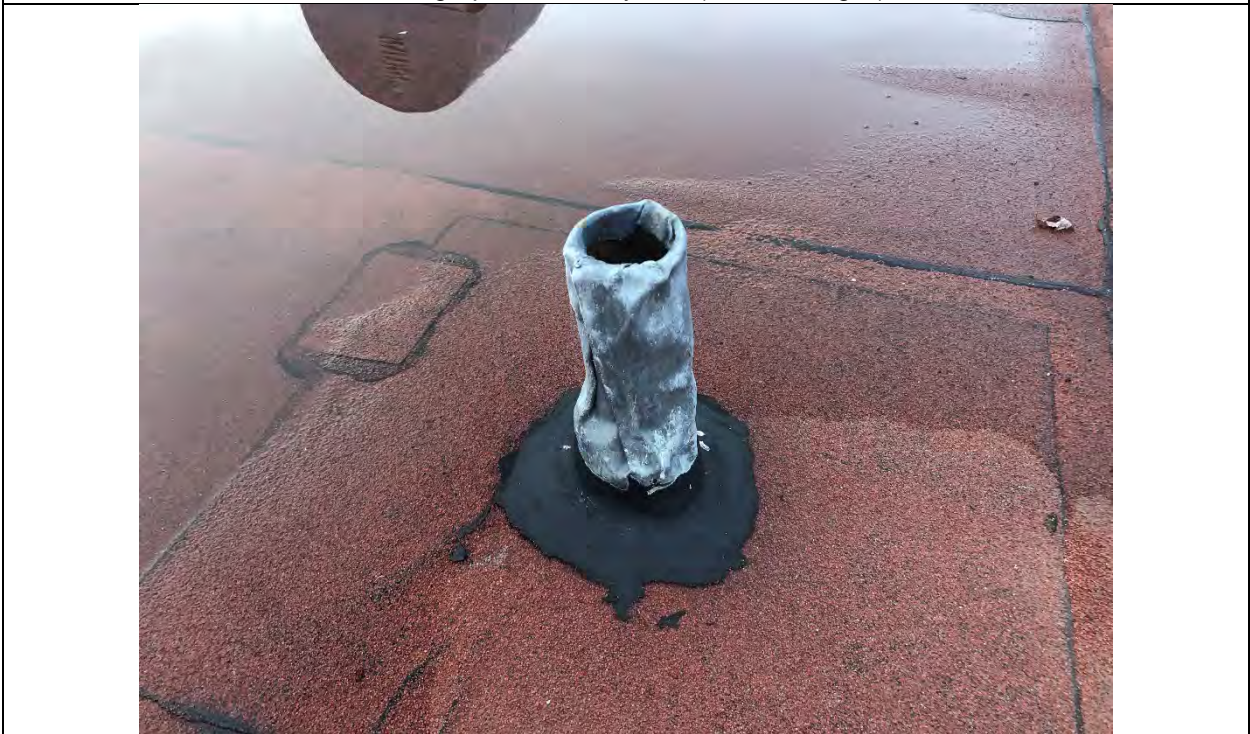
A single (1) material (vent cladding) is presumed to contain lead (see Photograph 4, Attachment A). As noted in Table 2, lead is presumed to be present at the project site, therefore construction work must comply with applicable Cal/OSHA and CDPH regulations governing lead. Coatings and other suspect lead materials at the project site shall be presumed to contain lead, unless sampled and proven otherwise.

Photograph 4 – Library roof vent (typical) - Metal cladding is presumed to be lead

The demolition waste stream shall be representatively sampled to determine the total and soluble concentration of lead in the waste. Transportation and disposal requirements shall be determined based on the waste characterization data.
