## Technical Memorandum

February 1, 2024

### **Asbestos Data Summary – Behavioral & Social Sciences Building Rooms: M-0A, M-0B, E/T-1A, C-5a, H-6 and Roof Exhaust**

### Asbestos Data Summary – Kinesiology & Athletics Building (024F) Third-Floor Mechanical Room (M-3B)

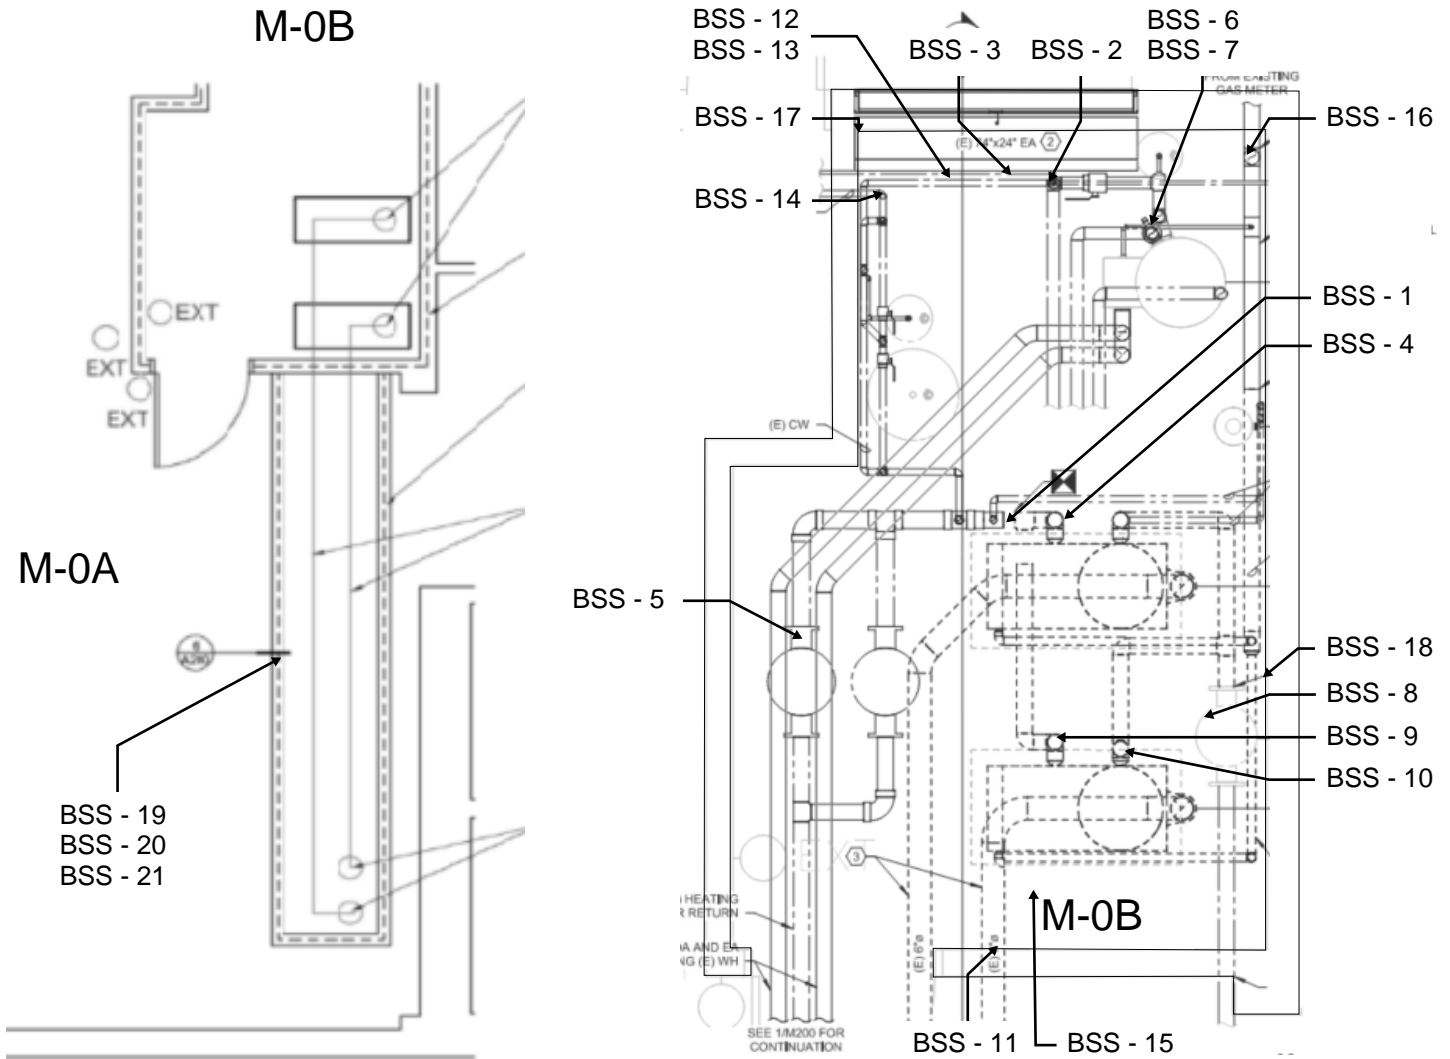
# Figure 1 - Sample Location Map

BSS - M-0A & M-0B

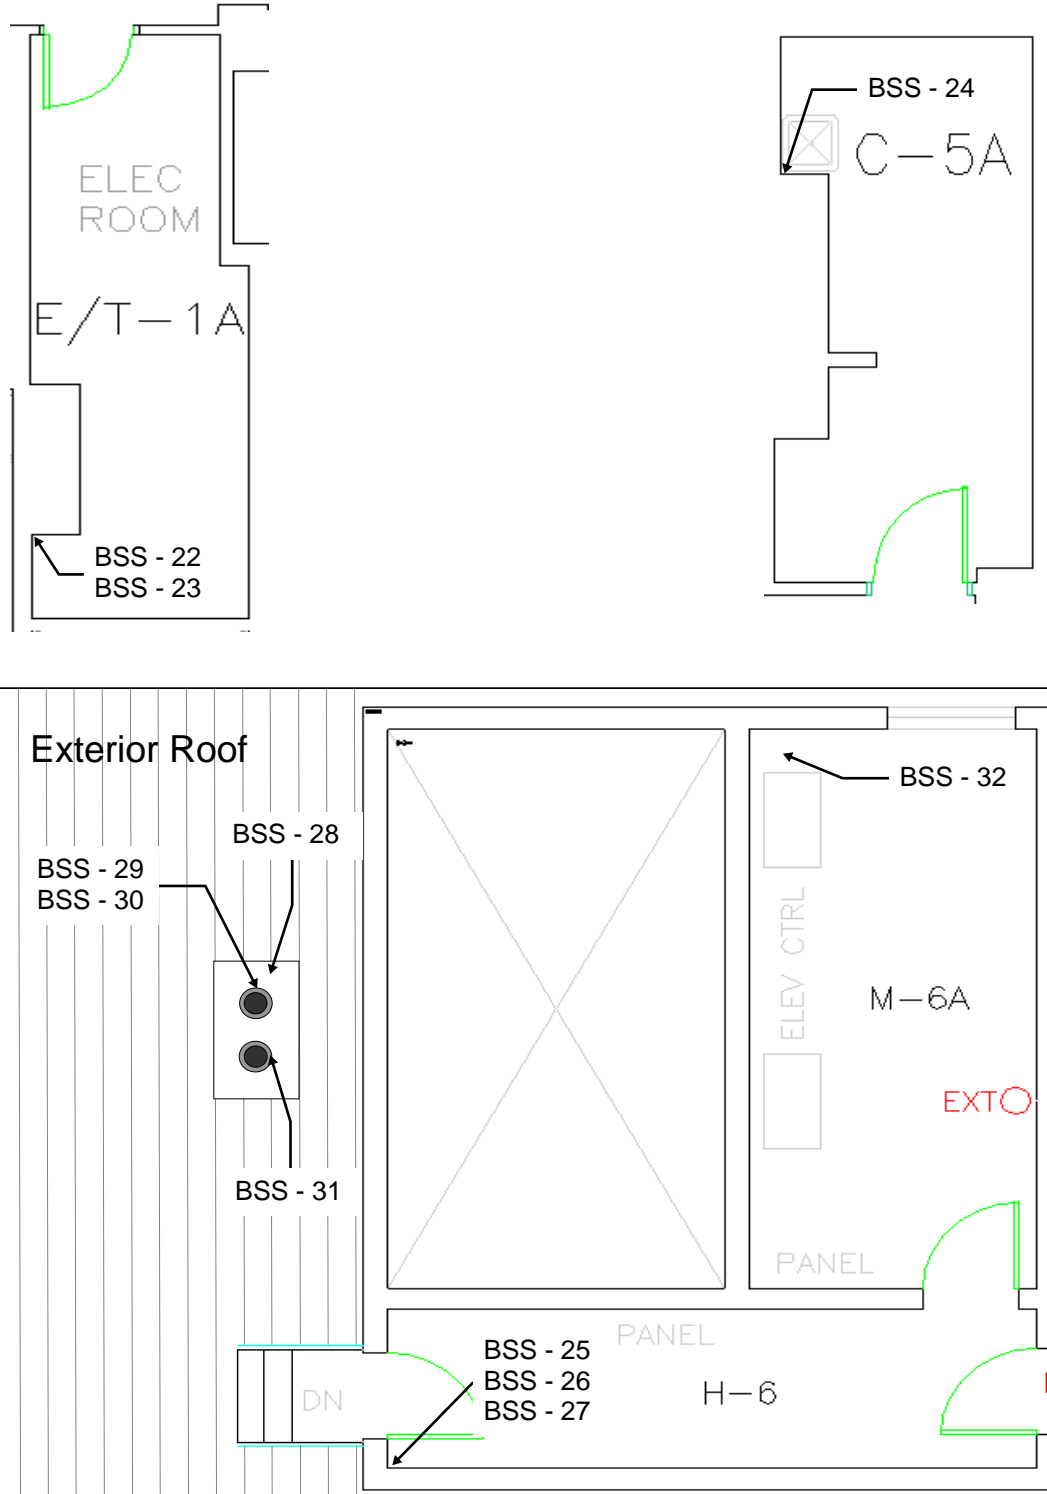
# Figure 1.2 - Sample Location Map

BSS - E/T-1A, C-5A, H-6, M-6A & Exterior Roof

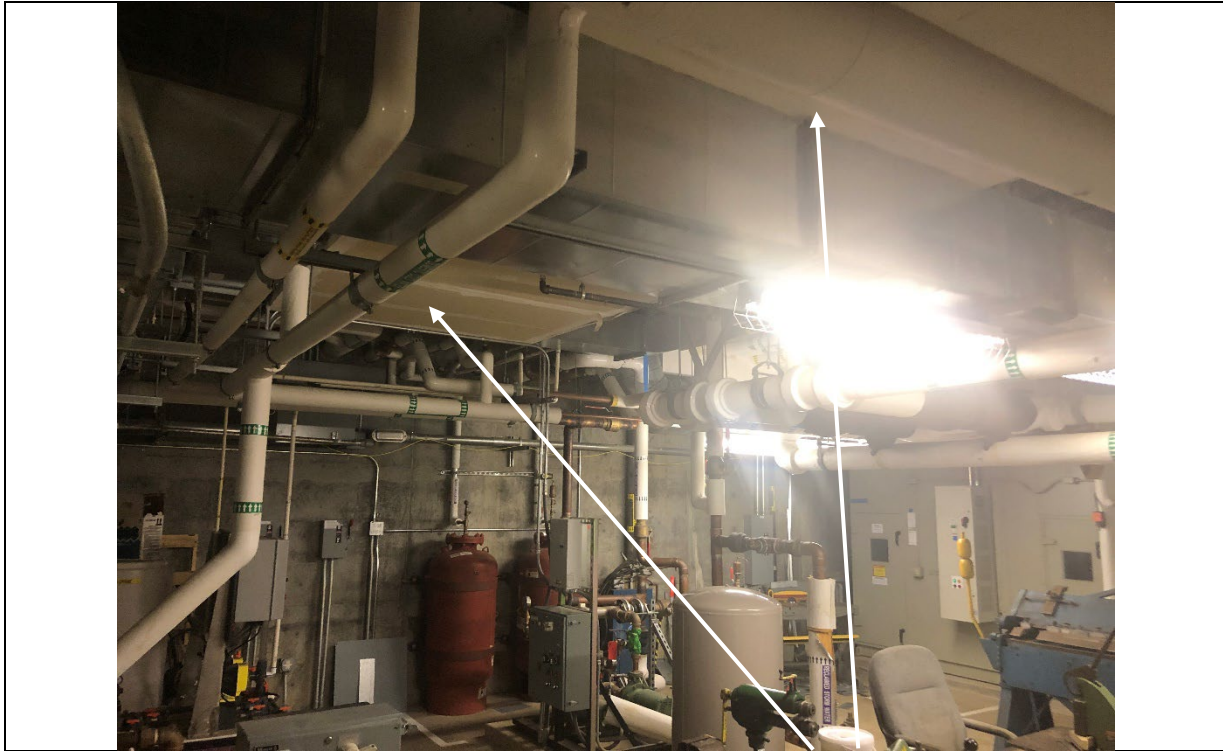
Photograph 1 – BSS Building – Room M-0A Horizontal Chase

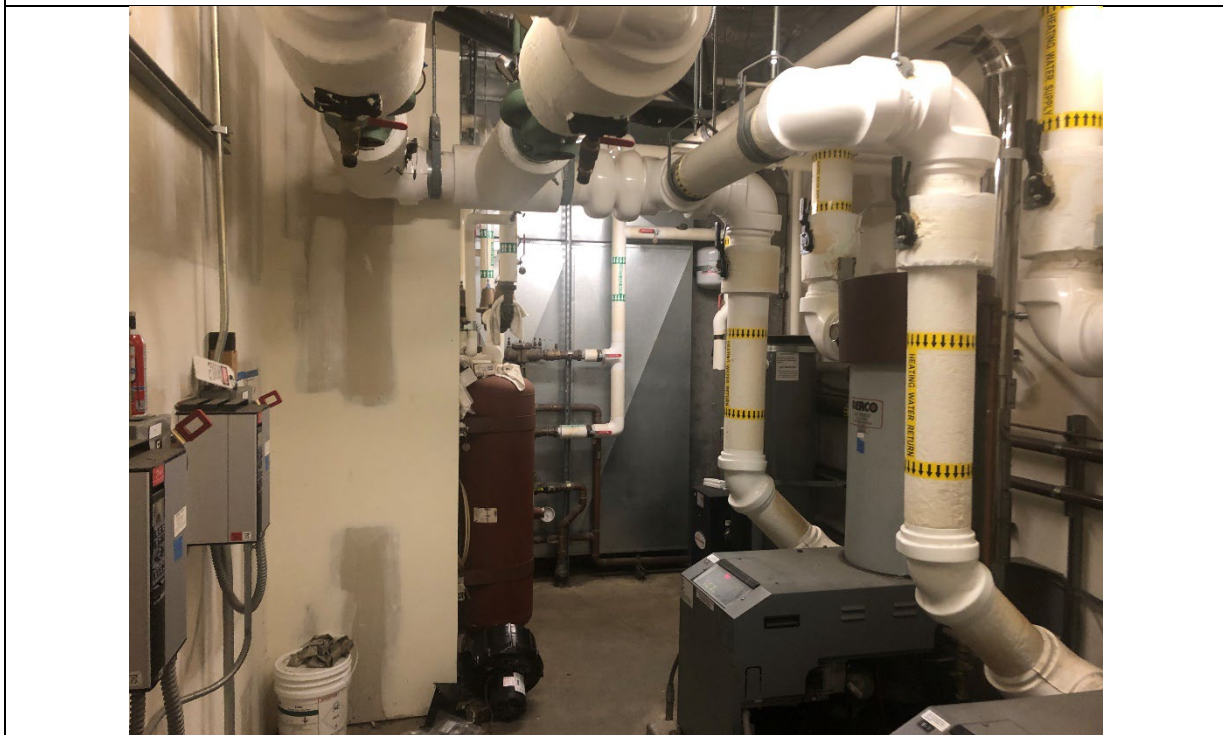
Photograph 2 – BSS Building – Room M-0B Horizontal and Vertical TSI Typical

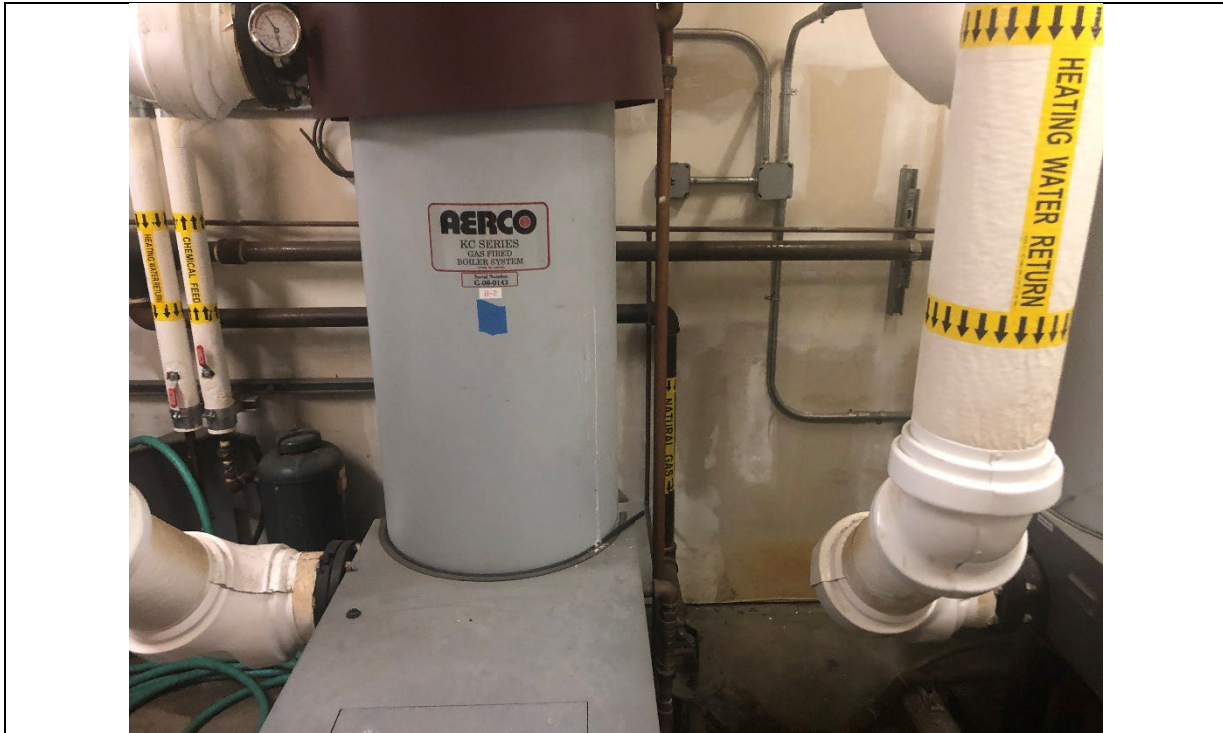
Photograph 3 – BSS Building – Room M-0B Vertical TSI and 45° Fitting (Typical)

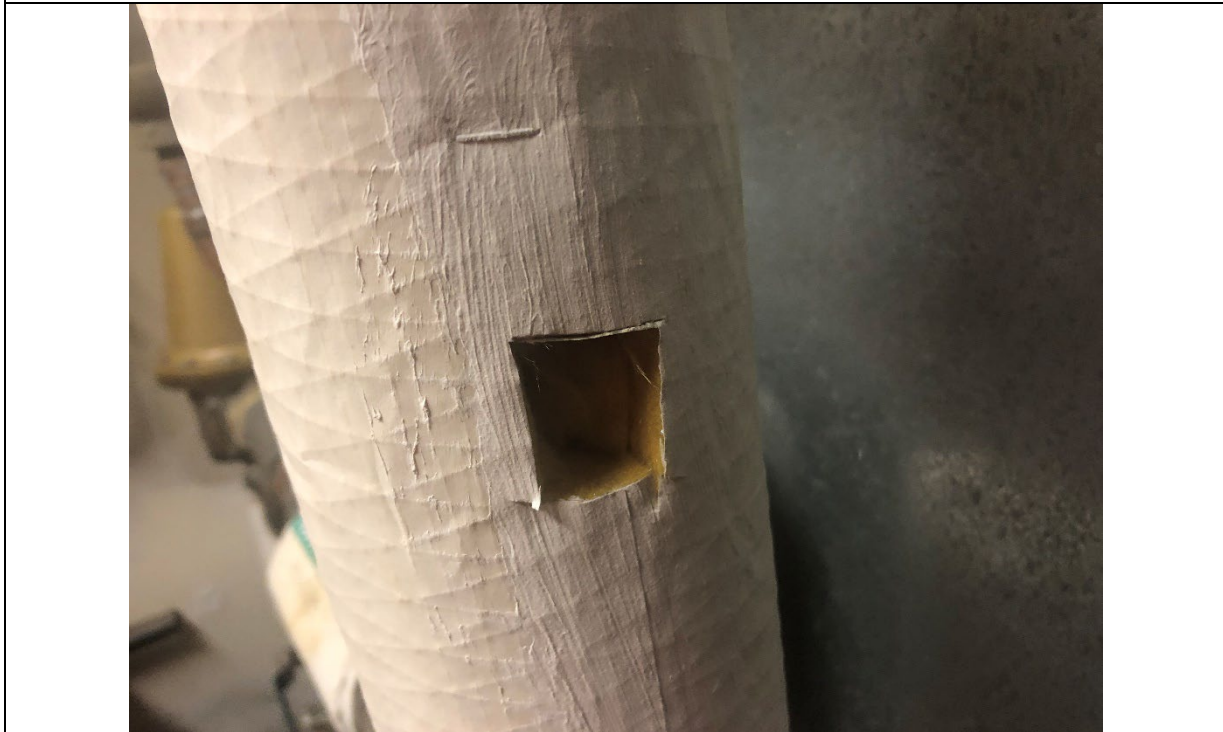
Photograph 4 – BSS Building – Room M-0B – Fiberglass TSI Run (Typical)

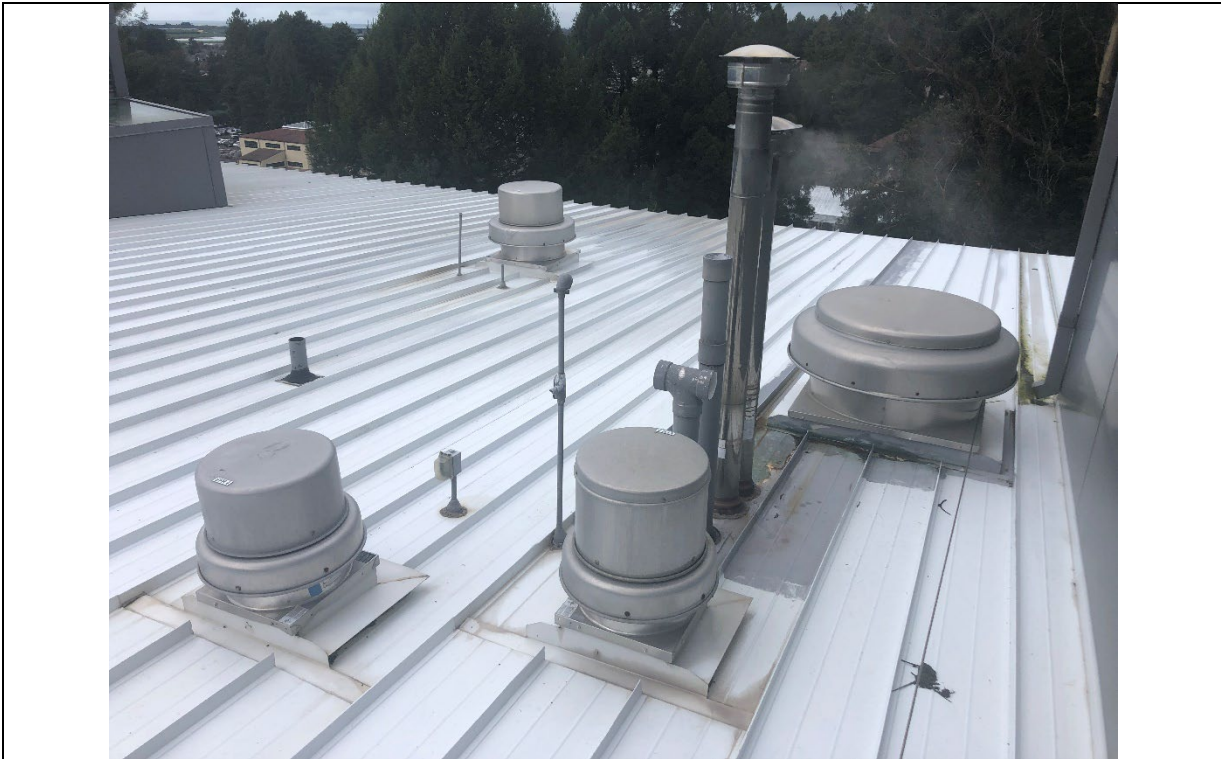
Photograph 5 – BSS Building – Roof Exhaust

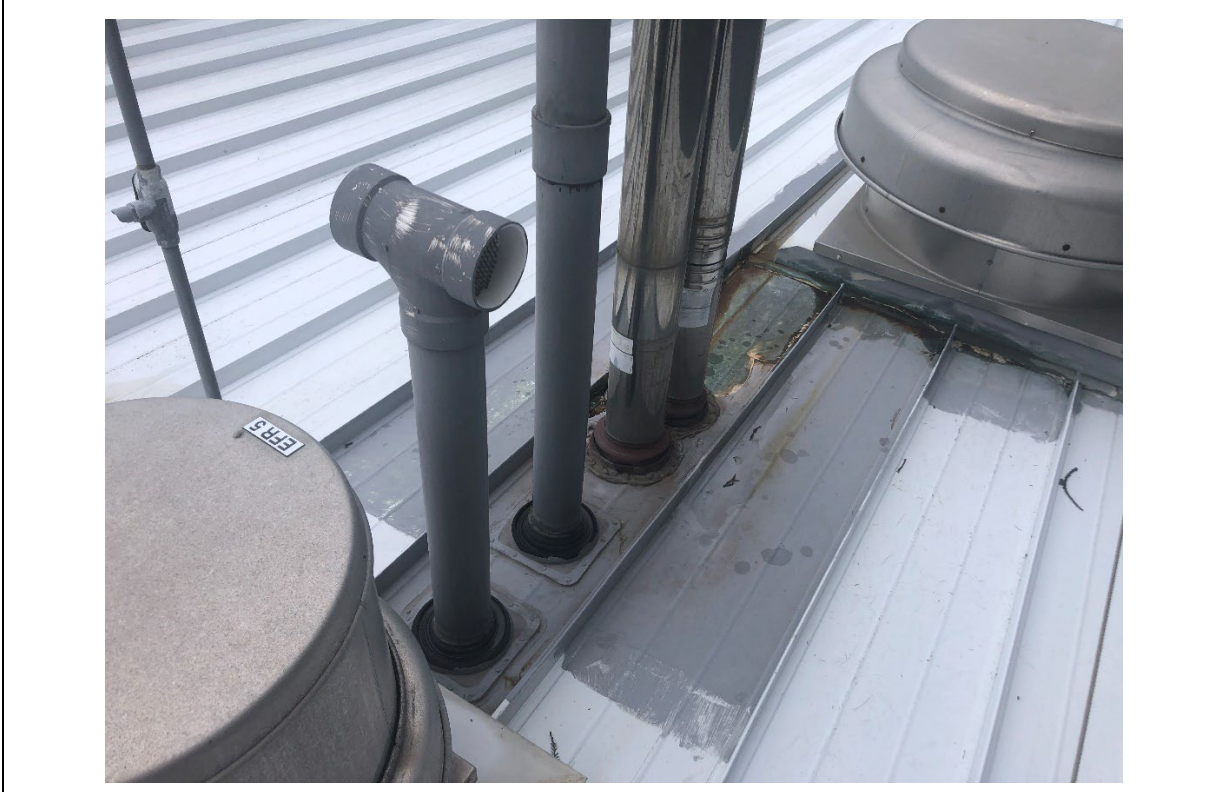
Photograph 6 – BSS Building – Roof Exhaust Detail

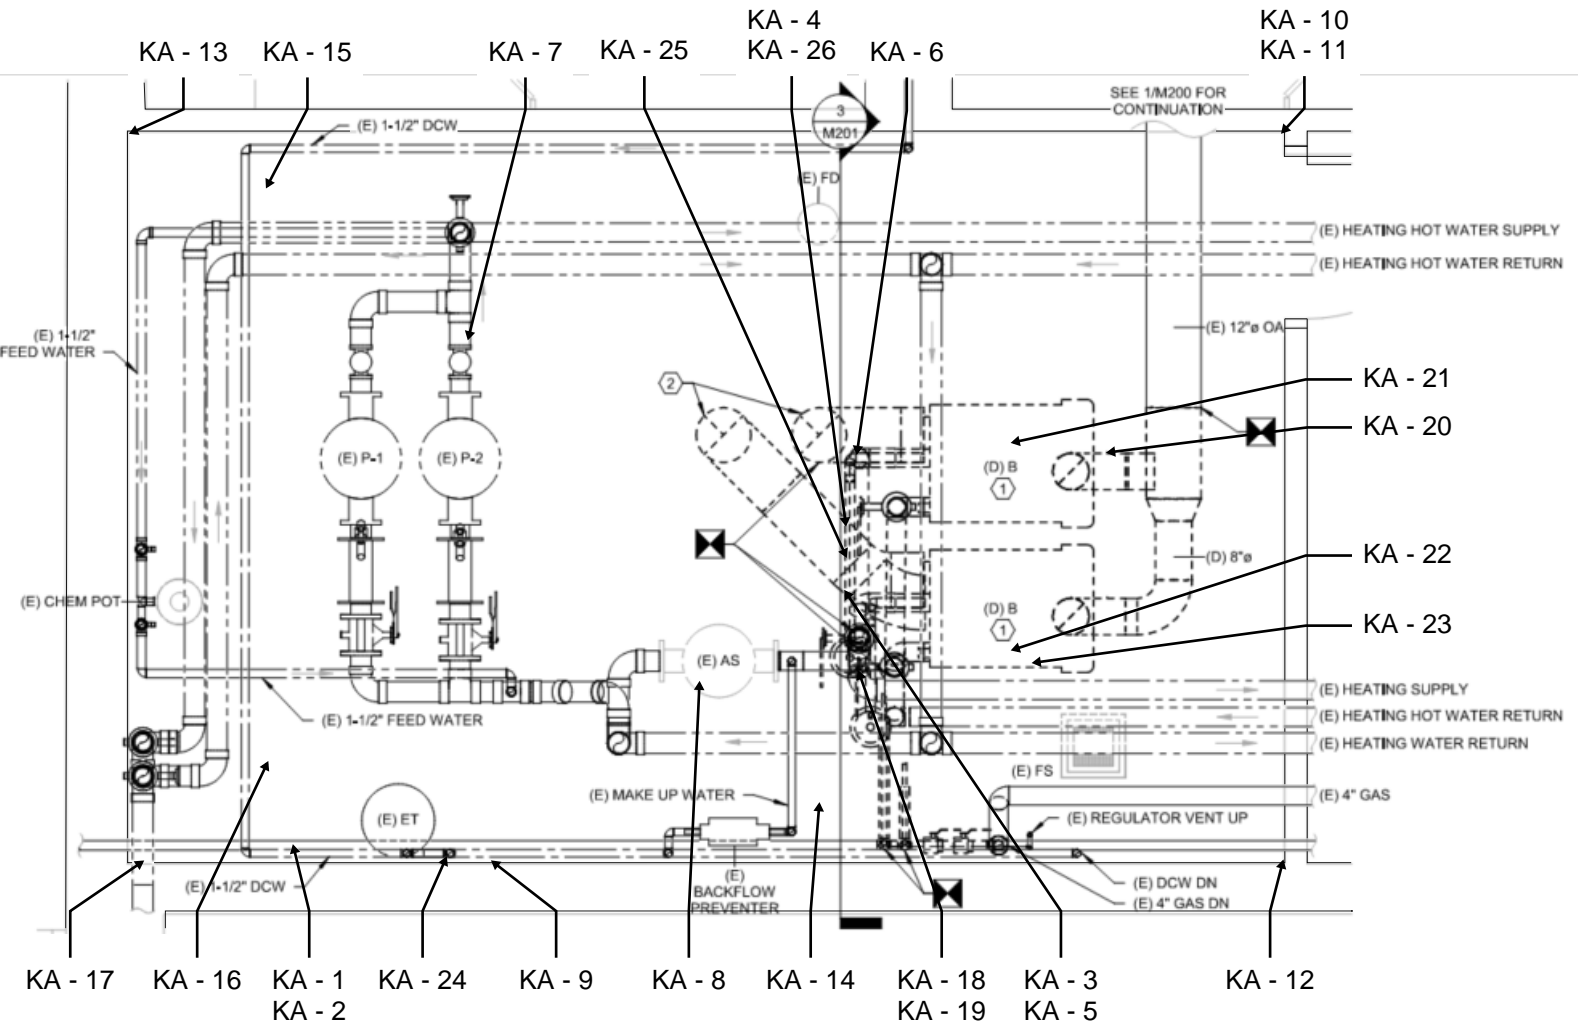
# Figure 1 - Sample Location Map

KA - M-3B

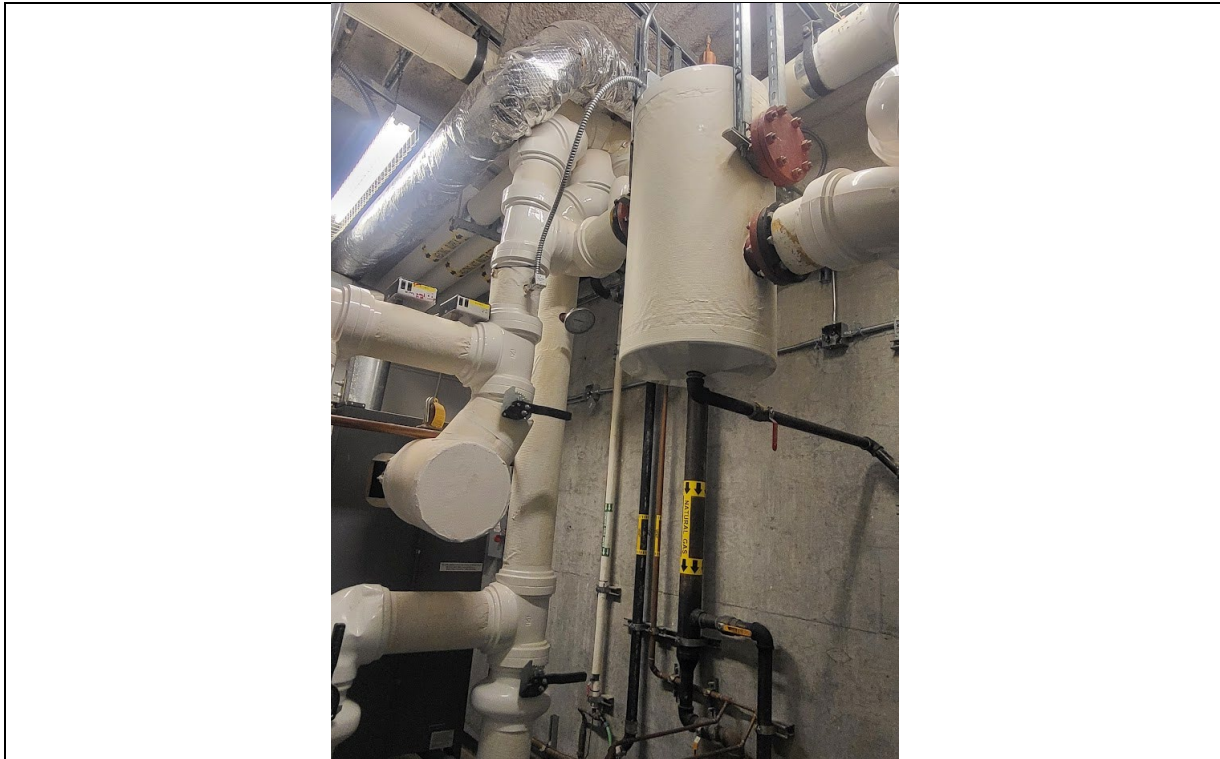
Photograph 5 – KA – Room M-3B – Fiberglass TSI (typical)

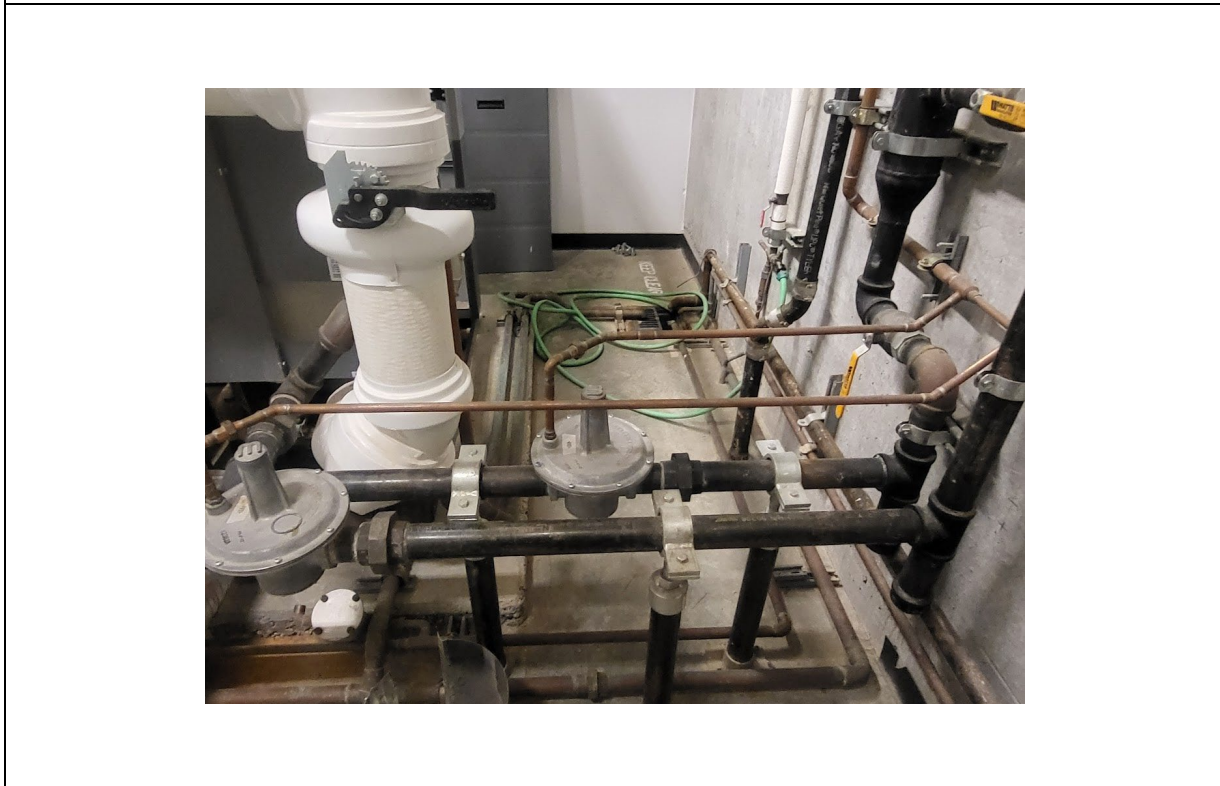
Photograph 6 – KA – Room M-3B – TSI (typical) and flange location (typical)
