Asbestos and Lead-Based Paint and Lead-Glazed Ceramic Tile Survey Report

Jenkins Hall at Humboldt State University in Arcata, CA

**Prepared For
Humboldt State University**

April 26, 2016

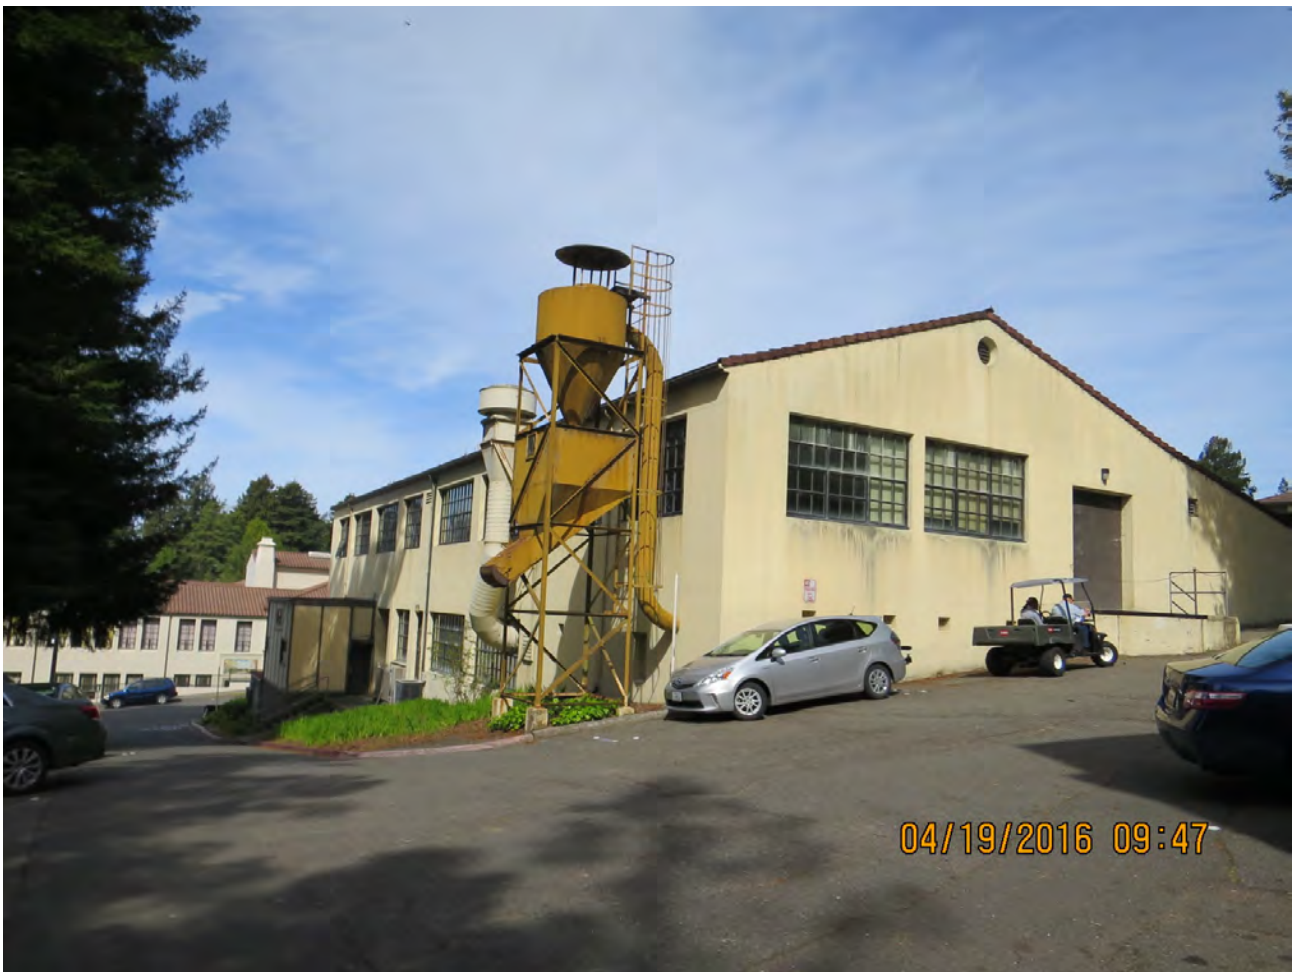
Photo 1: The exterior

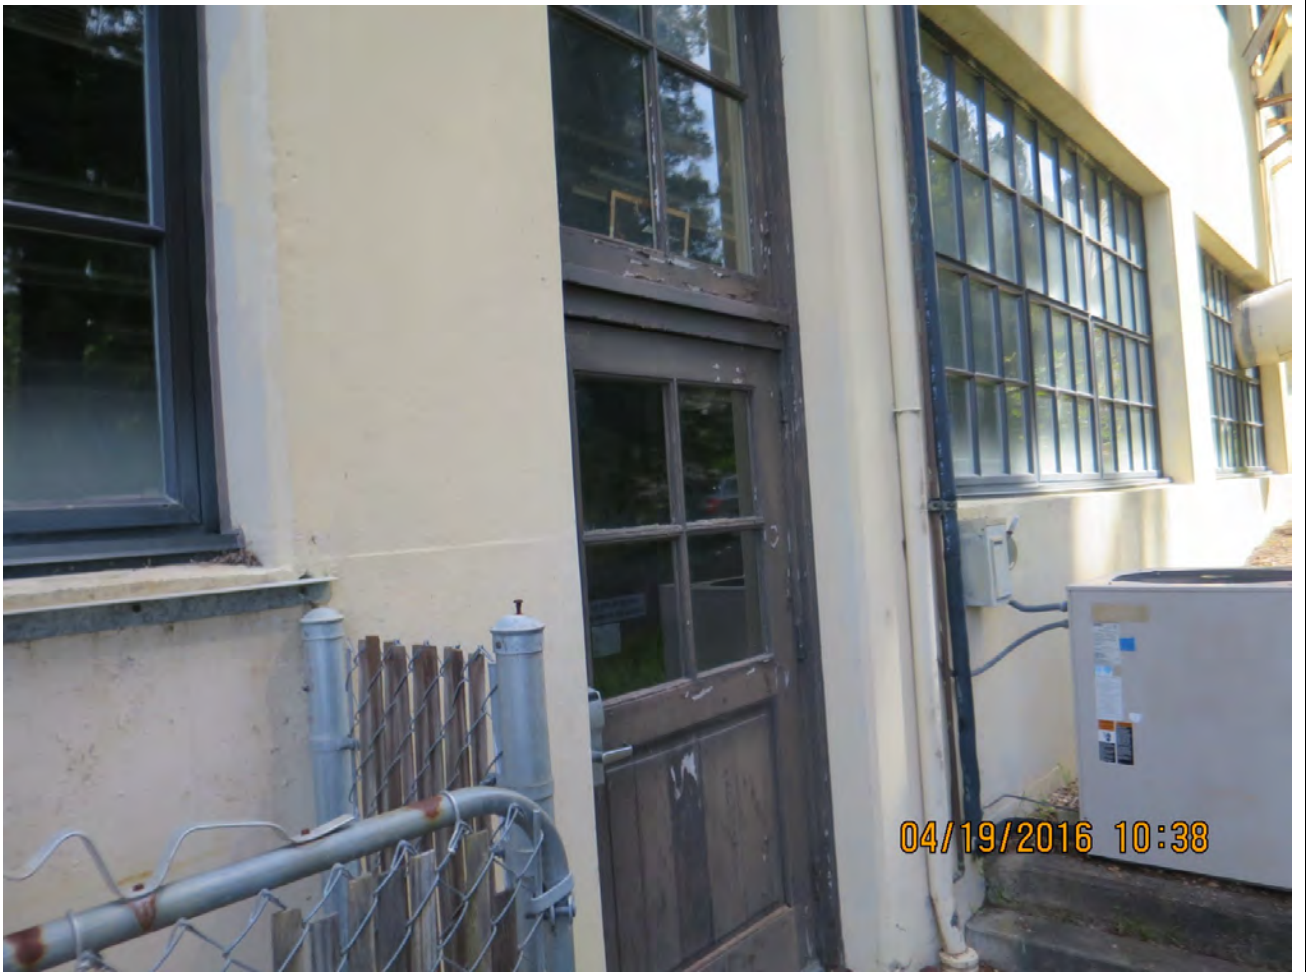
Photo 2: Lead-based paint on this wood doorway assembly

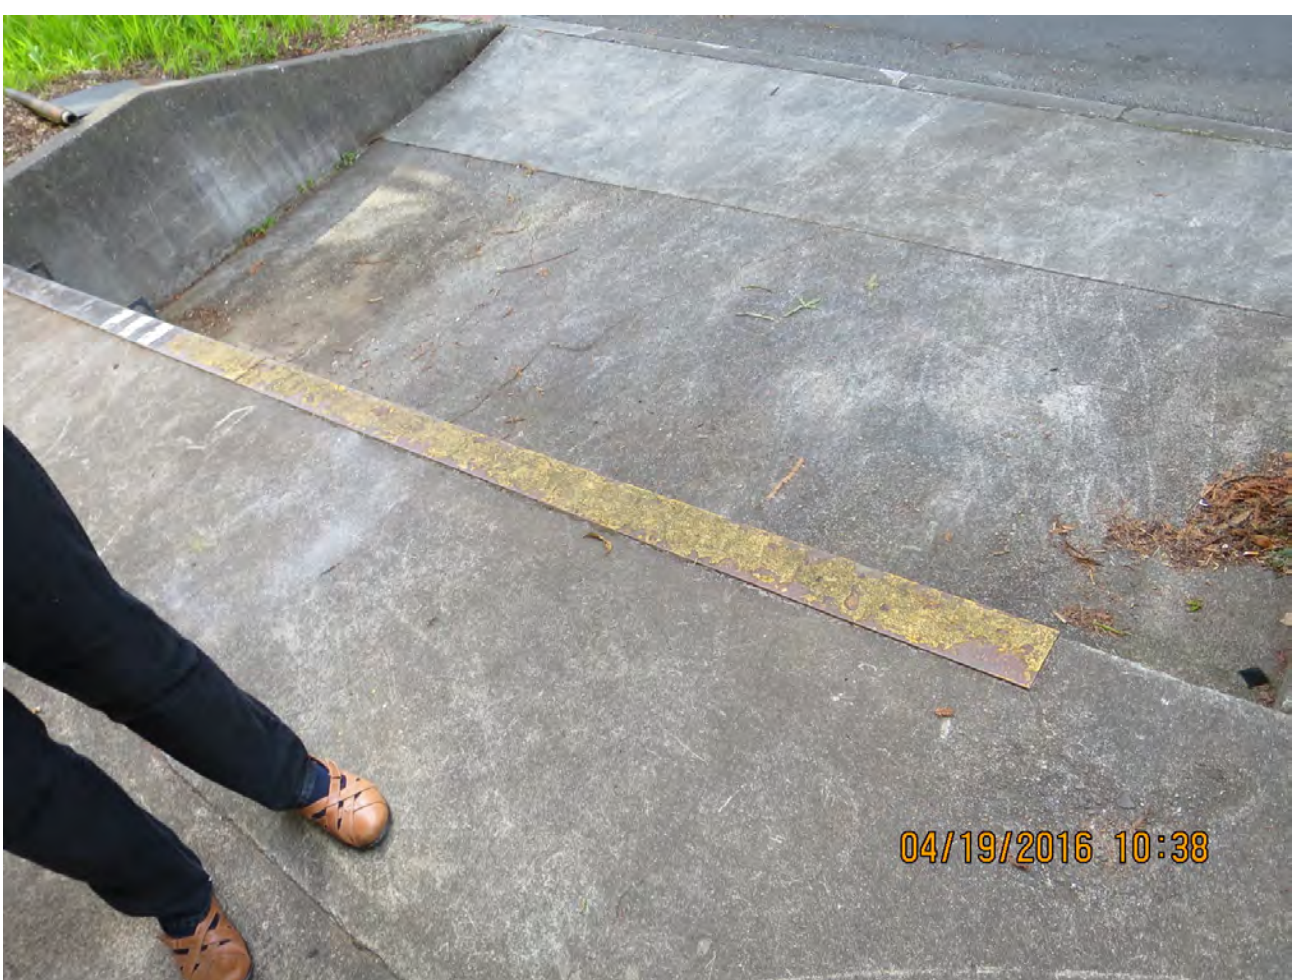
Photo 3: Lead-based paint on this metal strip at the loading dock is in poor condition

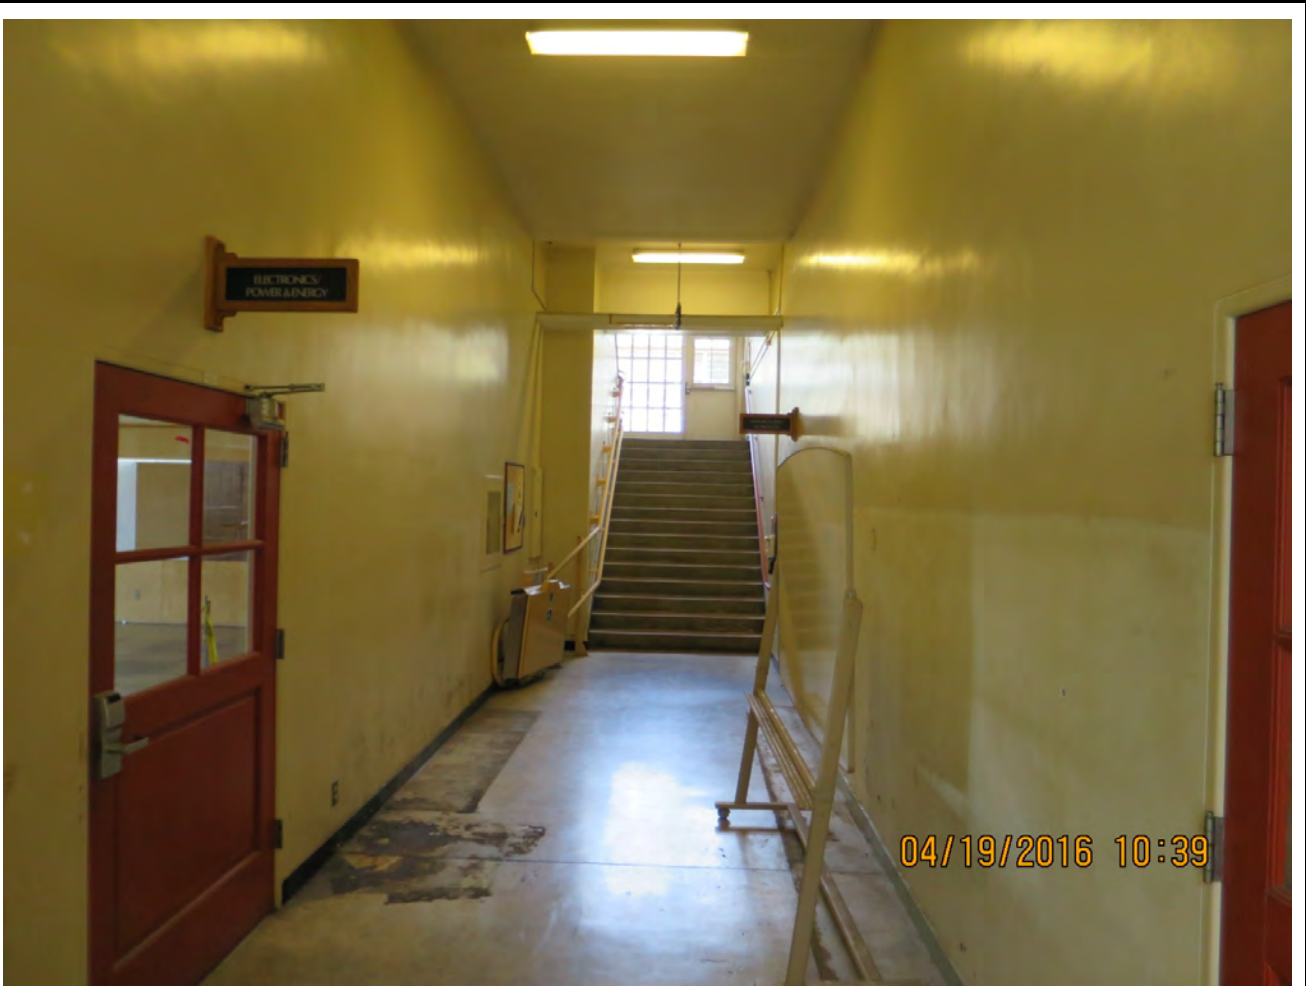
Photo 4: The first floor corridor

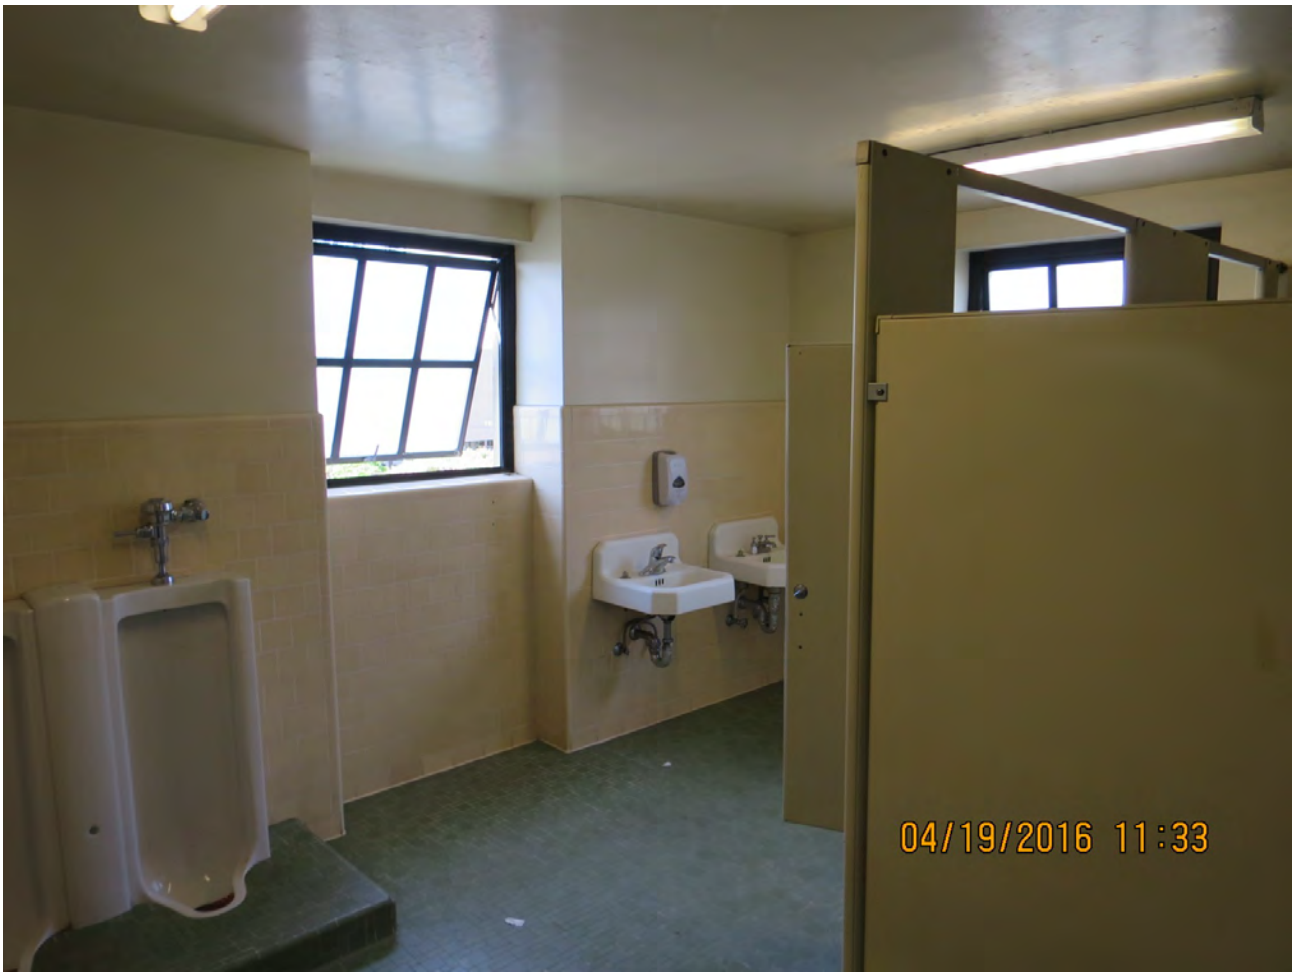
Photo 5: Lead-glazed ceramic wall tile in the restroom and janitor's closets area

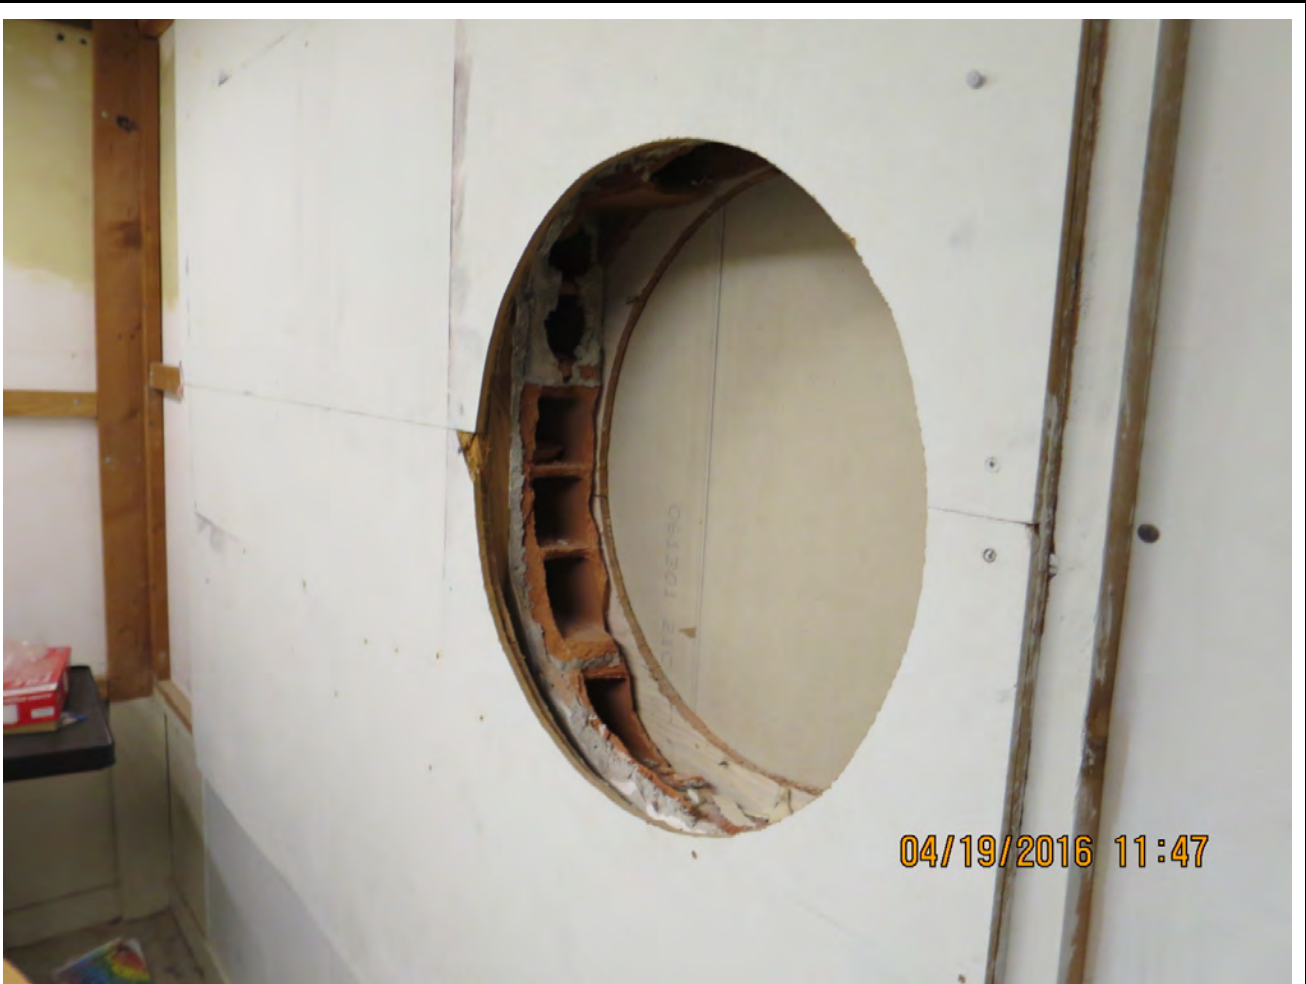
Photo 6: Except for a few newer drywall walls, the walls are made with hollow clay tile coated with plaster

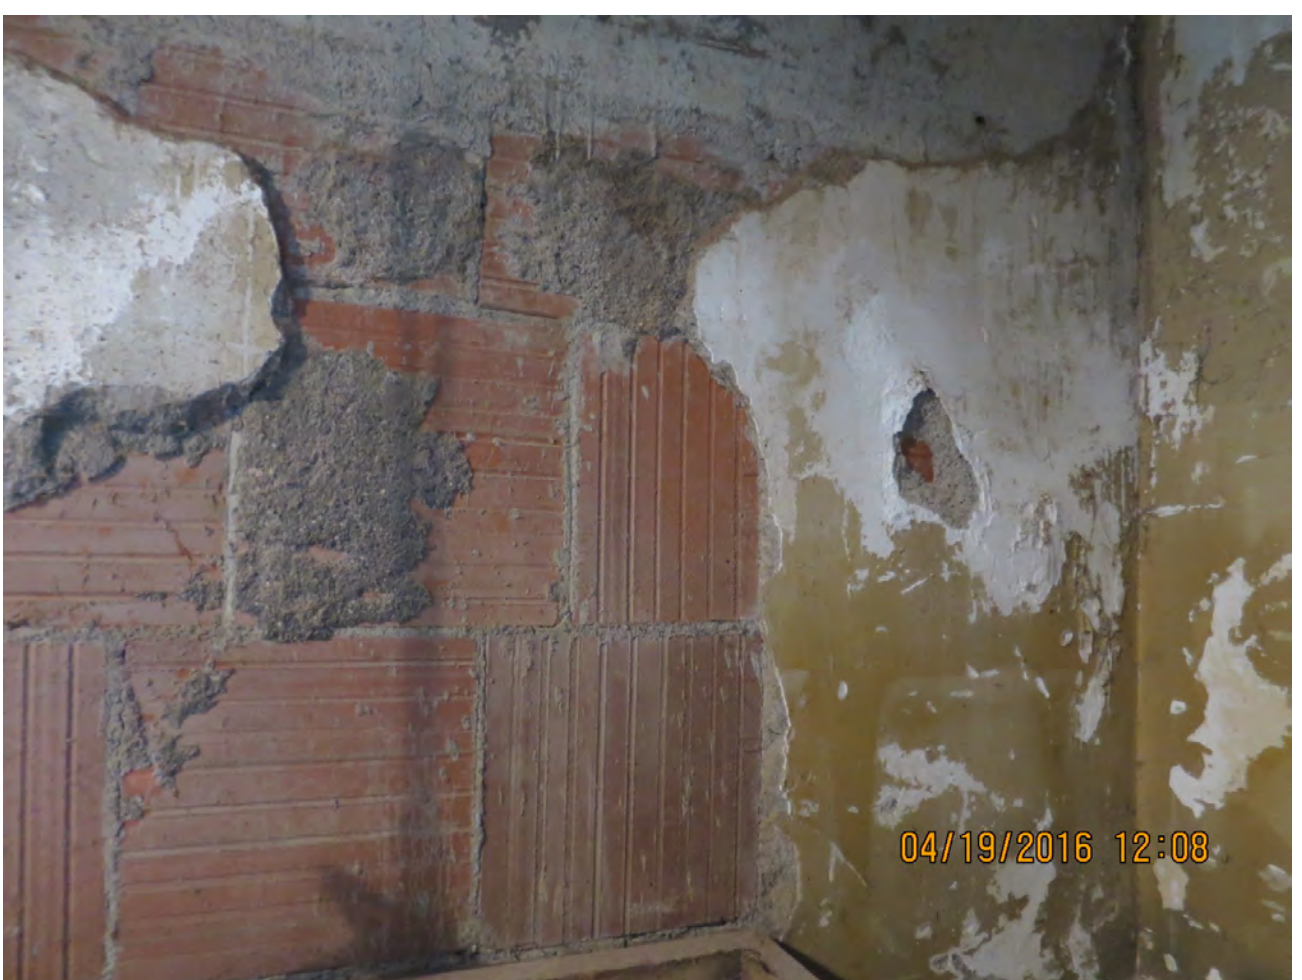
Photo 7: Another view of the hollow clay tile, hear applied on the inside of a concrete exterior wall

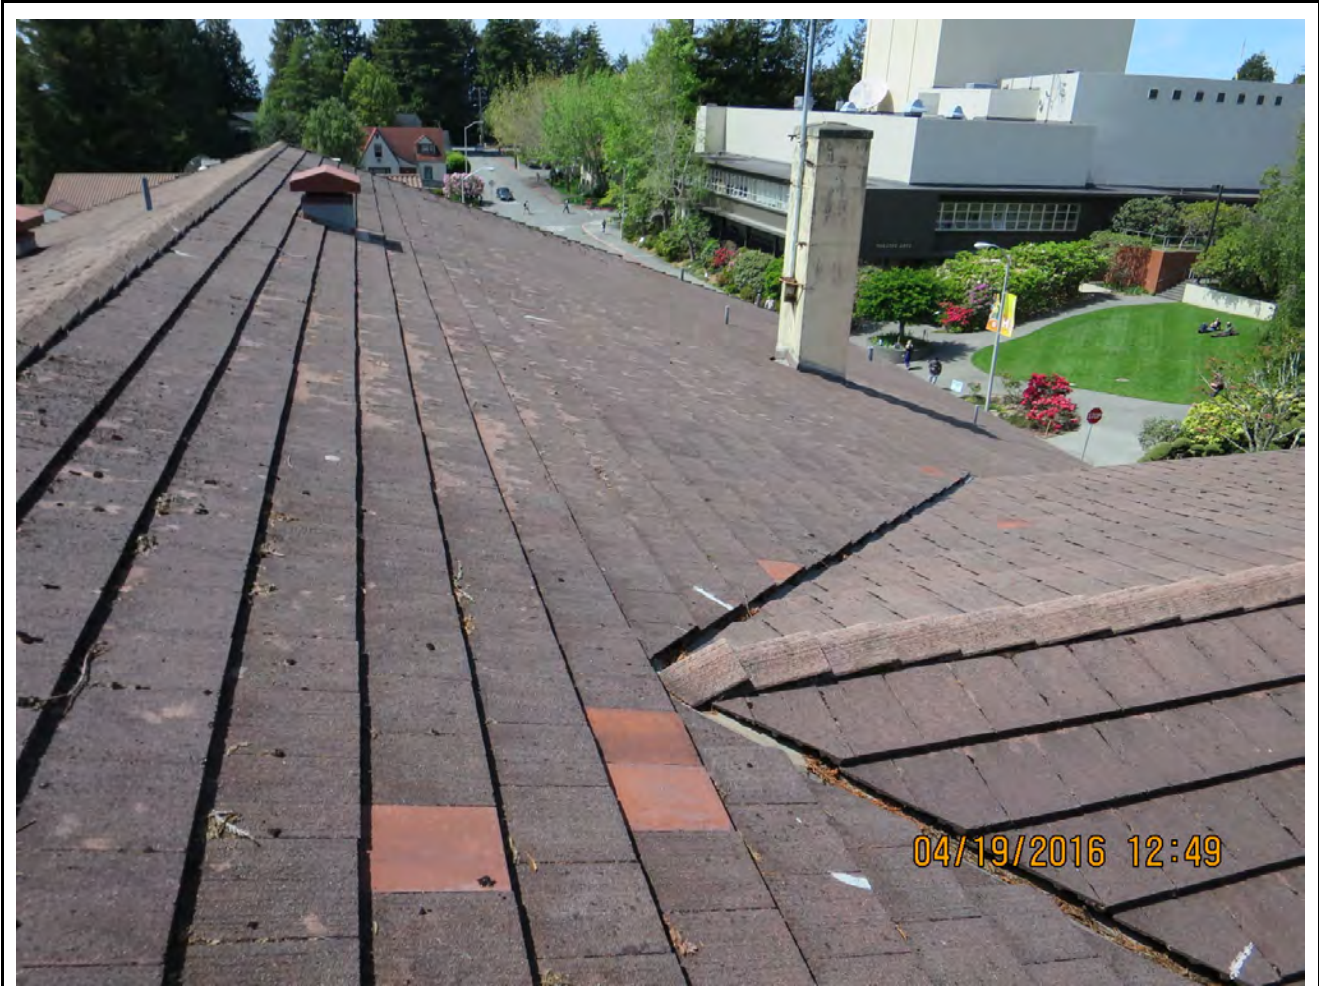
Photo 8: The roof is covered with concrete tile over tar paper and rubber-like roofing

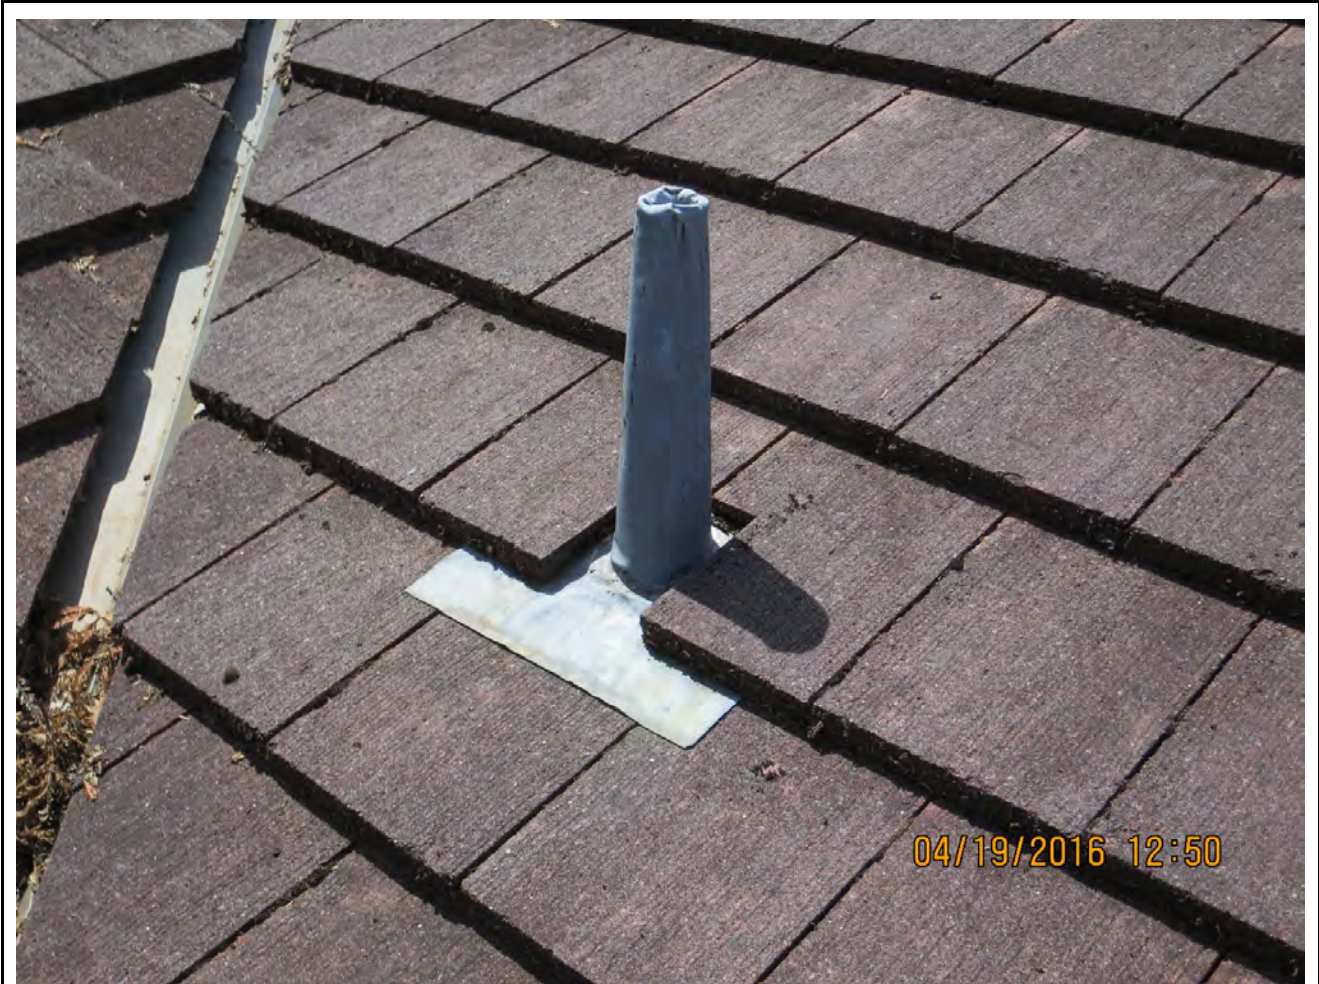
Photo 9: A typical lead vent flashing

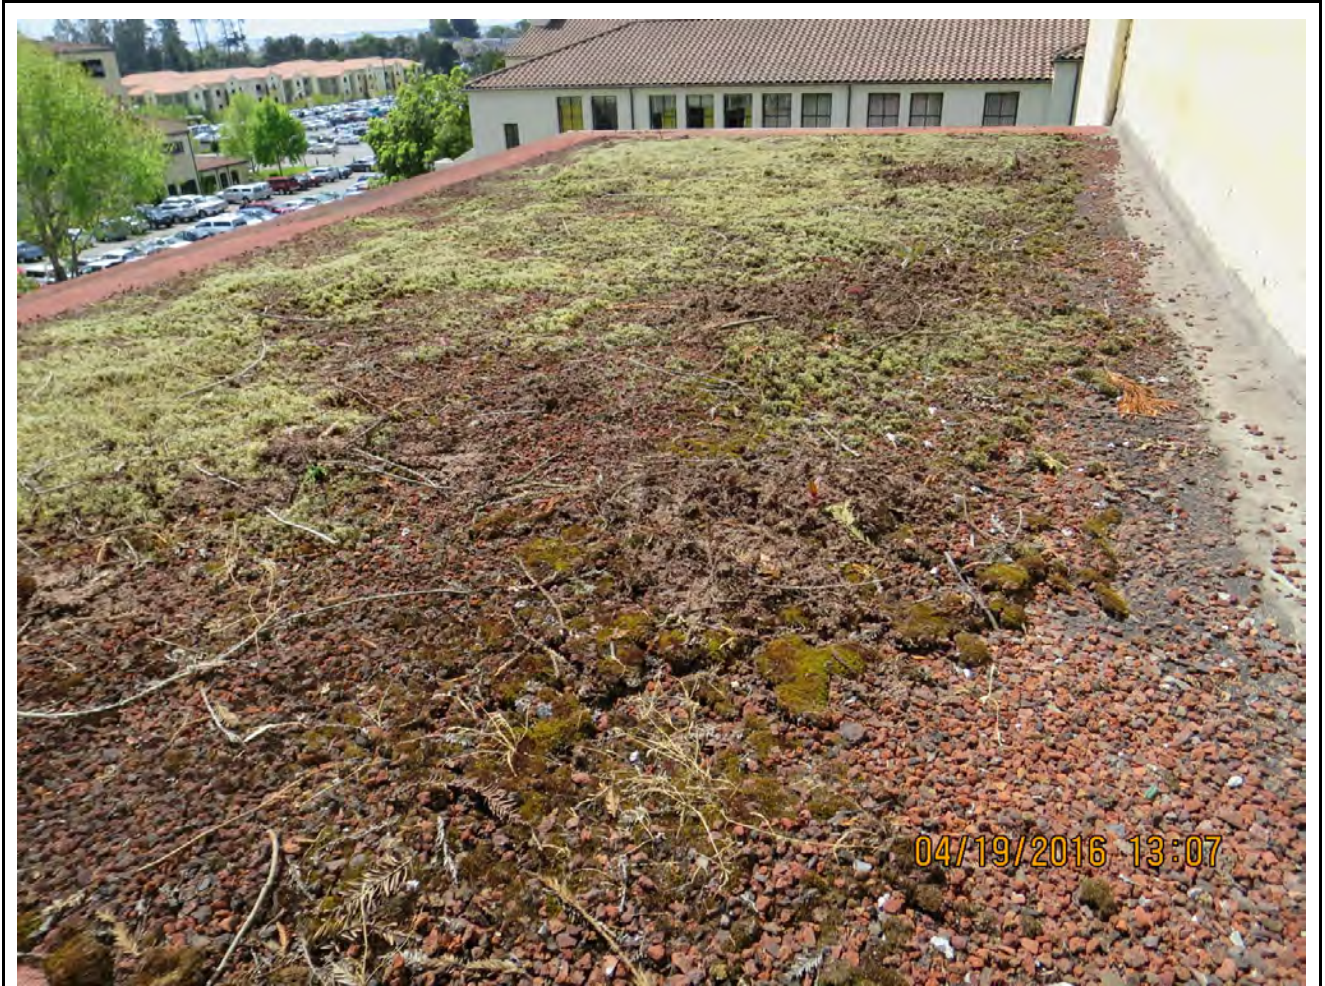
Photo 10: The flat roof over the addition

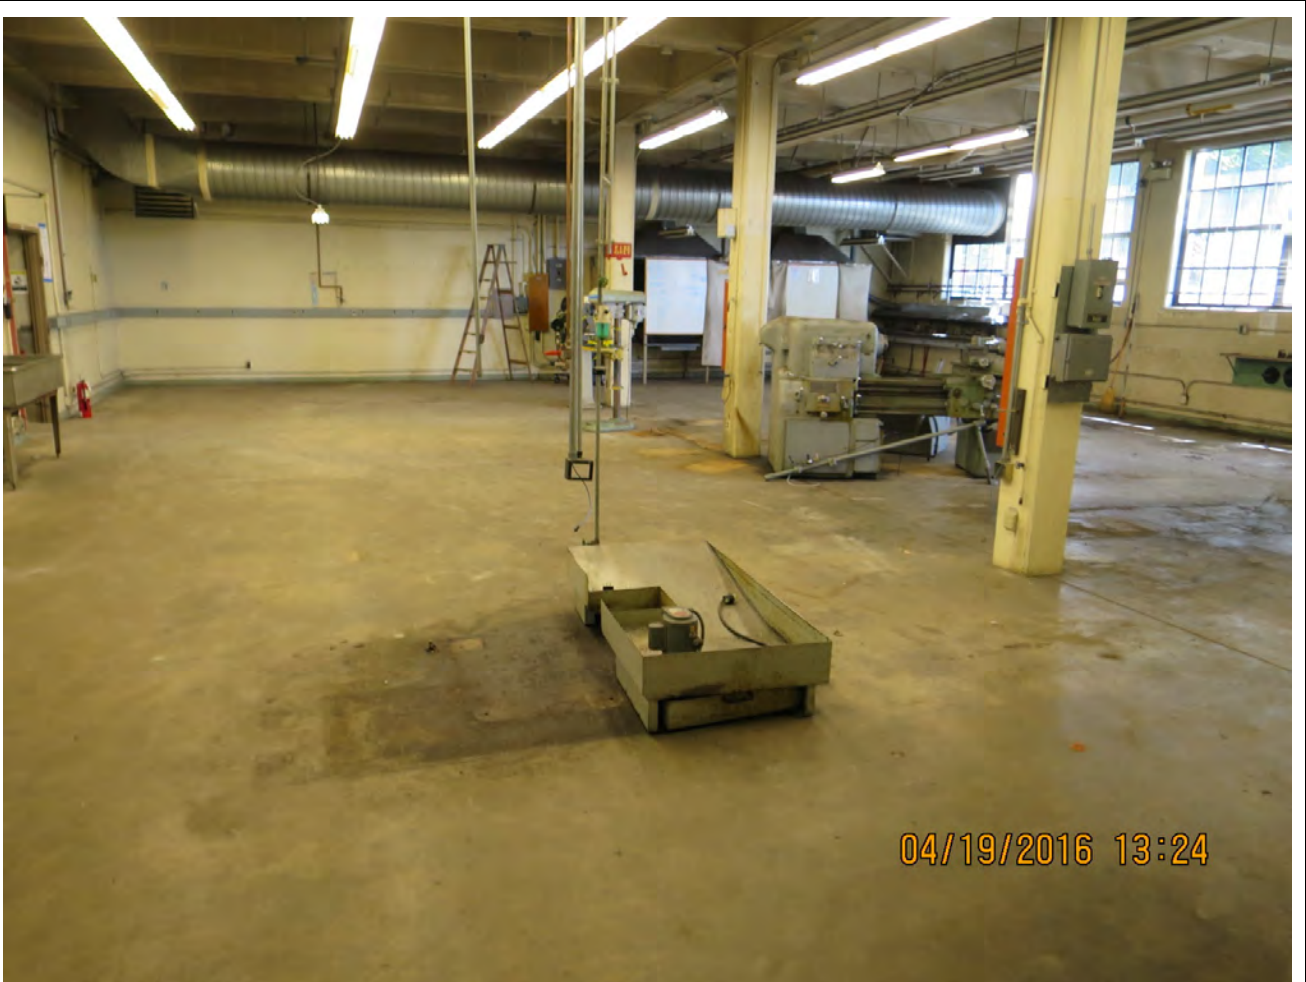
Photo 11: The former metal shop, Room 106. Note that it never had 9" x 9" vinyl floor tile as shown in a previous asbestos survey report. There are no shadow lines, nor any evidence of bead blasting

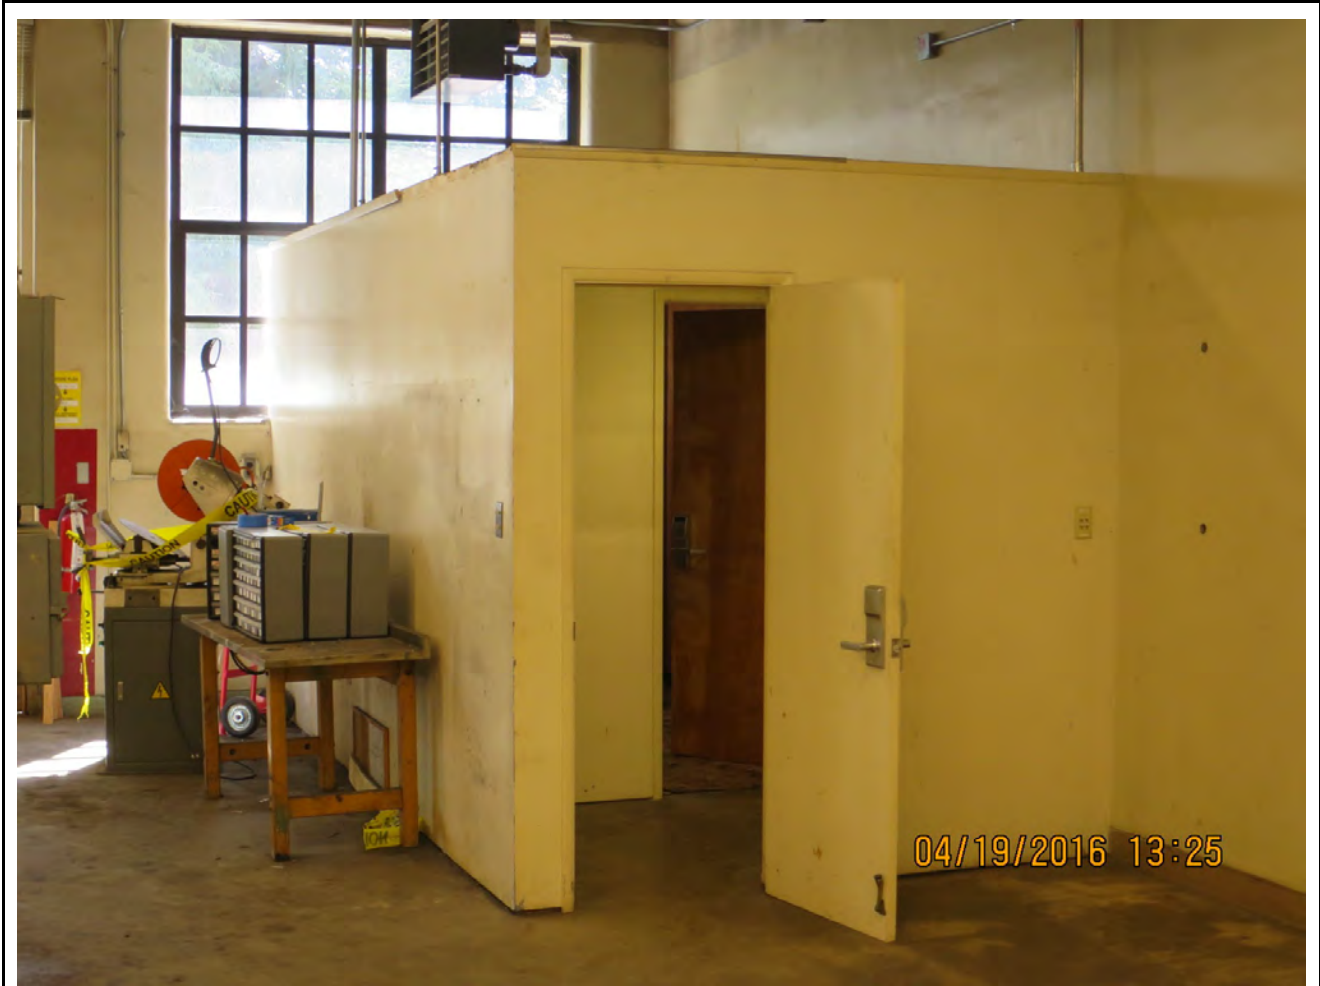
Photo 12: A small drywall office area in a corner of the former metal shop, Rooms 106A and 106B

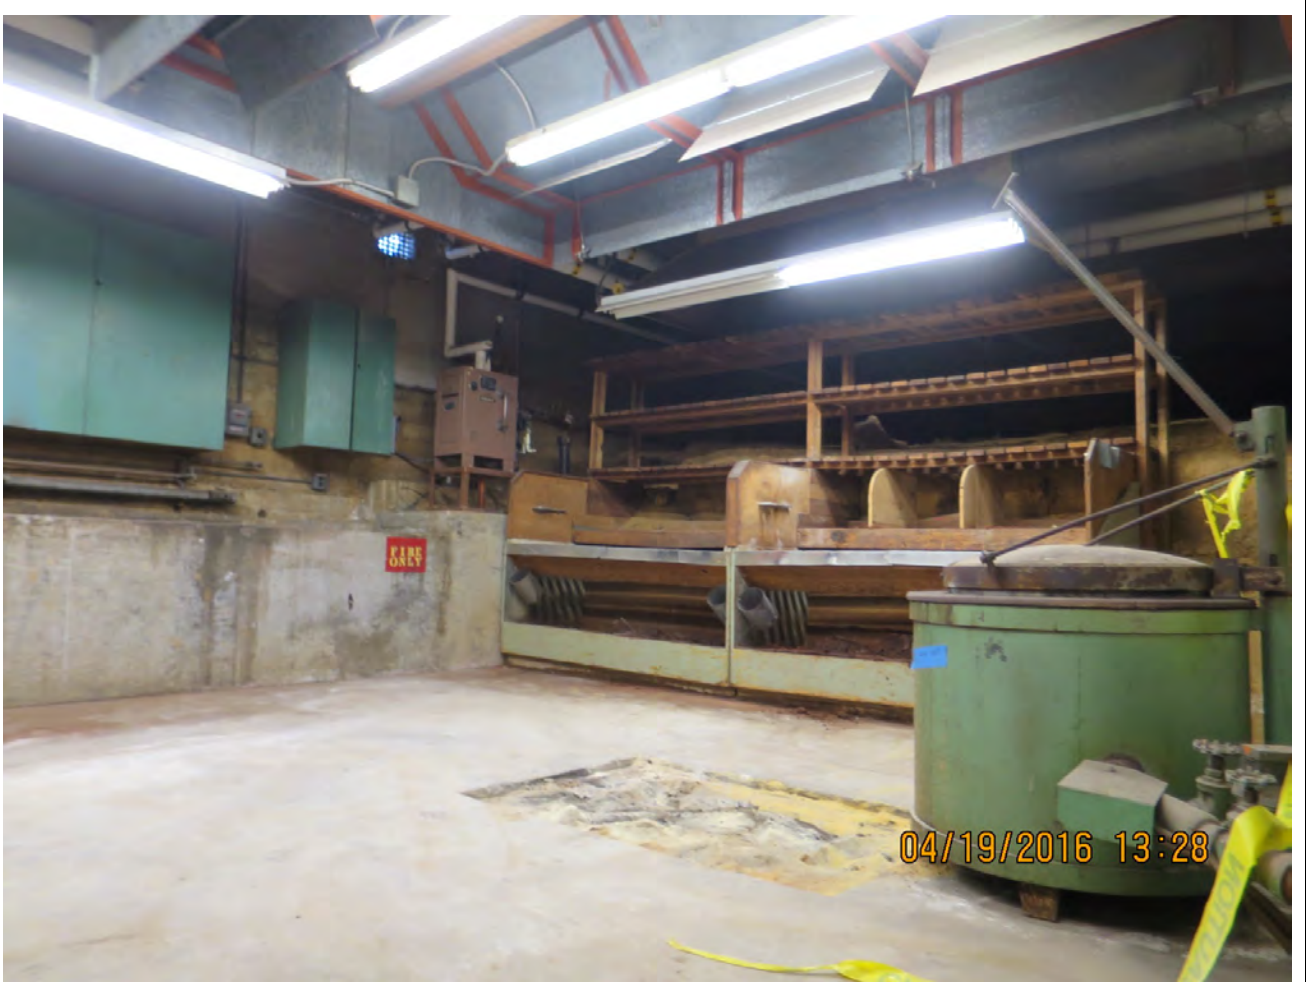
Photo 13: The former foundry, Room 109

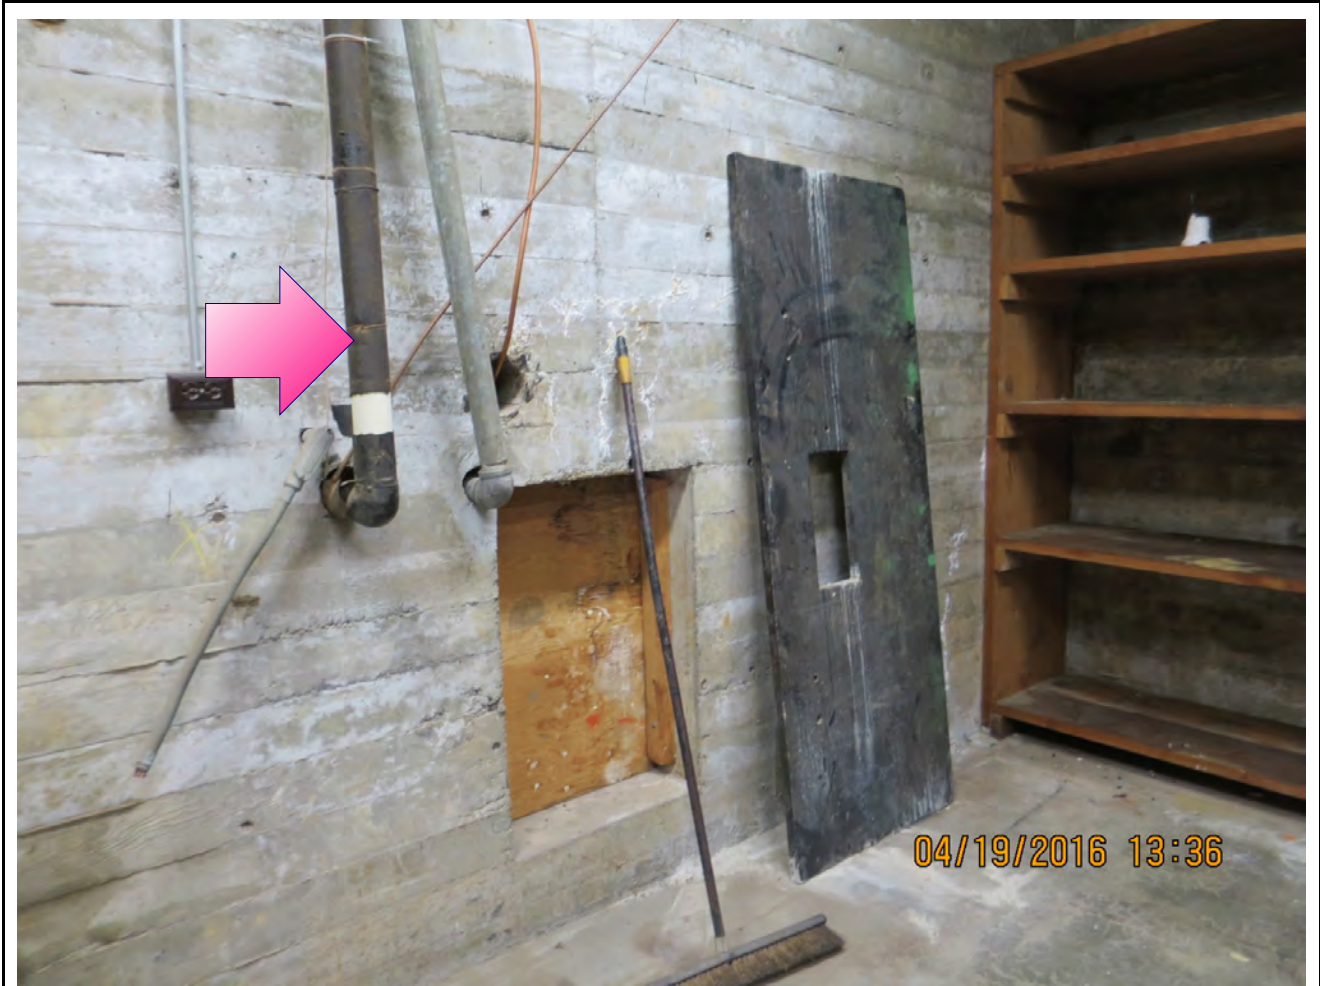
Photo 14: An asbestos-insulated pipe in Room 107, and continuing up to the second floor, and a laboratory table top stored in that room

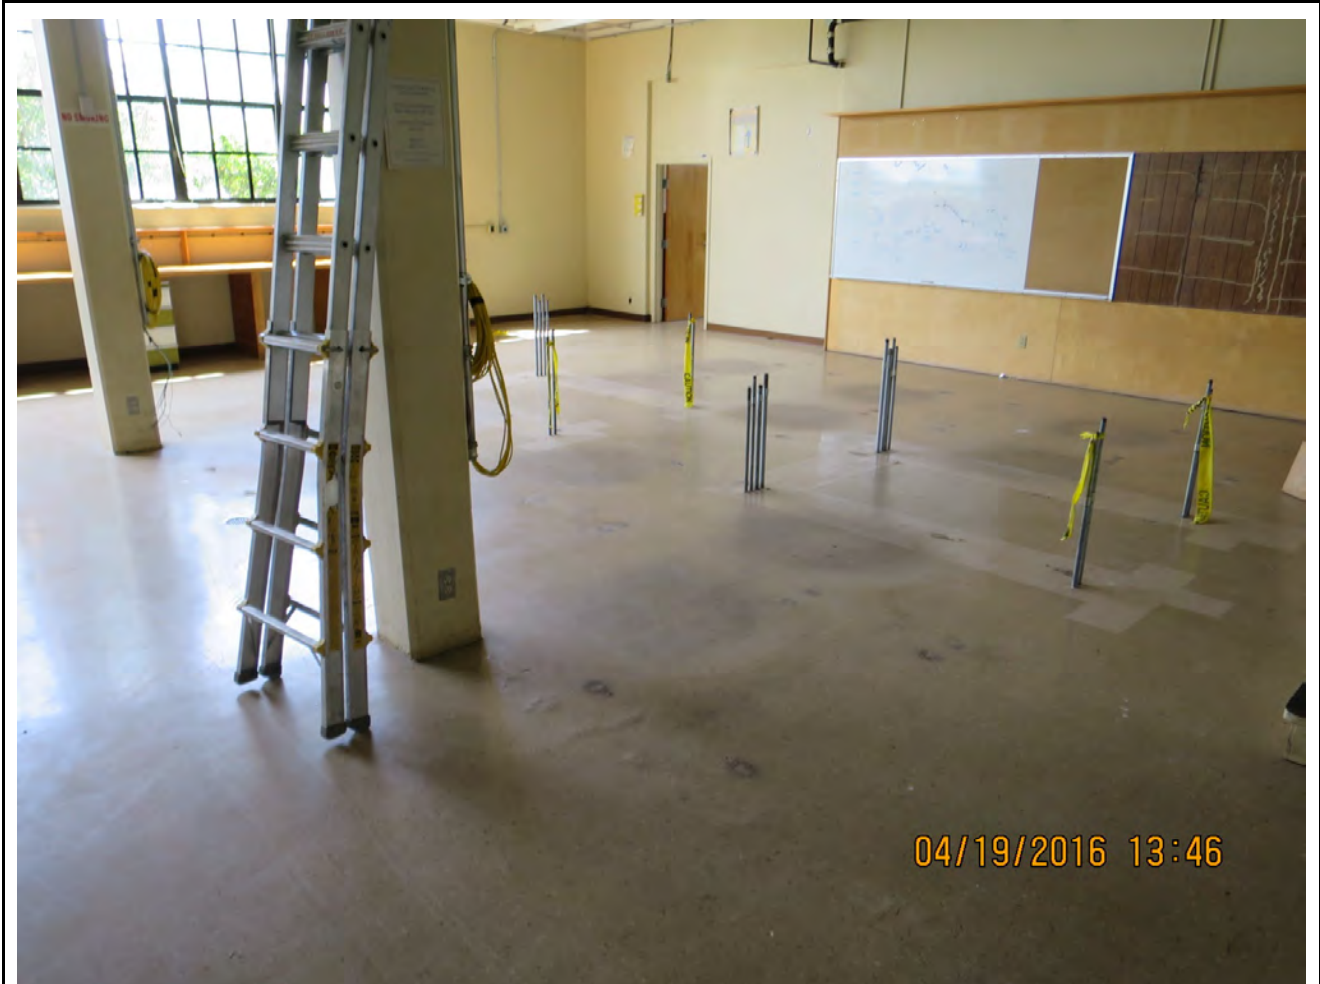
Photo 15: Room 102 and Room 101 beyond have 9" x 9" vinyl floor tile on the floors

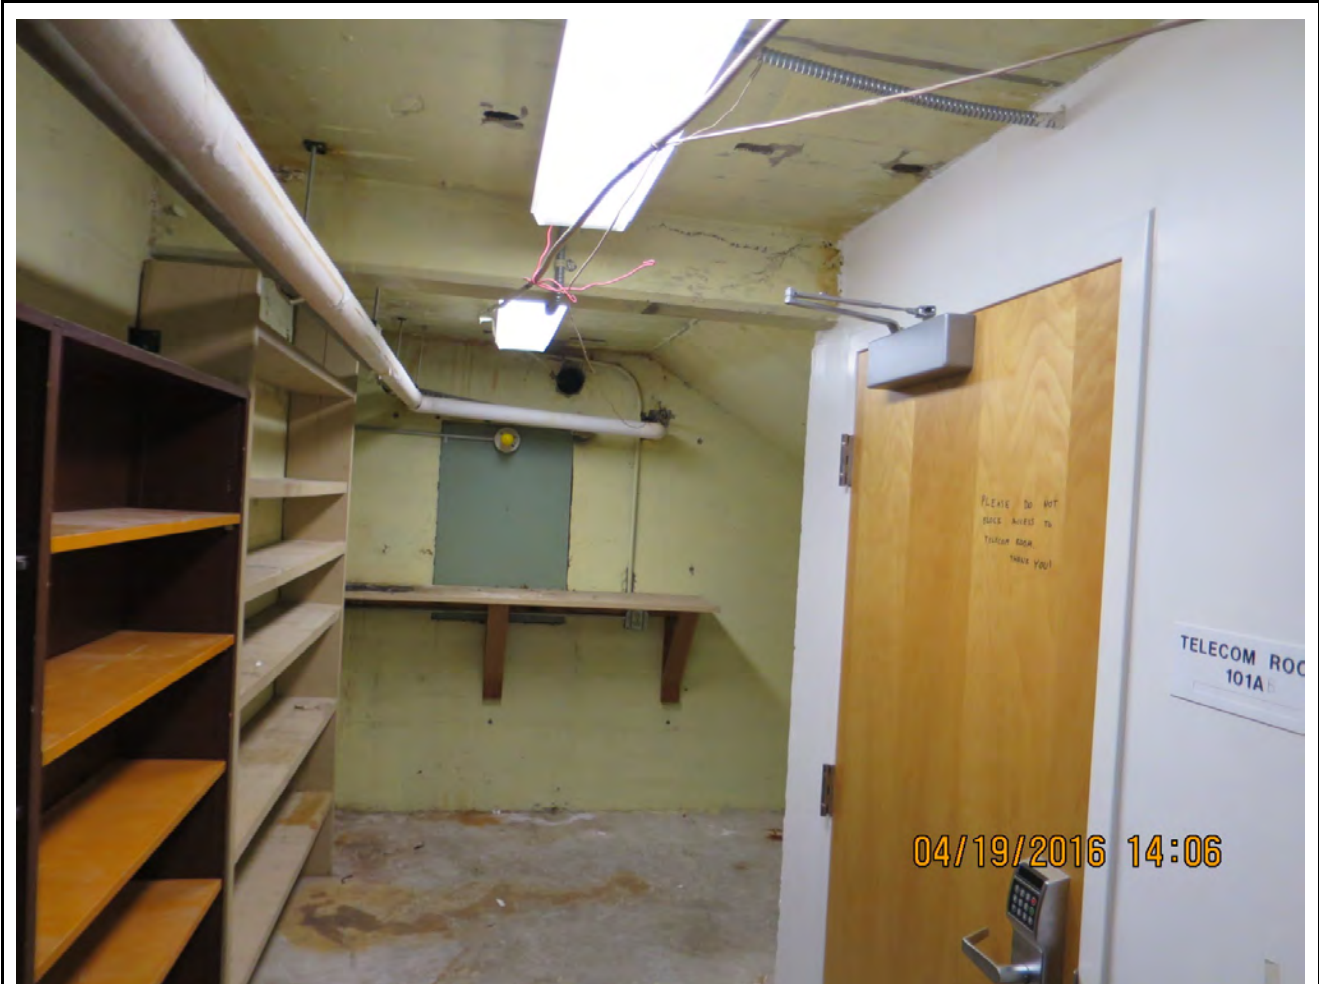
Photo 16: Room 101A where the pipe shown in Photo 14 has been re-insulated with fiberglass under foiled paper, and locked Room 101B

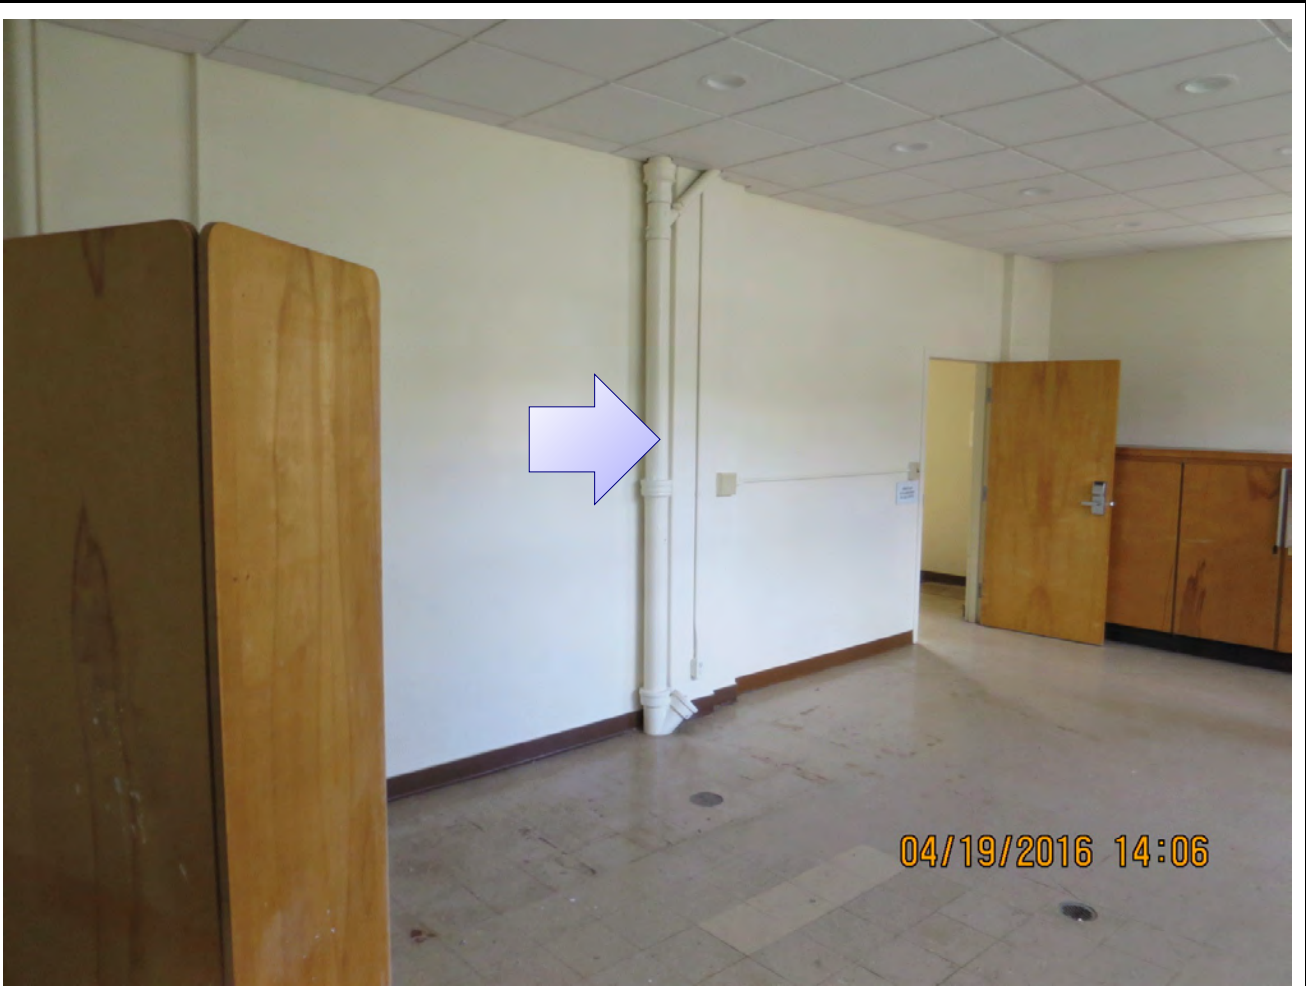
Photo 17:Room 101, and lead-based paint on the cast iron sewer pipe
