Asbestos and Lead-Based Paint and Lead-Glazed Ceramic Tile Survey Report

Jenkins Hall at Humboldt State University in Arcata, CA

**Prepared For
Humboldt State University**

April 26, 2016

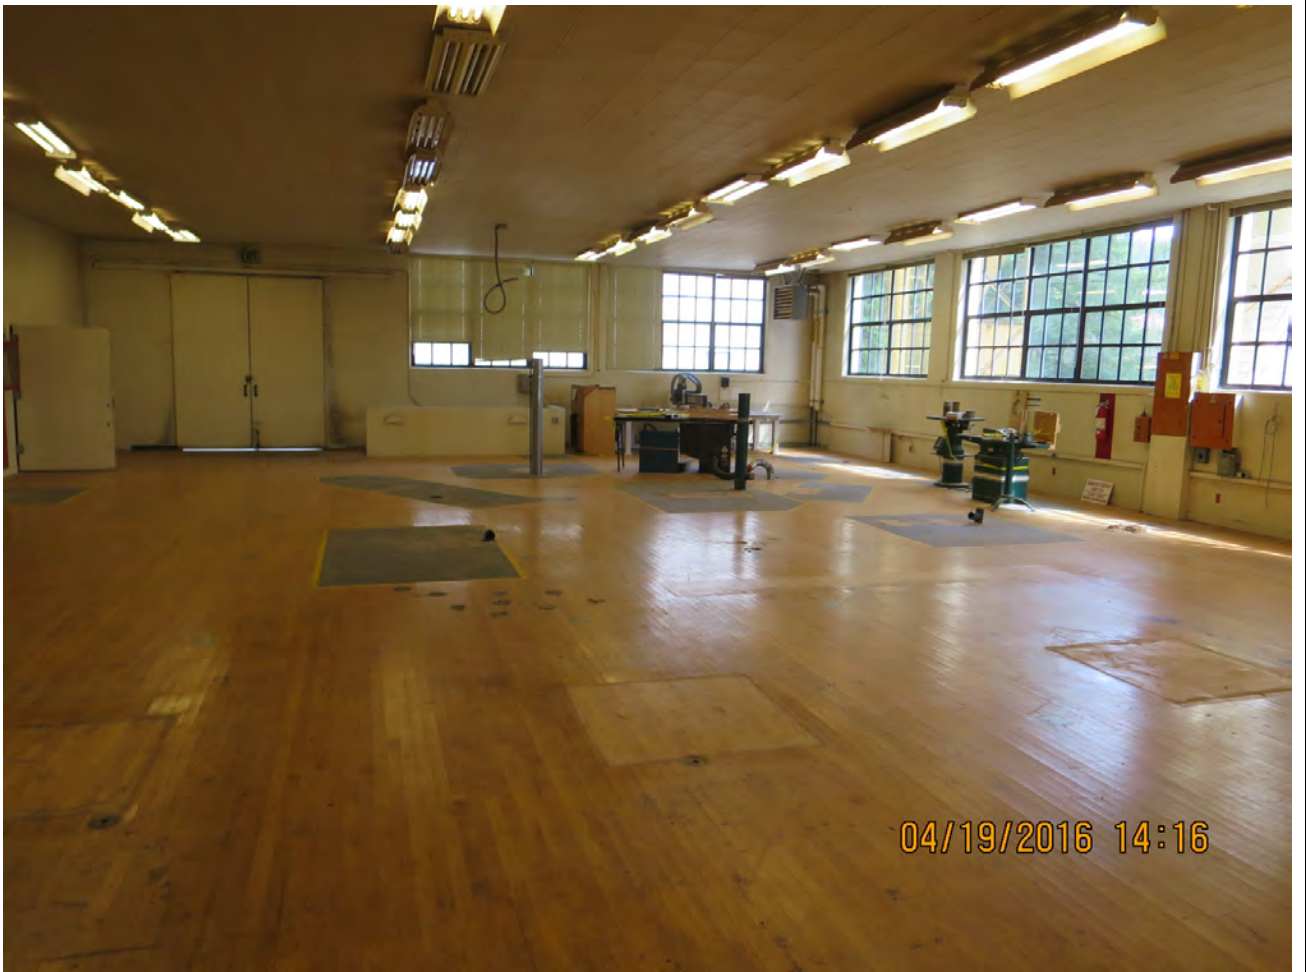
Photo 18: Room 211, the former wood shop

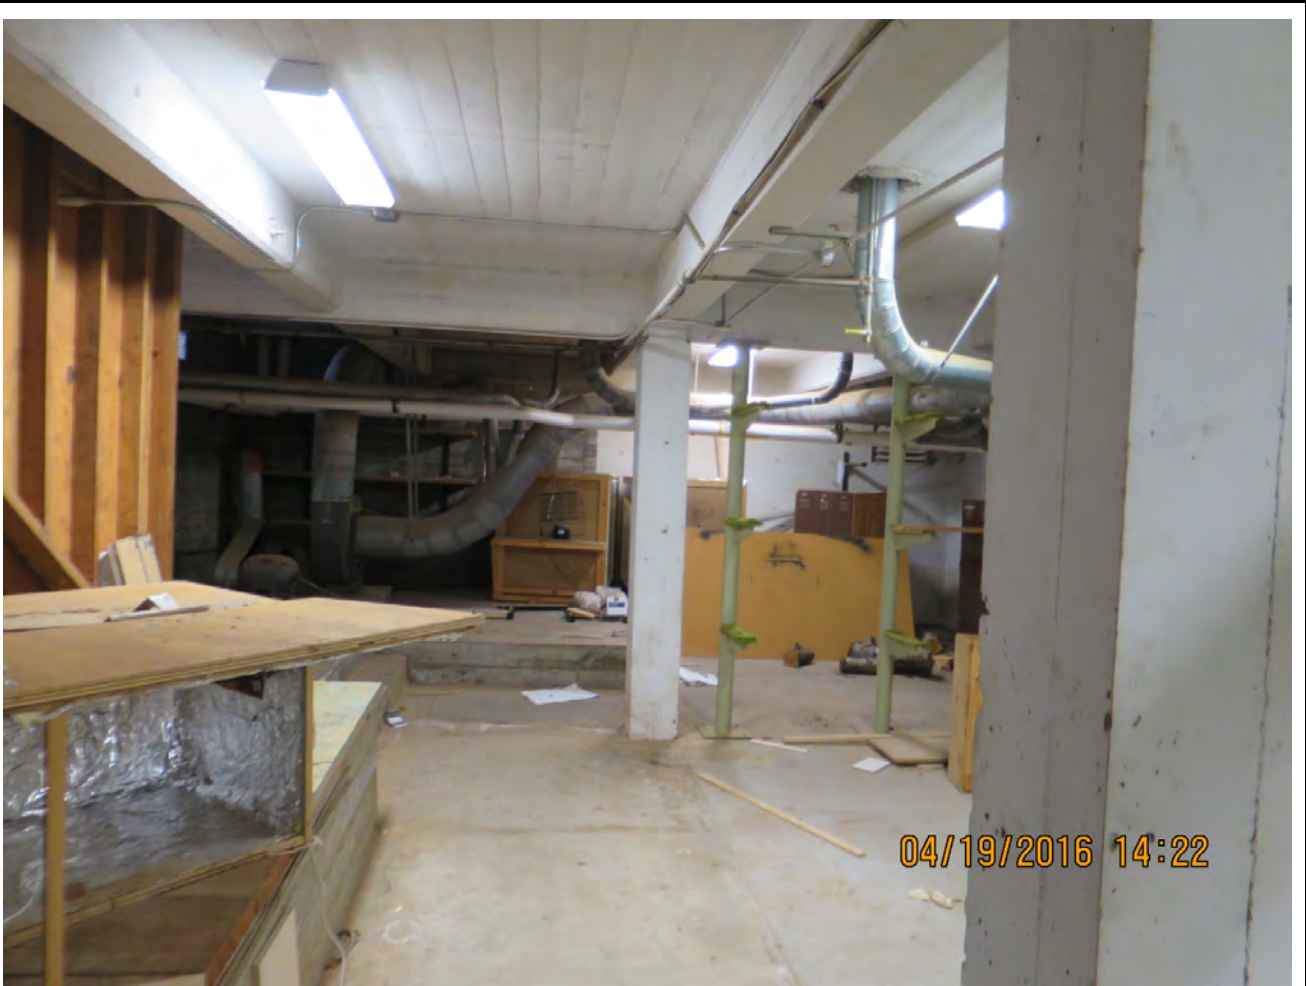
Photo 19: Room 110, the former wood storage room

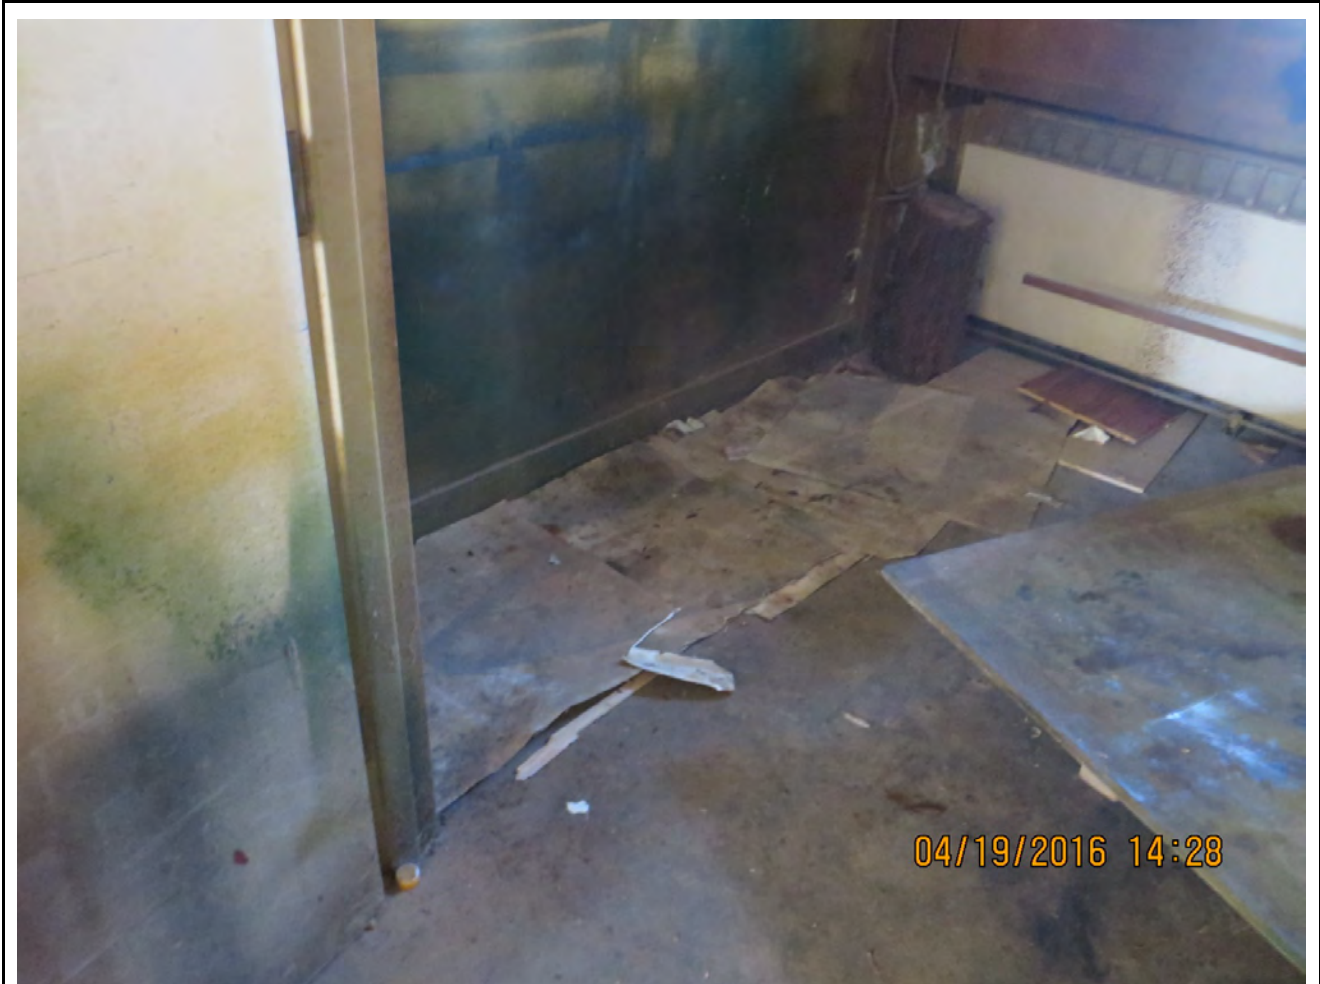
Photo 20: Suspect thick paper in the former finishing spray area, Room 210A
