August 7, 2023

### Ceramics Lab - Building Materials Asbestos Data Summary

Ceramics Lab (Building 074) 1760 LK Wood Blvd, Arcata, CA 95521

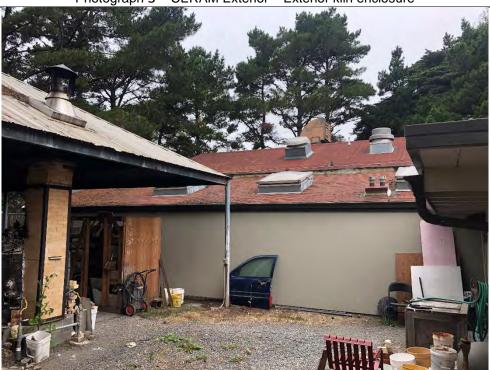
Photograph 4 – CERAM Exterior – South façade and roof

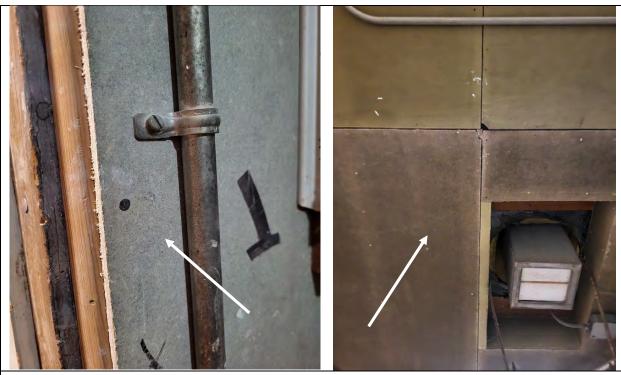
Photograph 5 – CERAM Interior – Cementitious panel (typical) reported to be ACM

Materials reported to contain greater than 1% asbestos are classified as either ACM or RACM depending on each material's physical characteristics. Material containing greater than 0.1% asbestos is designated by Cal/OSHA as Asbestos Containing Construction Material (ACCM). Asbestos materials that may be disturbed by the project shall be removed by a licensed abatement contractor prior to other site work.

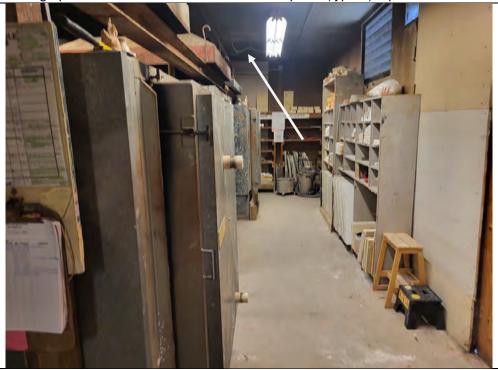
Photograph 6 – CERAM Interior – Room 108 Cementitious panel (ACM) at ceiling

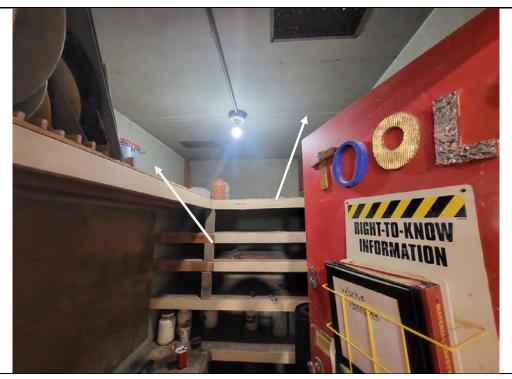
Photograph 7 – CERAM Interior – Cementitious panel (ACM) at walls and ceiling (typical)

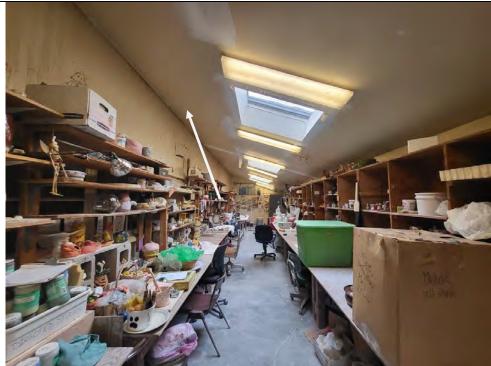
Photograph 8 – CERAM Interior – Drywall and joint compound walls and ceiling (typical) reported to contain asbestos

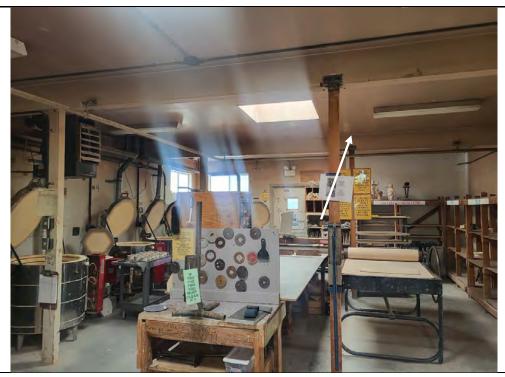
Photograph 9 – CERAM Interior – Drywall and joint compound walls and ceiling (typical) reported to contain asbestos

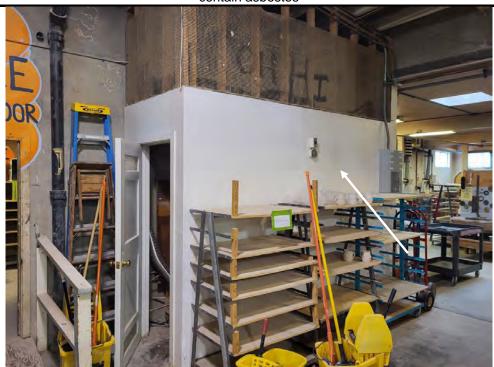
Photograph 10 – CERAM Interior – Drywall and joint compound wall (typical) reported to contain asbestos

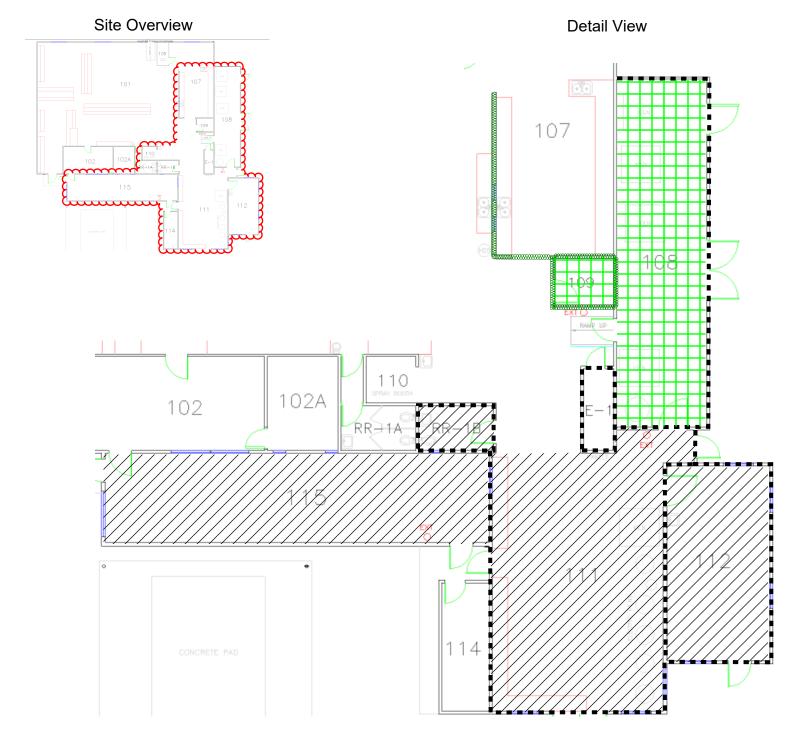
## Attachment B Figure 2 - Distribution & Quantity Detail Ceramics Lab (074)

As listed in Table 1, two (2) of the samples were reported to contain asbestos. These samples represent two (2) homogeneous areas of material distributed throughout the project site as shown on Figure 2 (Attachment B). All other sampled materials analyzed via PLM were reported to be ND. See attached PLM laboratory analytical reports (Attachment C).

- All locations and measurements approximate
- Not to scale
- CERAM # = Sample Location
- -Out lined box + Bold lettering = Material reported to contain asbestos
- ■ ■ ■ Drywall wall associated with joint compound on walls reported to contain asbestos
- -////= Drywall wall associated with joint compound on ceiling reported to contain asbestos
- Cementitious paneling on walls reported to contain asbestos
- Ecementitious paneling on ceiling reported to contain asbestos
- Approximately 4500 SF of drywall associated with joint compound reported to contain asbestos
- Approximately 900 SF of cementitious panel reported to contain asbestos
