## Technical Memorandum

### Student Health & Counseling Roof Restoration Project (XPL257) – Asbestos Data Summary

### Gutswurrak Student Activities Center Roof Restoration Project (XUC009) – Asbestos Data Summary

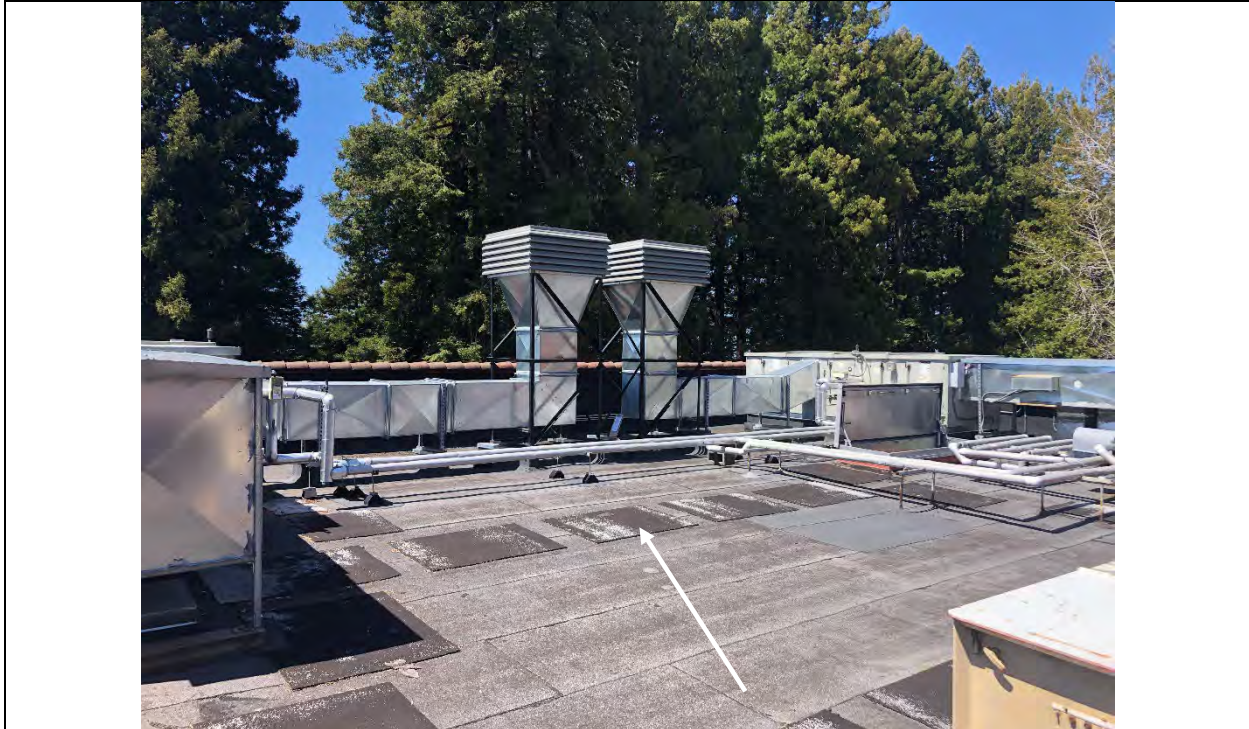
Photograph 1 – SHC Roof – Mastic associated with underside of walking pads reported to be ACM (note: walk pad is nondetect)

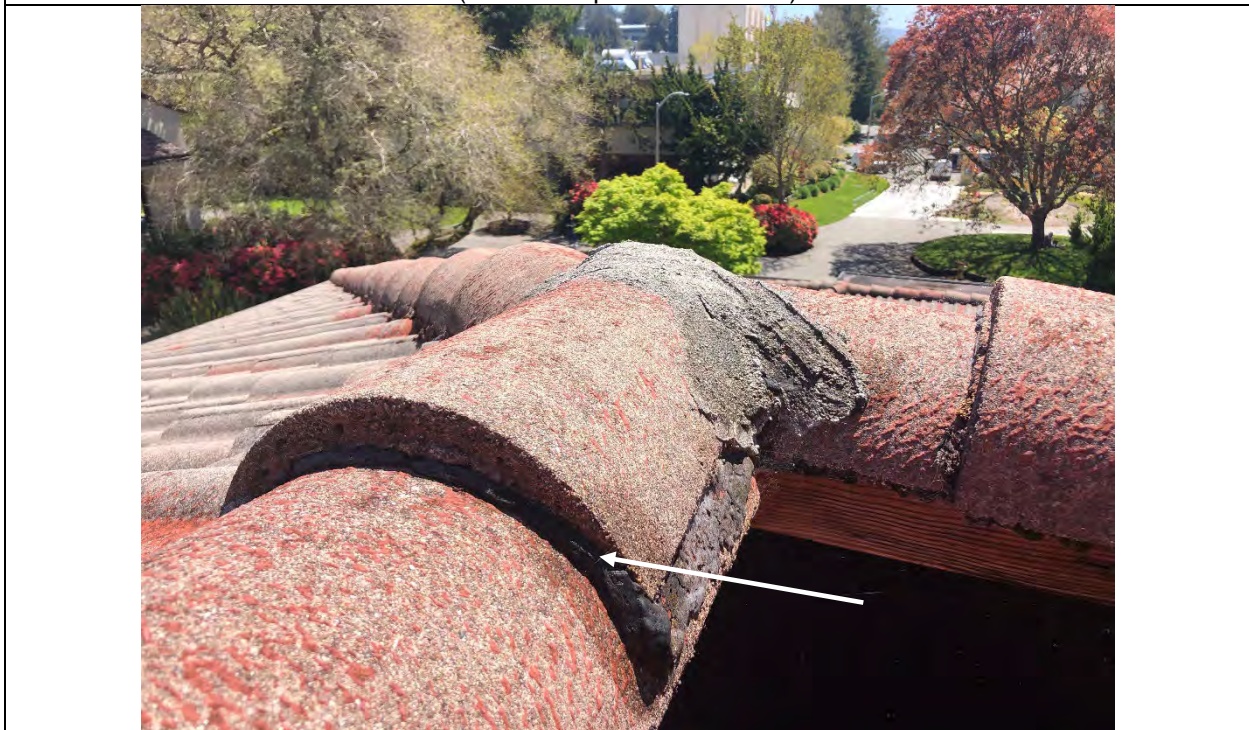
Photograph 2 – SHC Roof – Roof mastic (typical) at parapet tile reported to be ACM (note: cement patch material is nondetect)

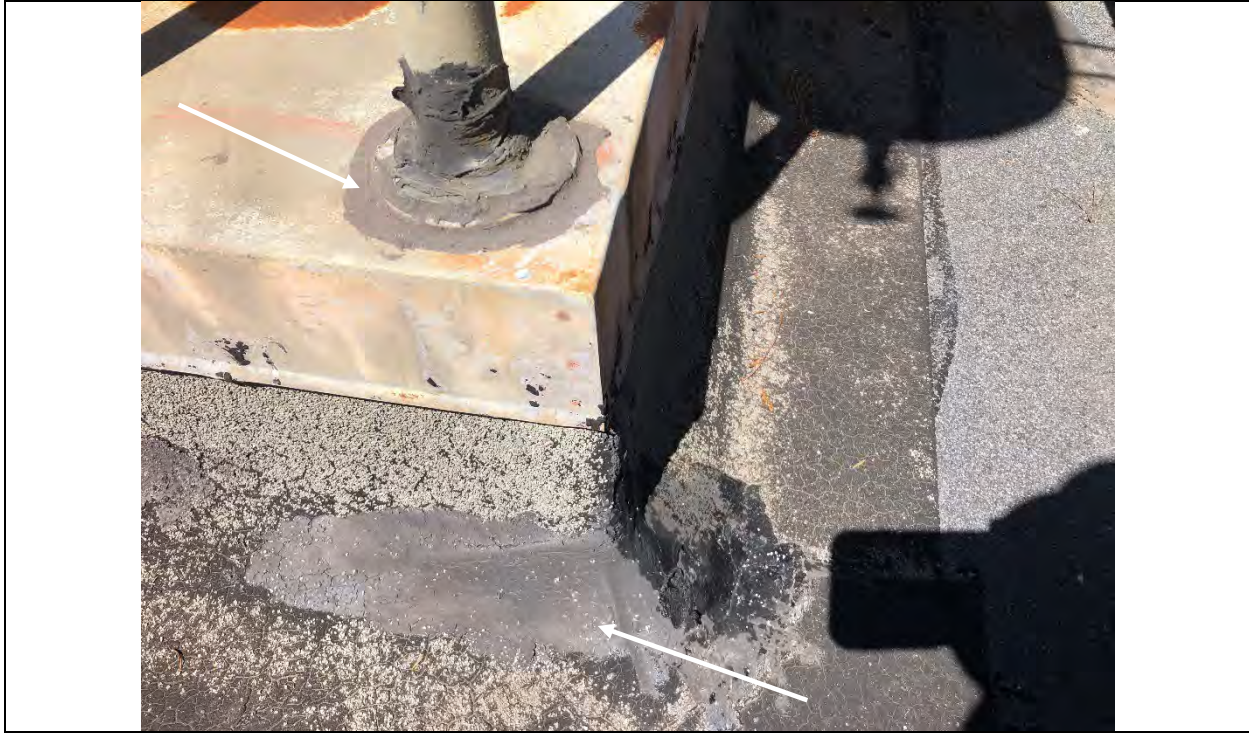
The samples reported to contain asbestos represent nonfriable mastic designated by the USEPA as Category I nonfriable ACM. Work impacting these materials is regulated by Cal/OSHA as Class II asbestos work. These asbestos mastics were used for different sealant/adhesion applications at two locations on the roof. As it is not possible to visually determine homogeneity among the various mastics, black roofing mastic throughout the project site shall be presumed to be ACM.

Photograph 3 – SHC Roof – Roof mastic (typical) homogeneous with material reported to be ACM

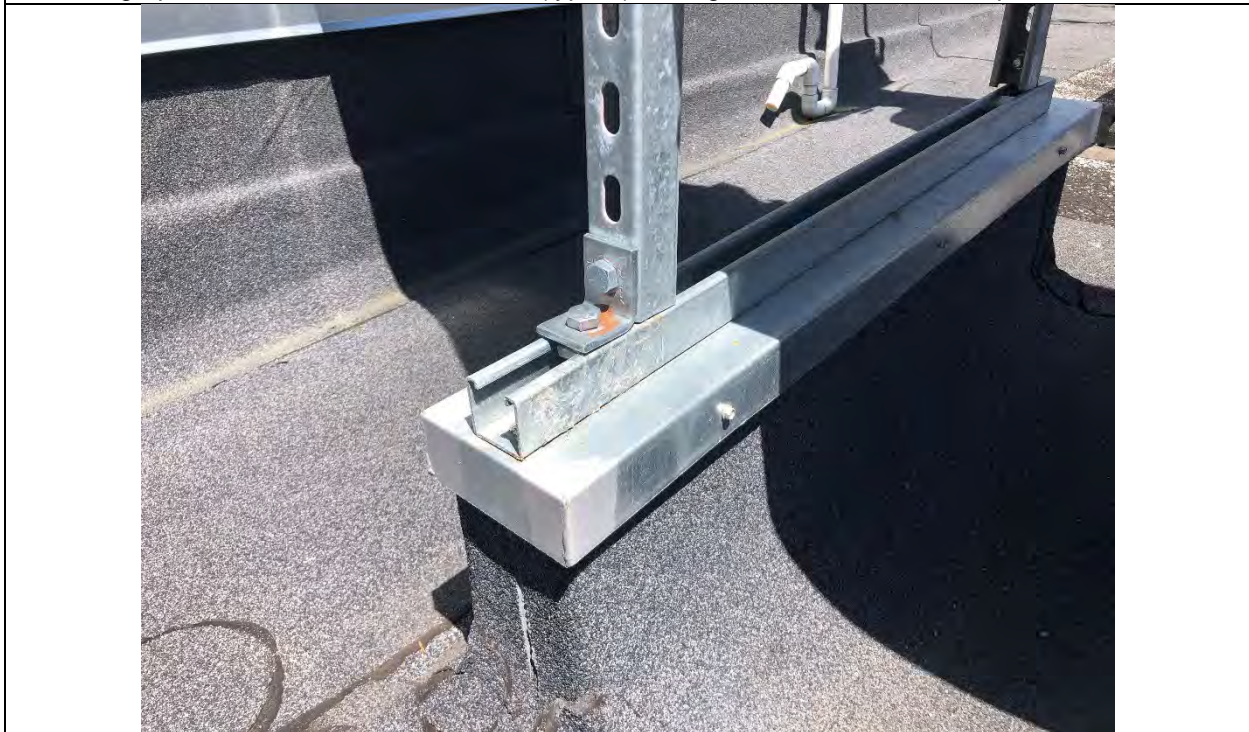
Photograph 4 – SHC Roof – HVAC support curb (typical)

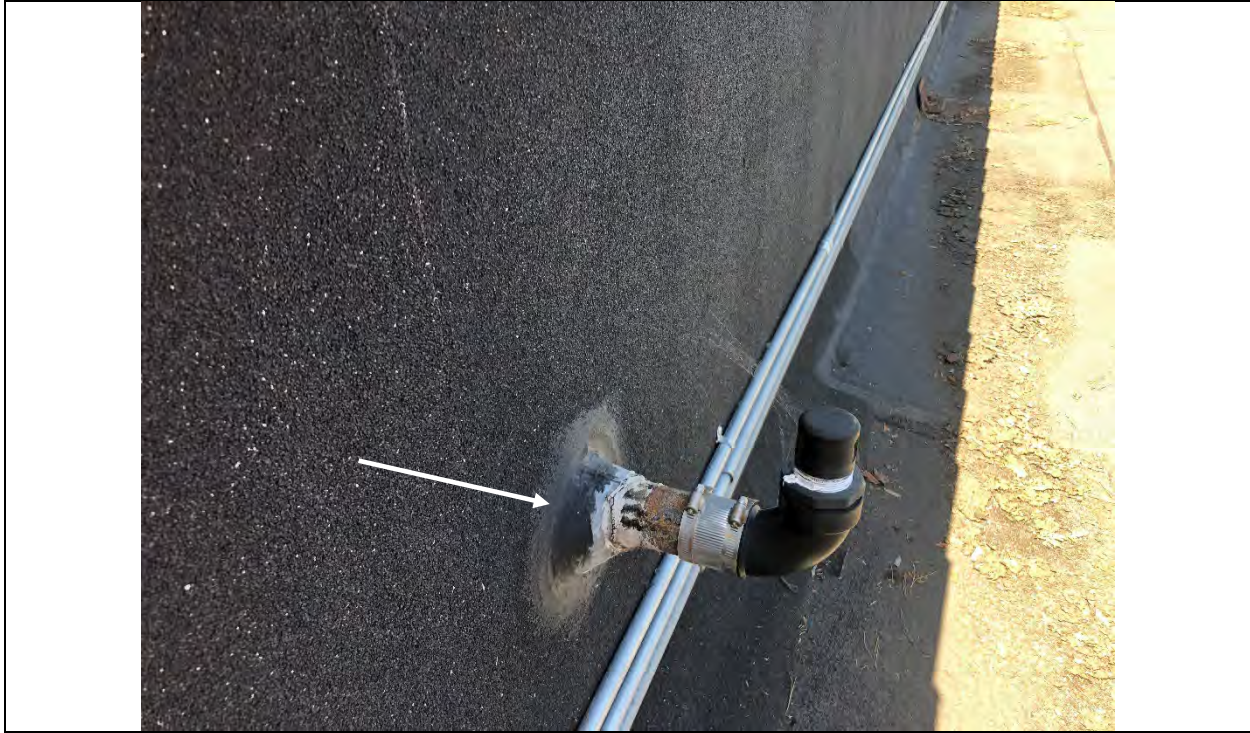
Photograph 5 – SHC Roof – Roof mastic (typical) homogeneous with material reported to be ACM

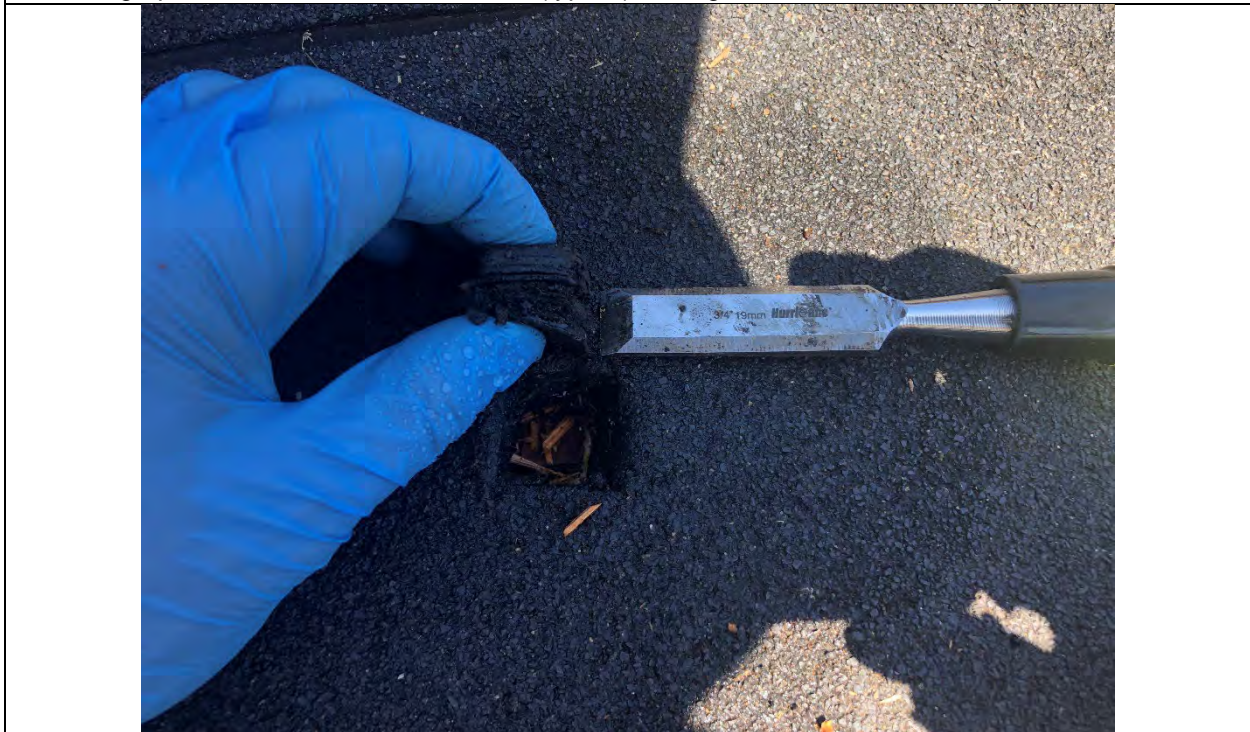
Photograph 6 – SHC Roof – Rolled roof detail (typical)

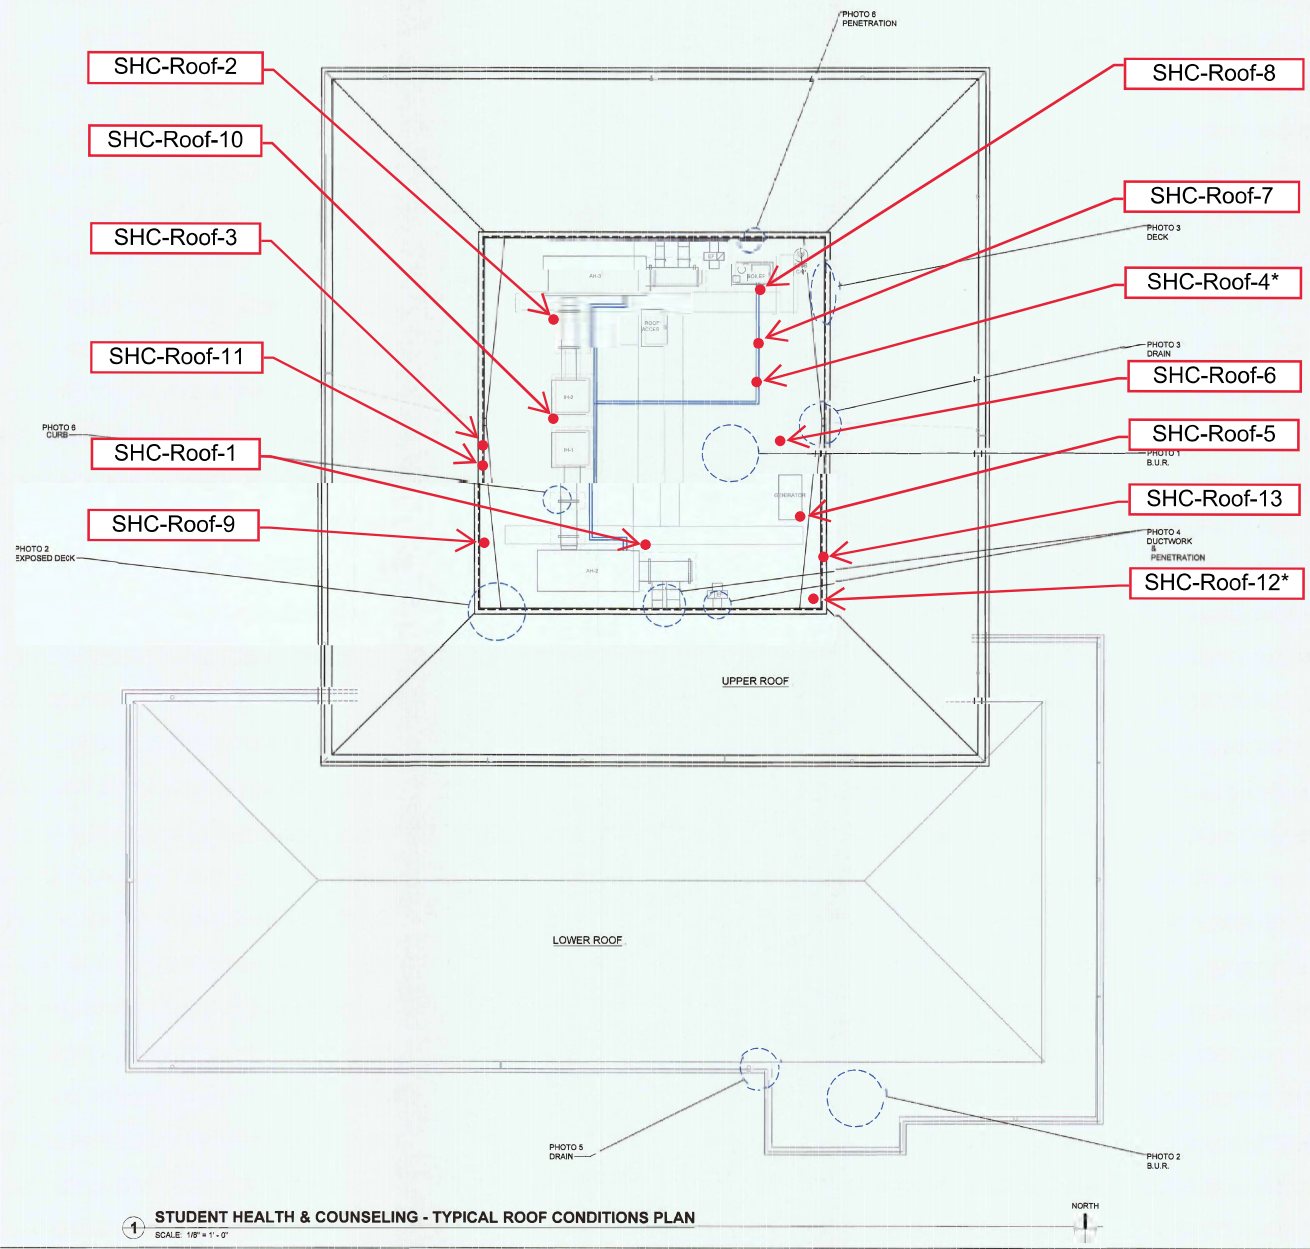
**STUDENT HEALTH & COUNSELING - TYPICAL ROOF CONDITIONS PLAN**  
 SCALE: 1/8" = 1'-0"

The general locations of bulk samples collected at the project site are depicted on Figure 1 (Attachment B). Sampling was conducted by Scott Harris, a FM PDC California Department of Industrial Relations, Division of Occupational Safety and Health (Cal/OSHA) Certified Asbestos Consultant (11-4713).

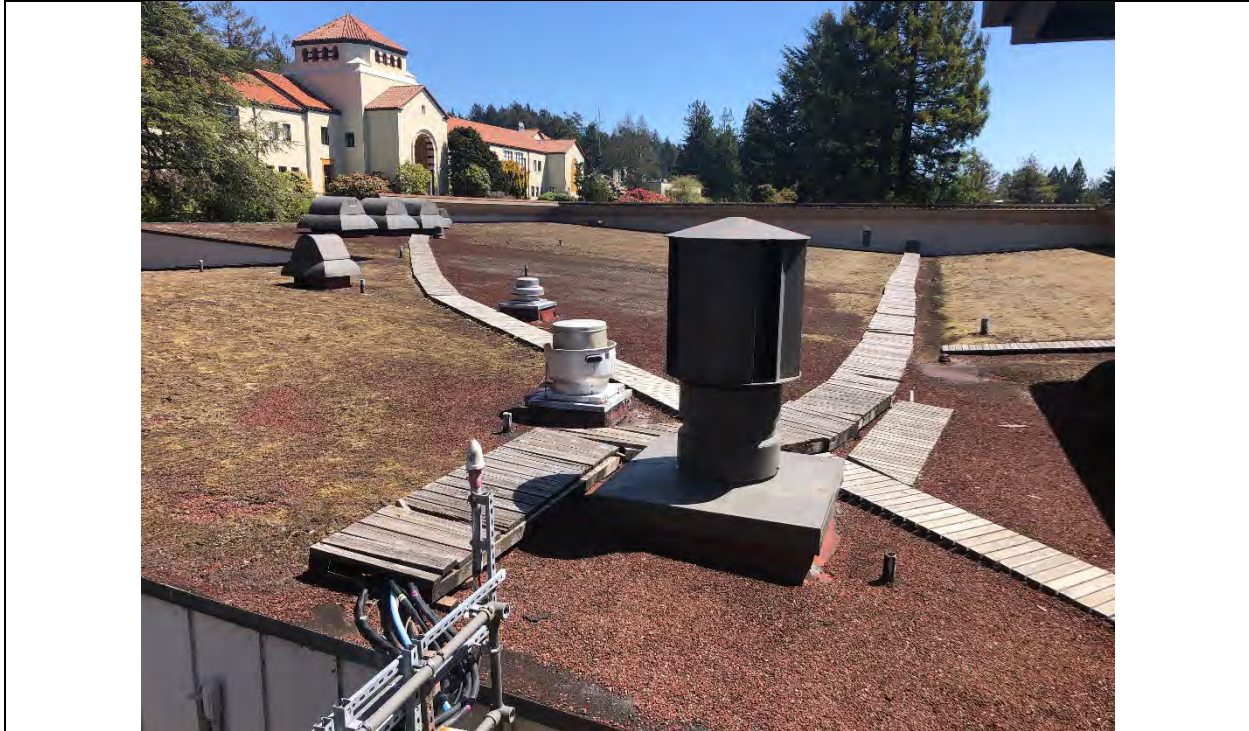
Photograph 1 – GSAC Roof – View looking southeast

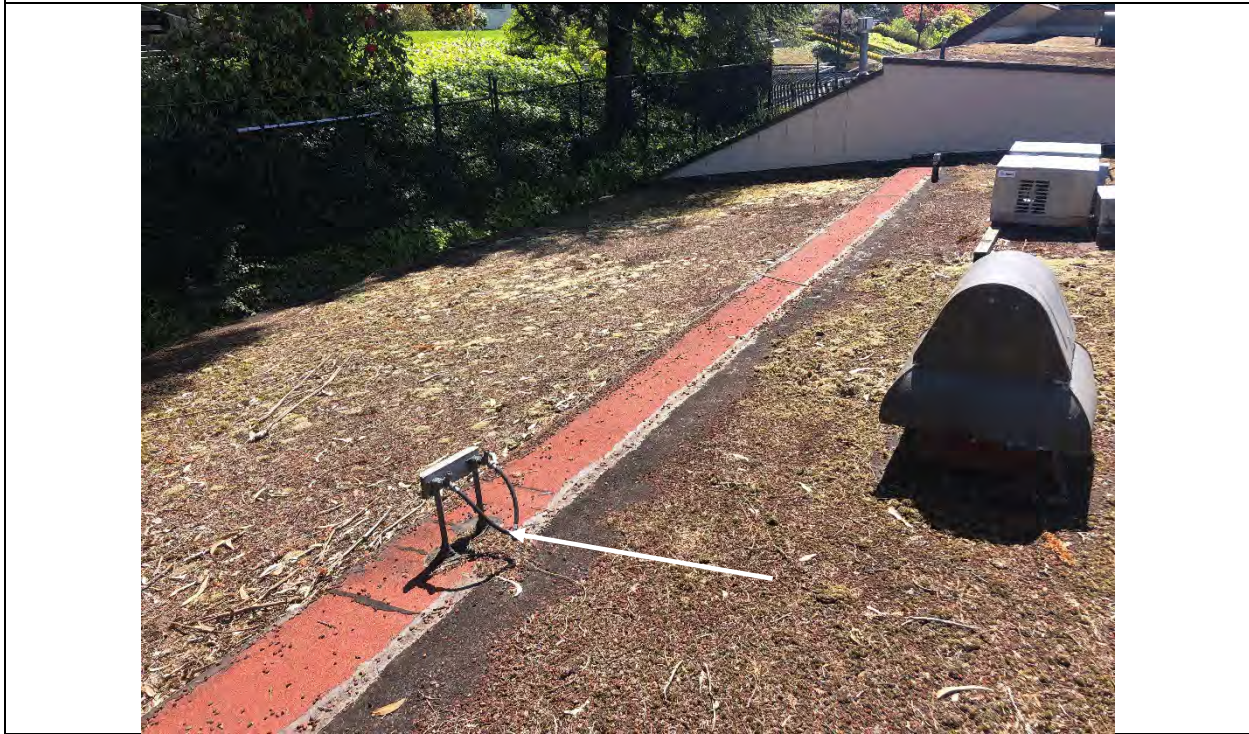
As listed in Table 1, four (4) of the sampled materials were reported to contain greater than 1% asbestos, thus are classified as ACM. These samples represent nonfriable mastic designated by the USEPA as a Category I nonfriable ACM, thus work impacting such materials must be performed in accordance with Cal/OSHA Class II asbestos work protocols.

Photograph 2 – GSAC Roof – Roof mastic (typical) at seams and penetrations reported to be ACM

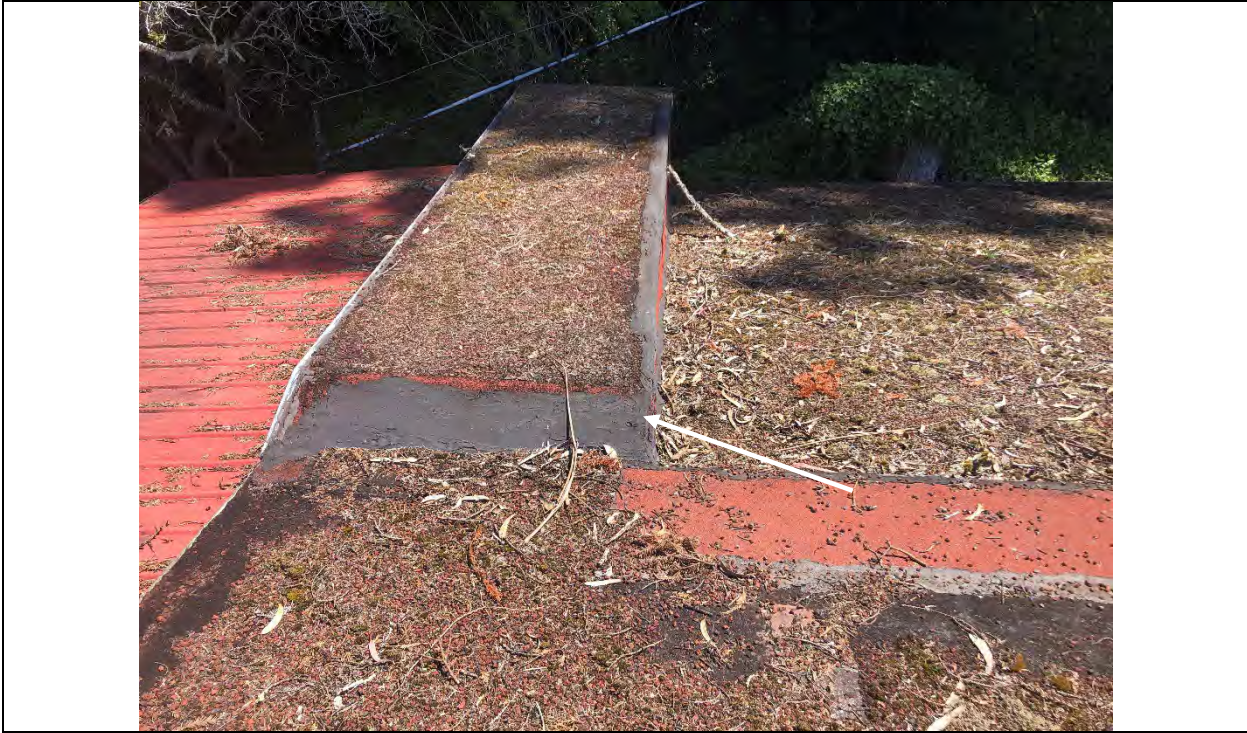
Photograph 3 – GSAC Roof – Roof mastic (typical) at seams and penetrations reported to be ACM

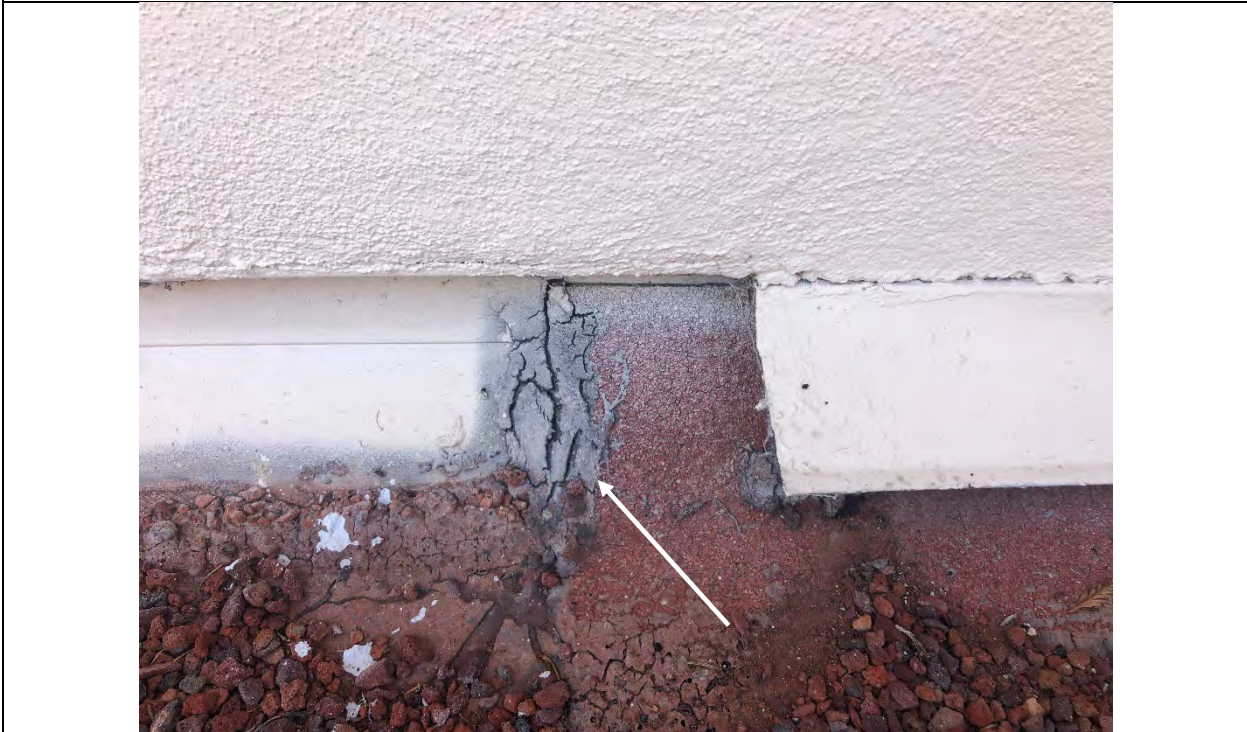
Photograph 4 – GSAC Roof – Roof mastic (typical) at seams and penetrations reported to be ACM

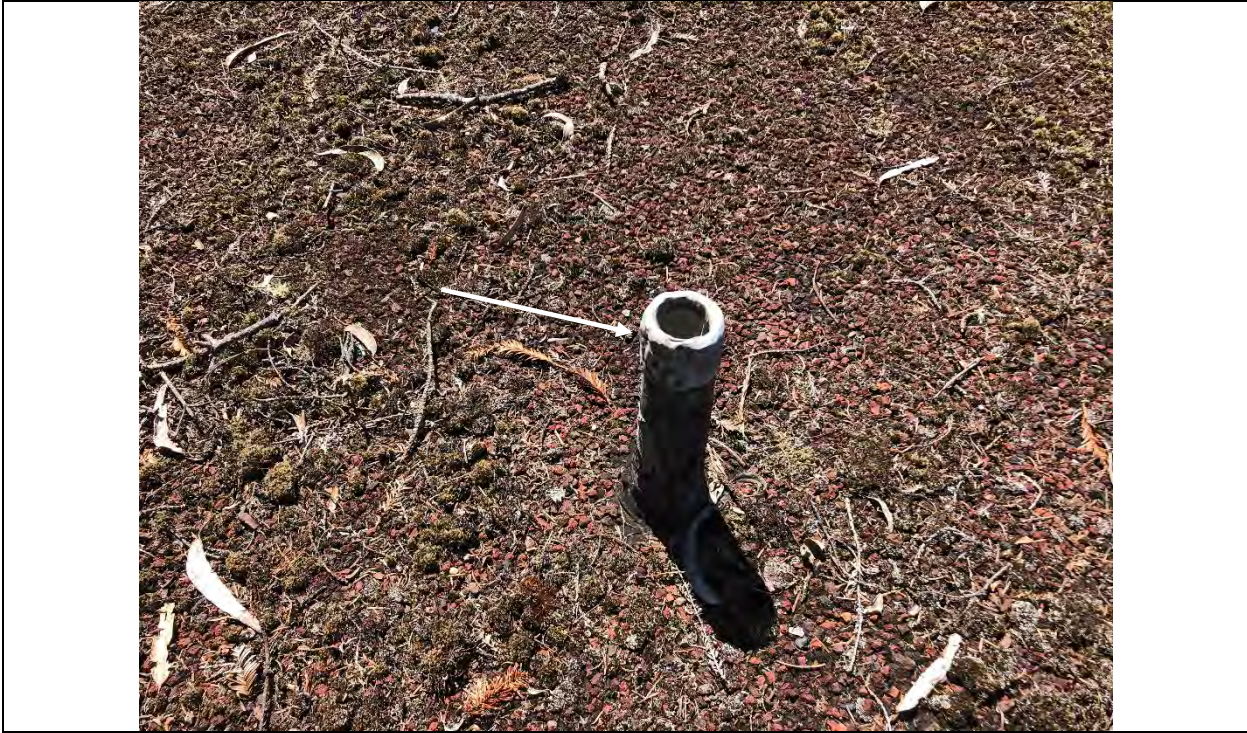
Metal flashing at vent pipe throughout the roof are presumed to contain lead. Work impacting material known or presumed to contain lead must be performed in accordance with applicable lead-safe work practices and regulations.

Photograph 5 – GSAC Roof – Vent cap (typical) presumed to be lead.

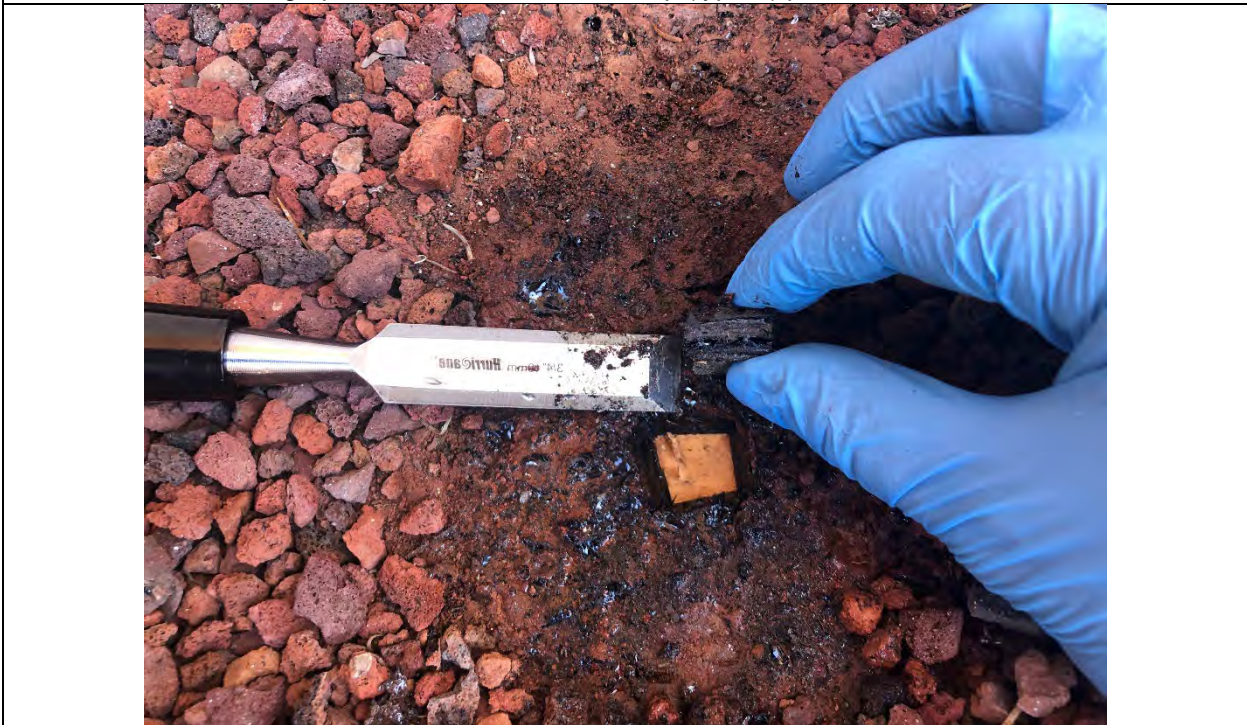
Photograph 6 – GSAC Roof – Built-up tar/ballast roof detail (typical)

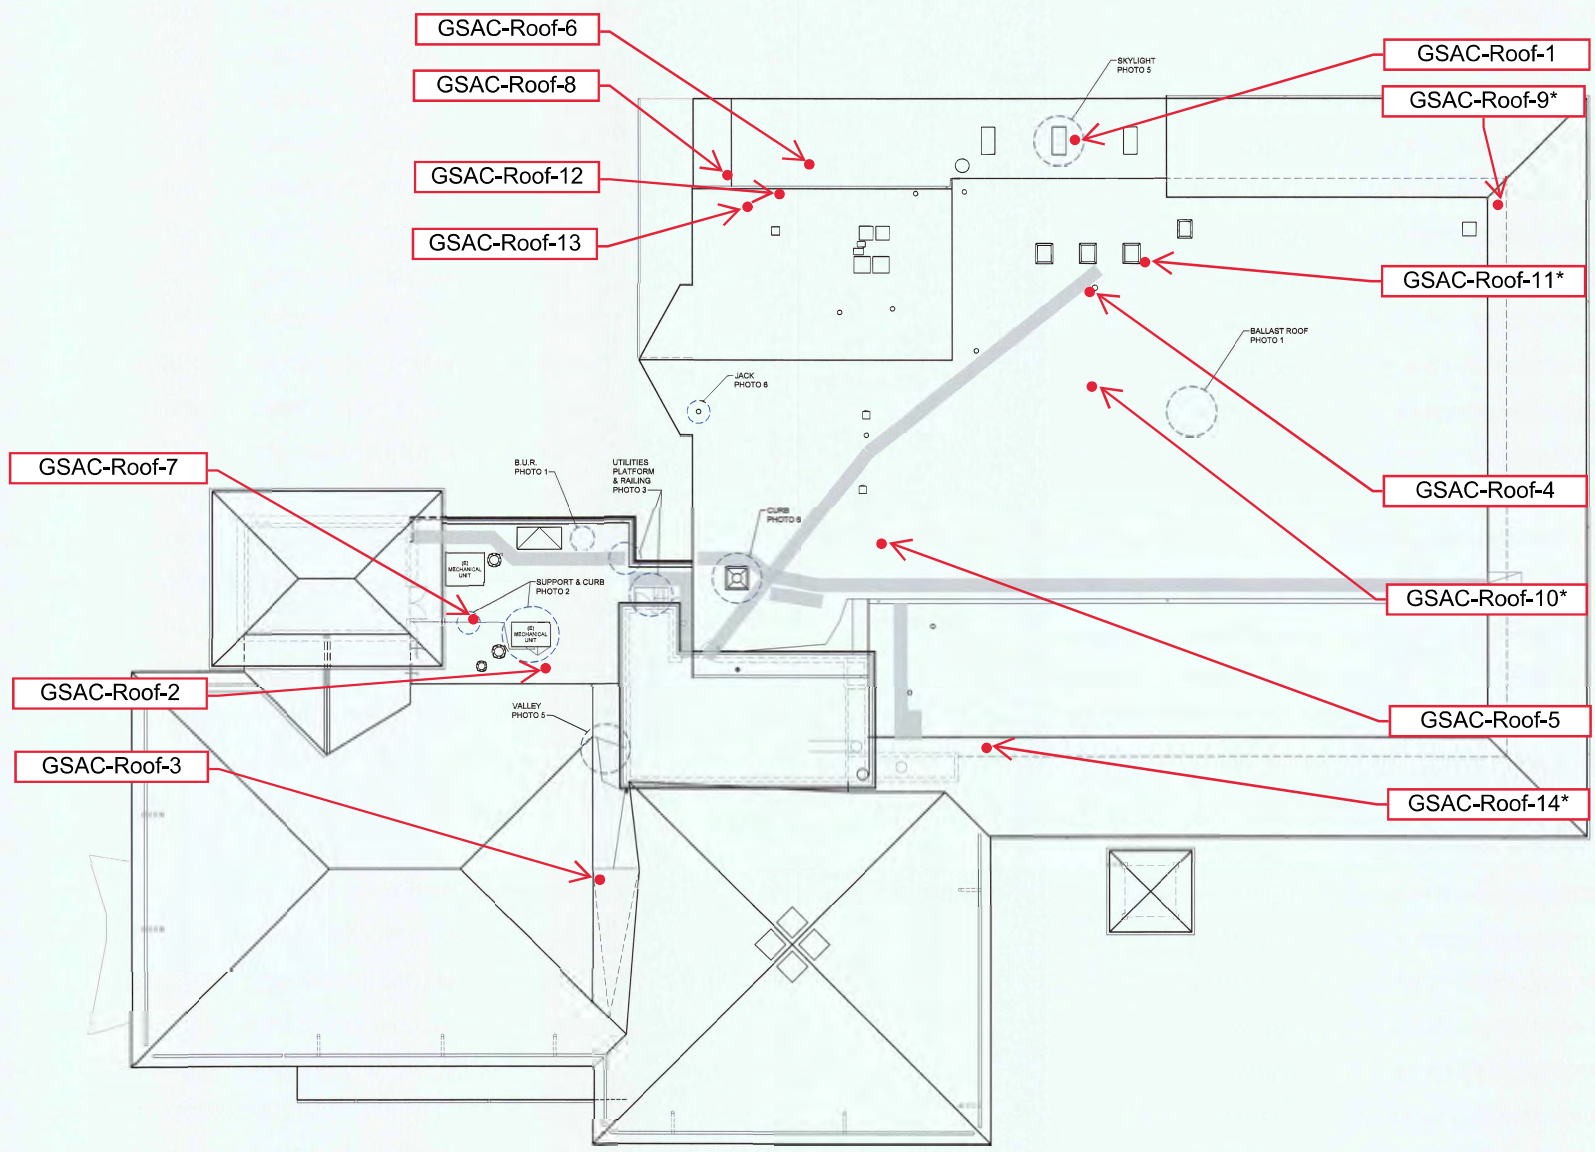
**STUDENT ACTIVITIES CENTER - TYPICAL ROOF CONDITIONS PLAN**  
SCALE: 3/32" = 1'-0"

The general locations of bulk samples collected at the project site are depicted on Figure 1 (Attachment B). Sampling was conducted by Scott Harris, a FM PDC California Department of Industrial Relations, Division of Occupational Safety and Health (Cal/OSHA) Certified Asbestos Consultant (11-4713).
