Limited Hazardous Materials Assessment Report

Sunset Residence Hall Roof Replacement Project

1 Harpst Street, Arcata, California

January 17, 2022

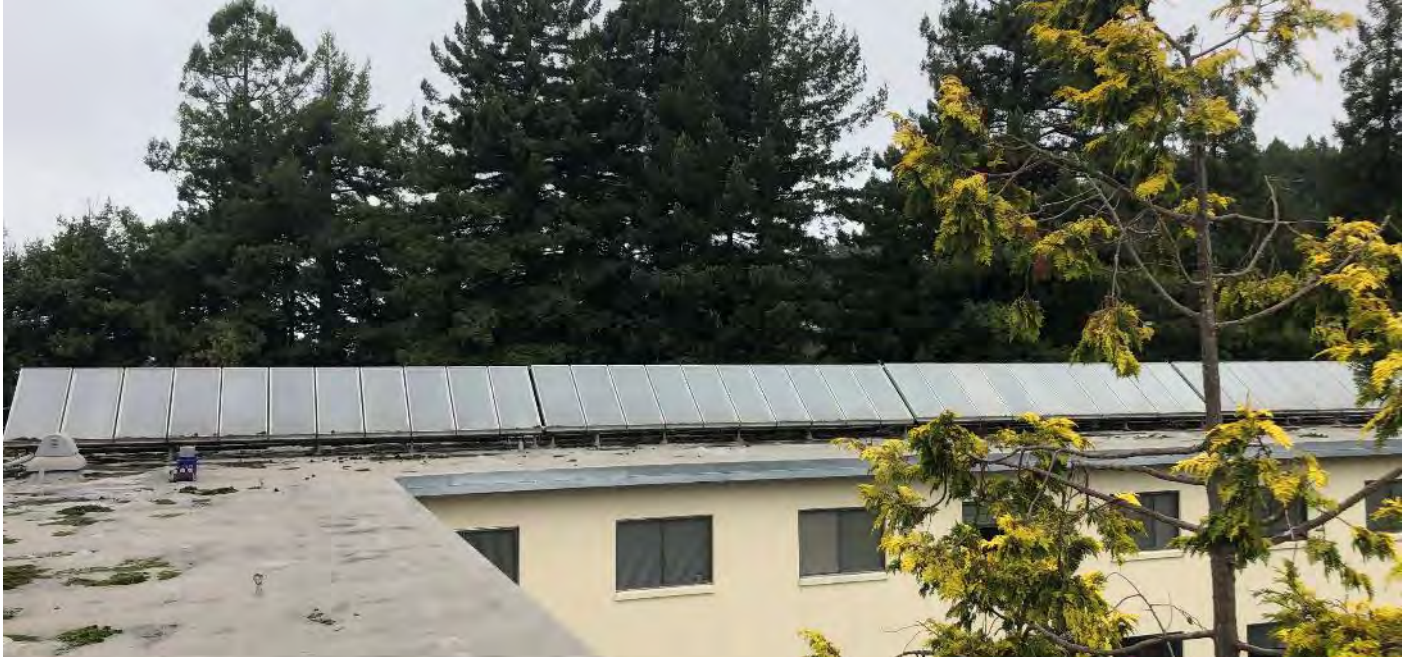
Photo 1 *Main Roof – North and East wing roofs with solar hot water panels*

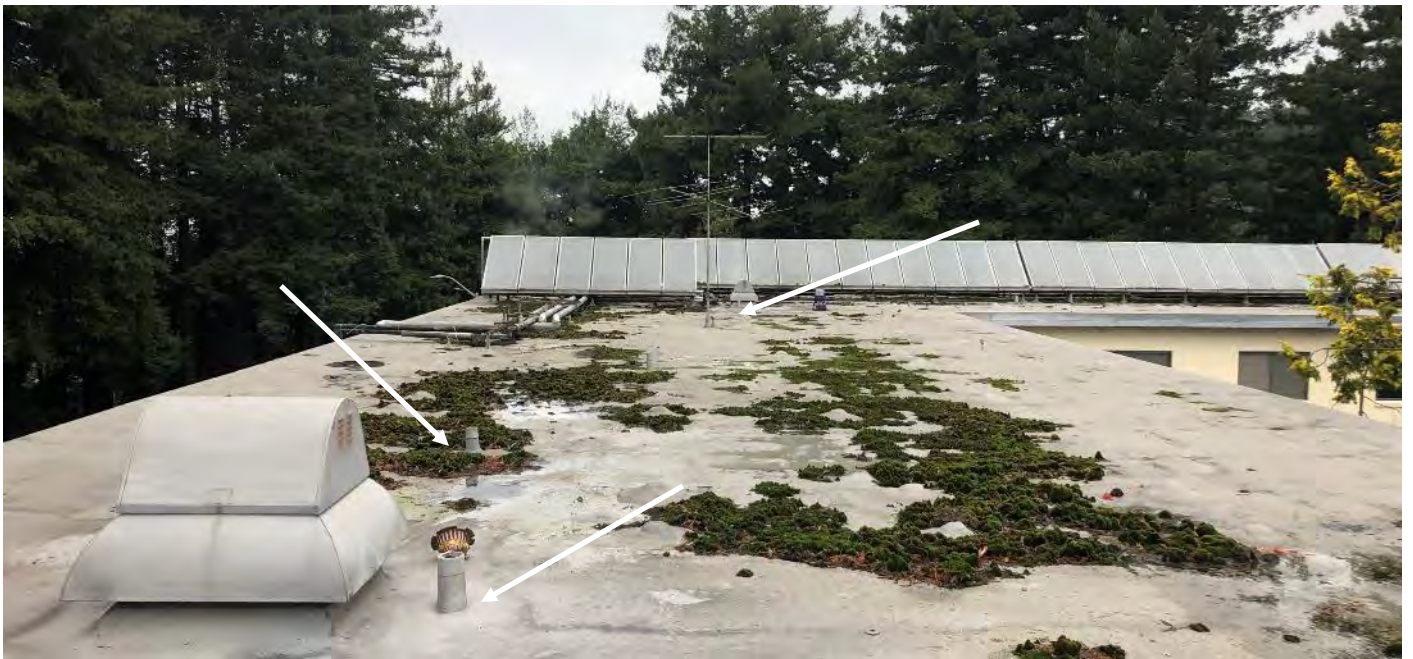
Photo 2 *Main roof – Roofing mastic at penetrations (typical indicated by arrow), vents, and equipment footers reported to contain asbestos*

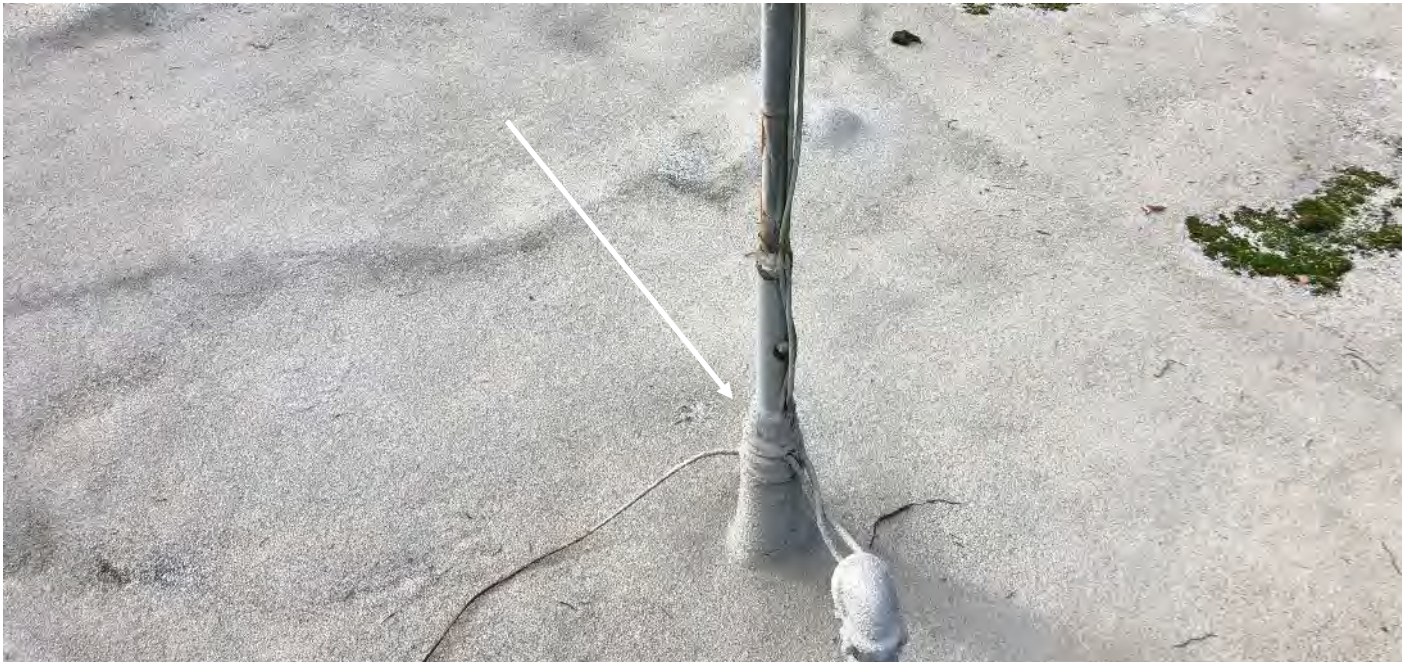
Photo 3 Main roof – Penetration caulk (white/grey) at penetrations (typical indicated by arrow) reported to contain asbestos

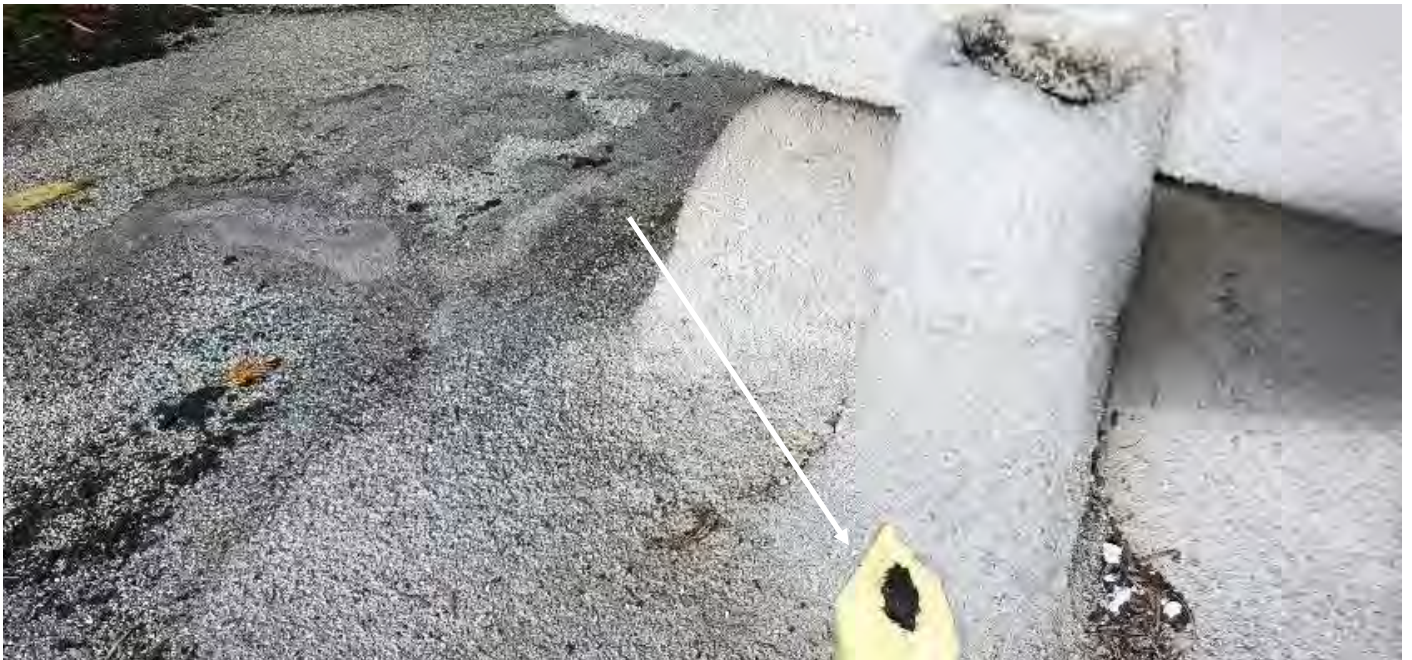
Photo 4 Main Roof – Roof mastic (black), indicated by arrow, reported to contain asbestos (foam coating [grey/cream] is nondetect for asbestos)

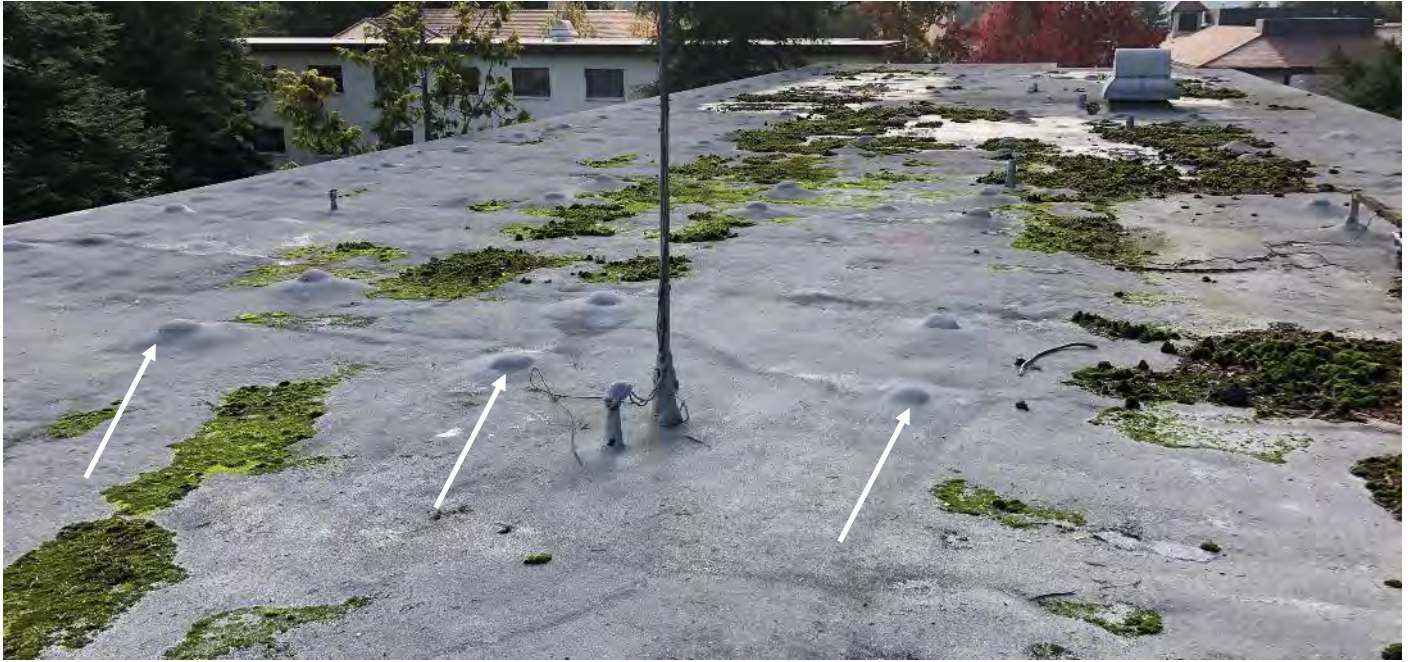
Photo 5 Main roof – Roofing mastic (not shown, location typical) at remanent footers reported to contain asbestos

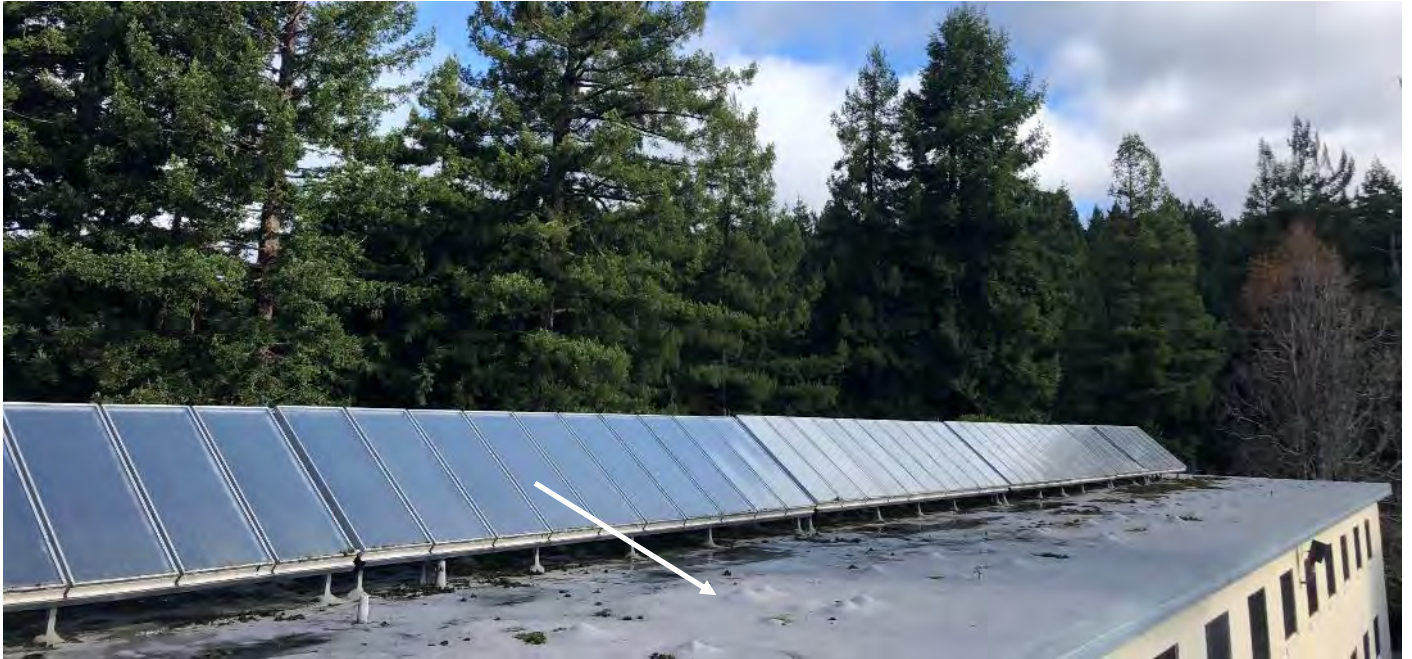
Photo 6 Main roof – Roofing mastic at former footers (typical indicated by arrow) reported to contain asbestos

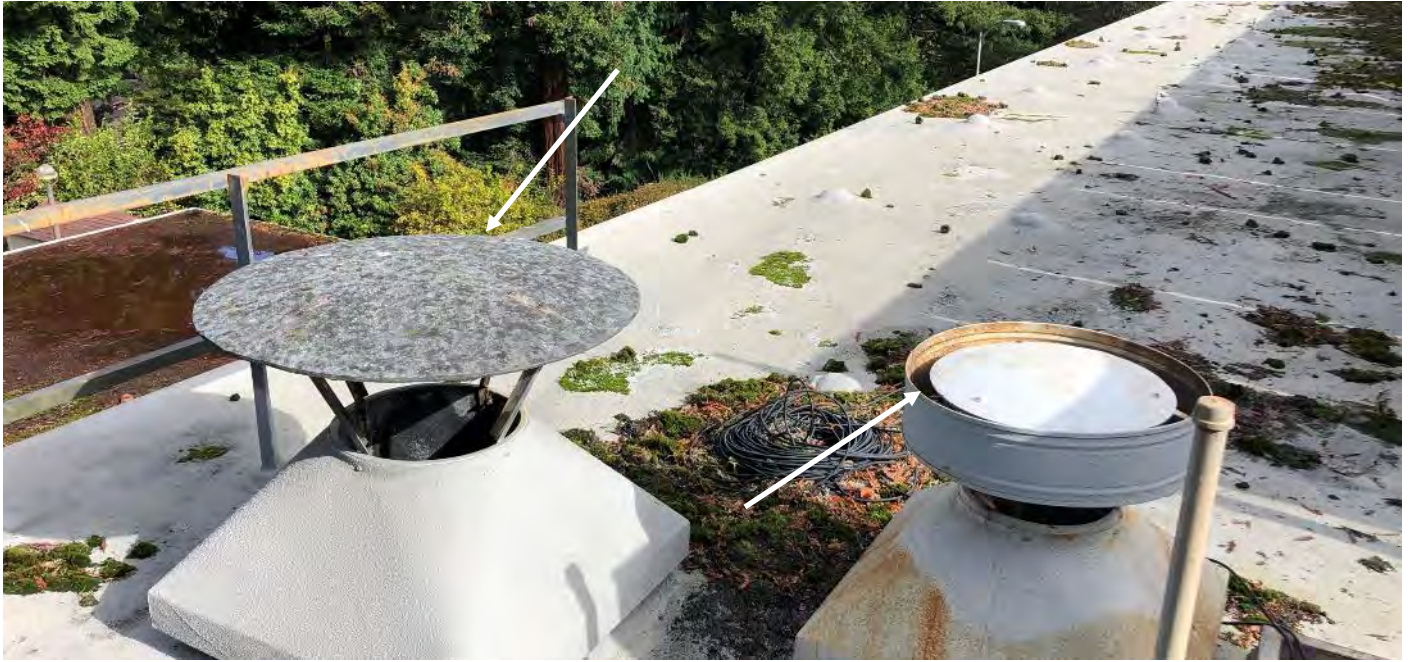
Photo 7 Main roof – HVAC vents at NE corner – Vent caps (indicated by arrows) reported to contain asbestos

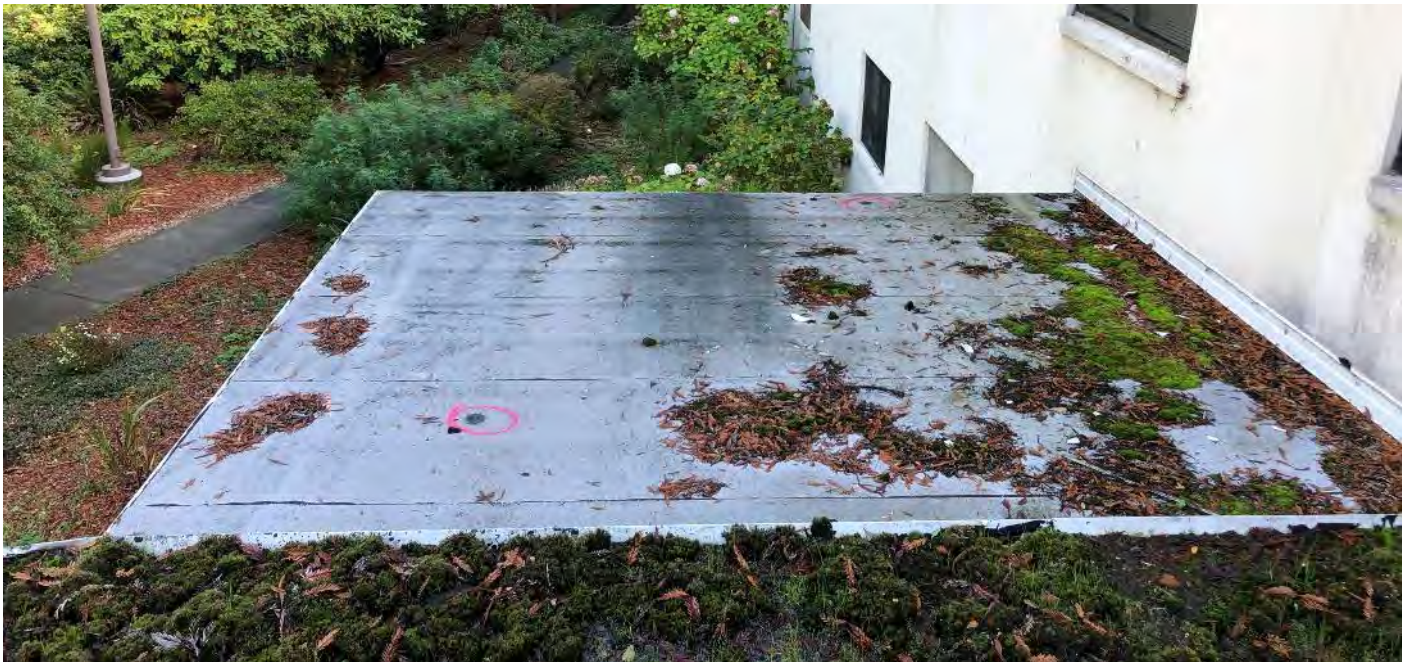
Photo 8 Northeast Addition Roof (NE Roof) – Rolled roofing system reported to be nondetect for asbestos

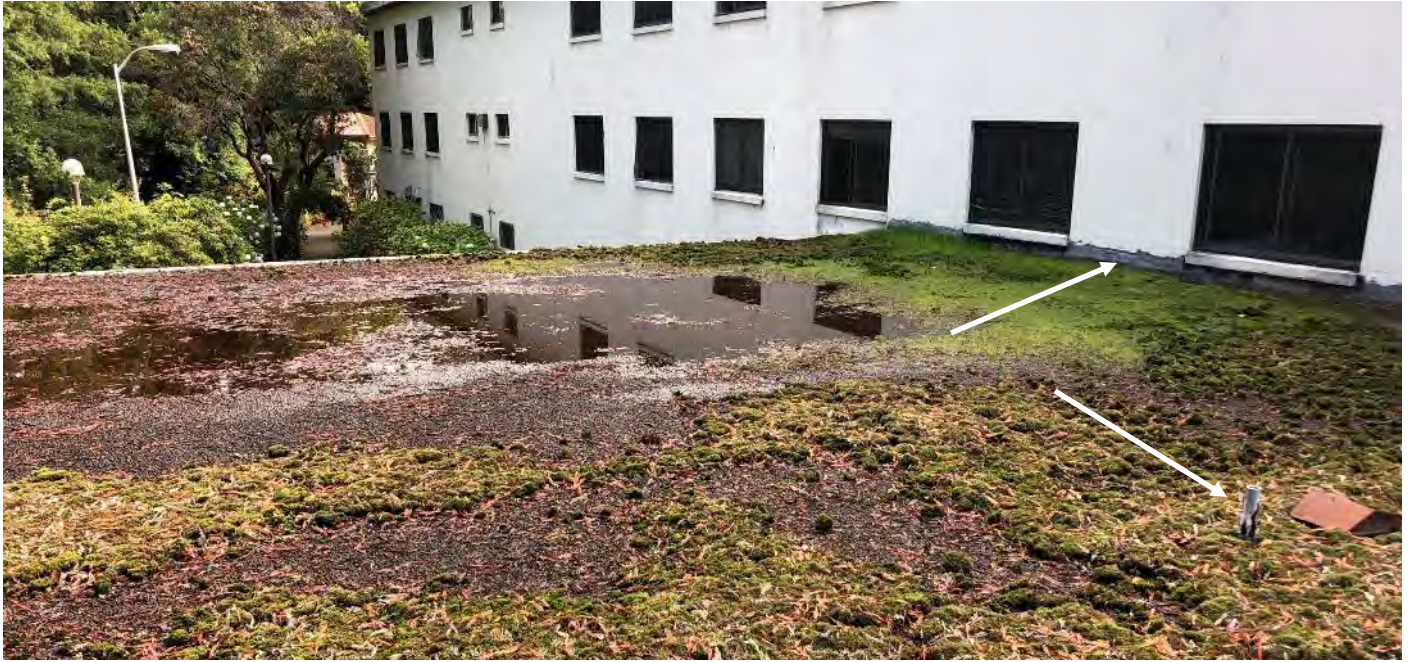
Photo 9 Lower Roof (L1) – Roof mastic (black) associated building exterior wall and roof penetrations (typical location indicated by arrows) reported to contain asbestos

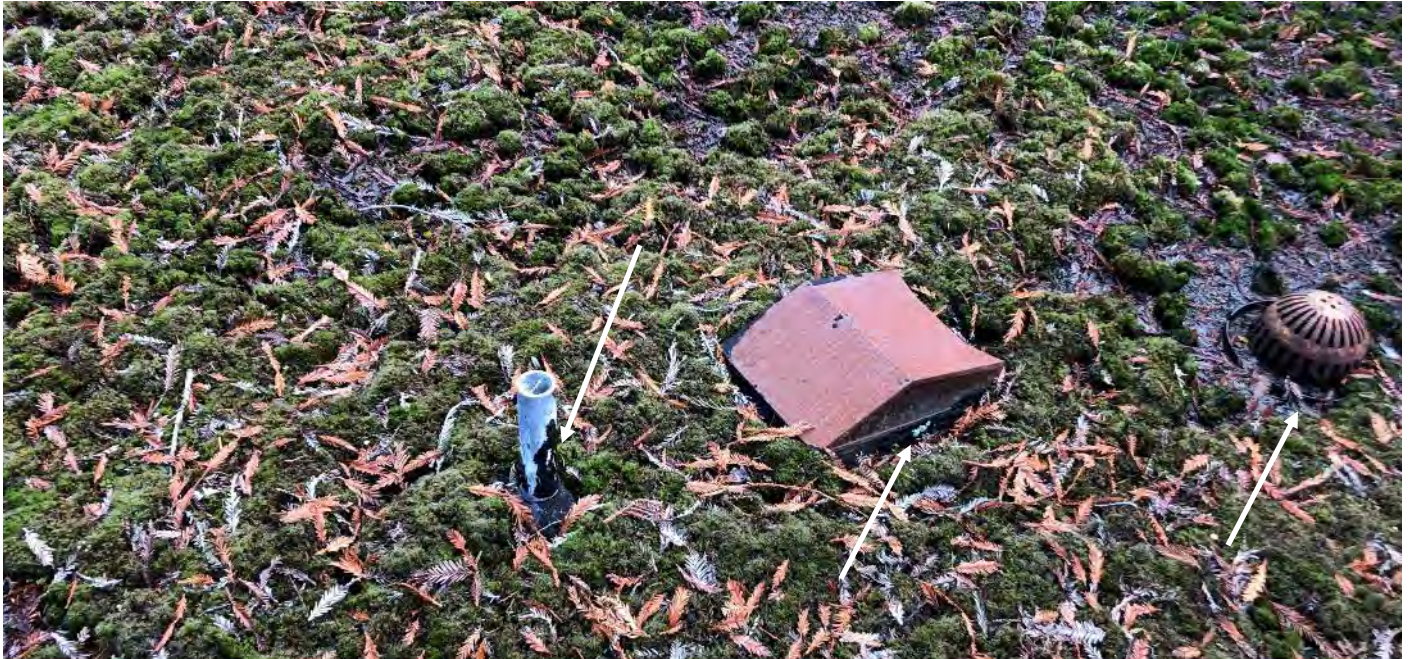
Photo 10 Lower Roof (L1) – Roof mastic (black) (typical) associated with building exterior walls reported to contain asbestos

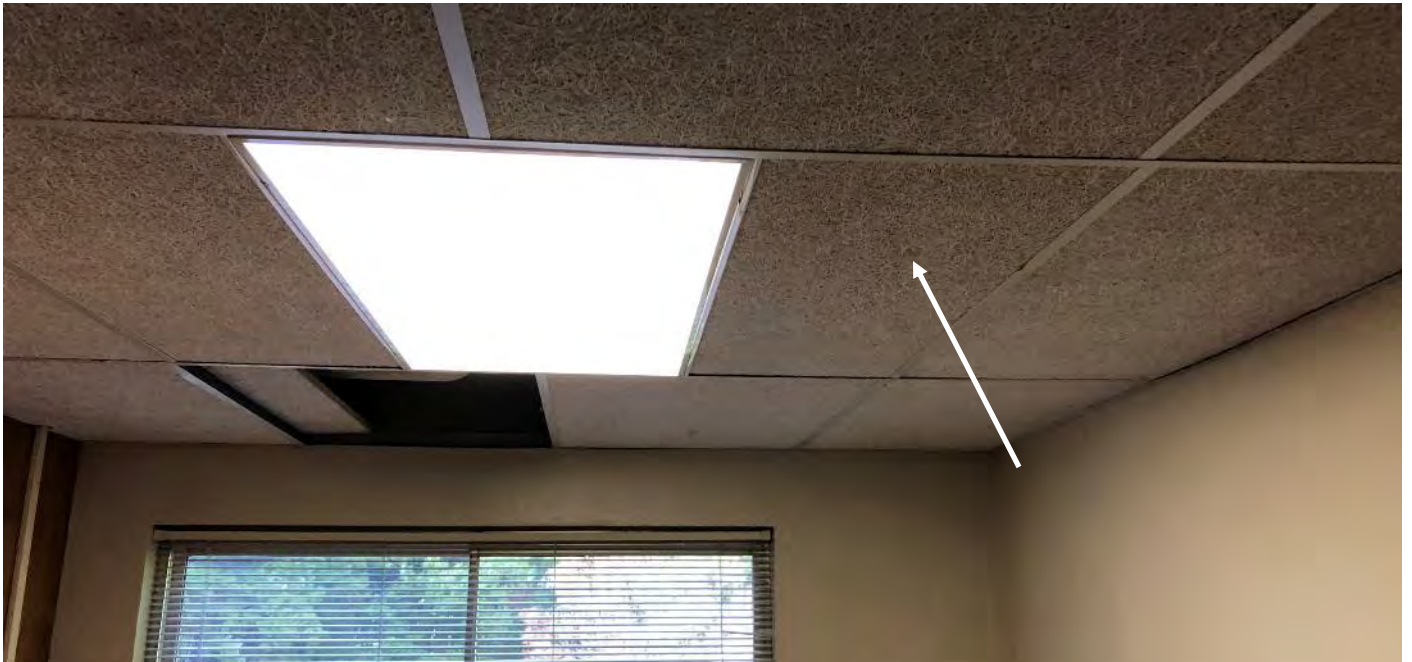
Photo 11 *Sunset Hall – Third Floor – Interior – Acoustical ceiling tiles reported to be nondetect for asbestos*

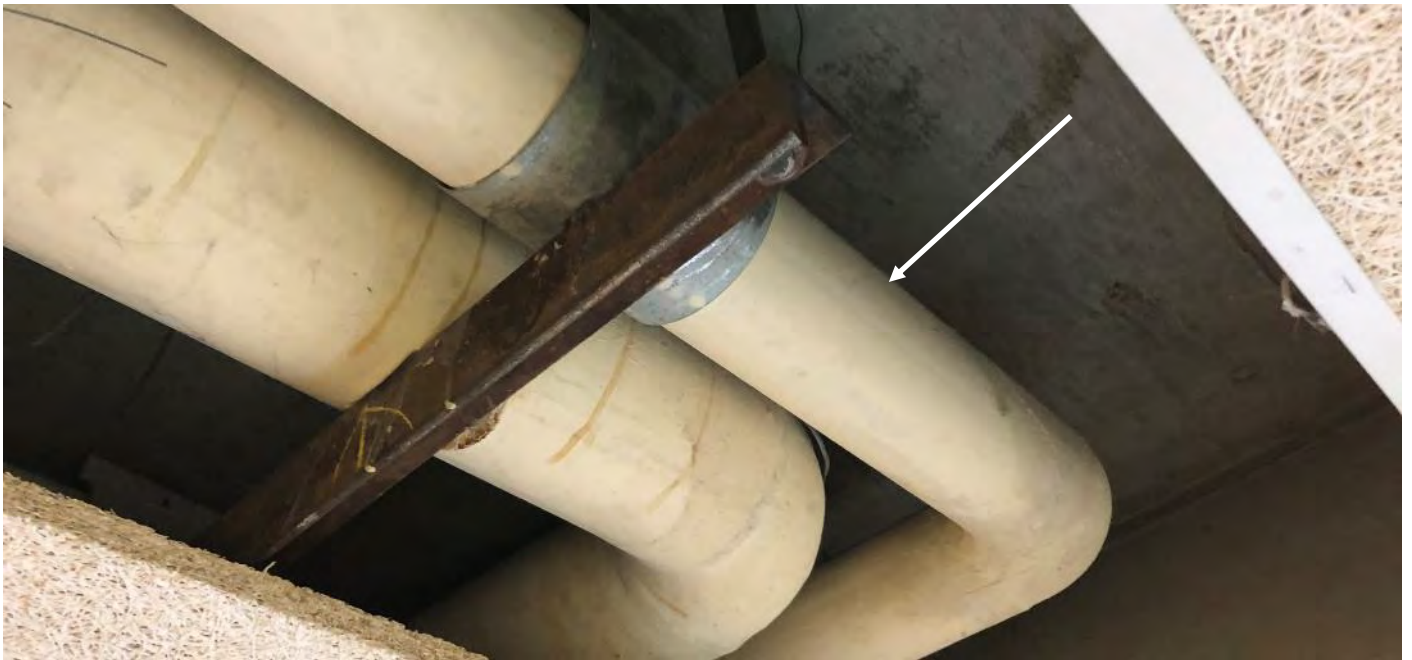
Photo 12 *Sunset Hall – Third Floor – Interior – Thermal System Insulation (TSI) located above drop ceiling not in survey scope, but TSI is presumed to contain asbestos*
