August 8, 2023

## **Cal Poly Humboldt Sculpture Lab – Building Materials Asbestos Data Summary**

- Sculpture Lab (Building 075)
- 1770 LK Wood Blvd, Arcata, CA 95521

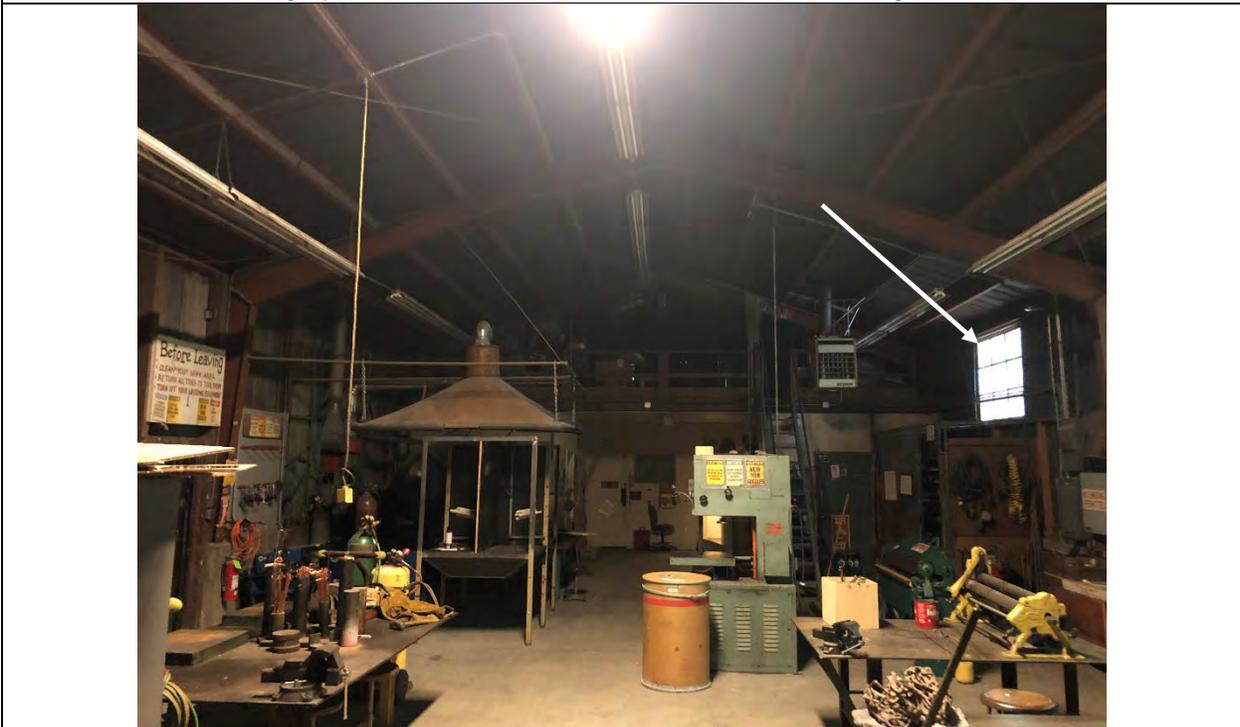
Photograph 4 – SCULPT Interior – Shop looking north. Window with glazing compound (putty) reported to be ACM at right.

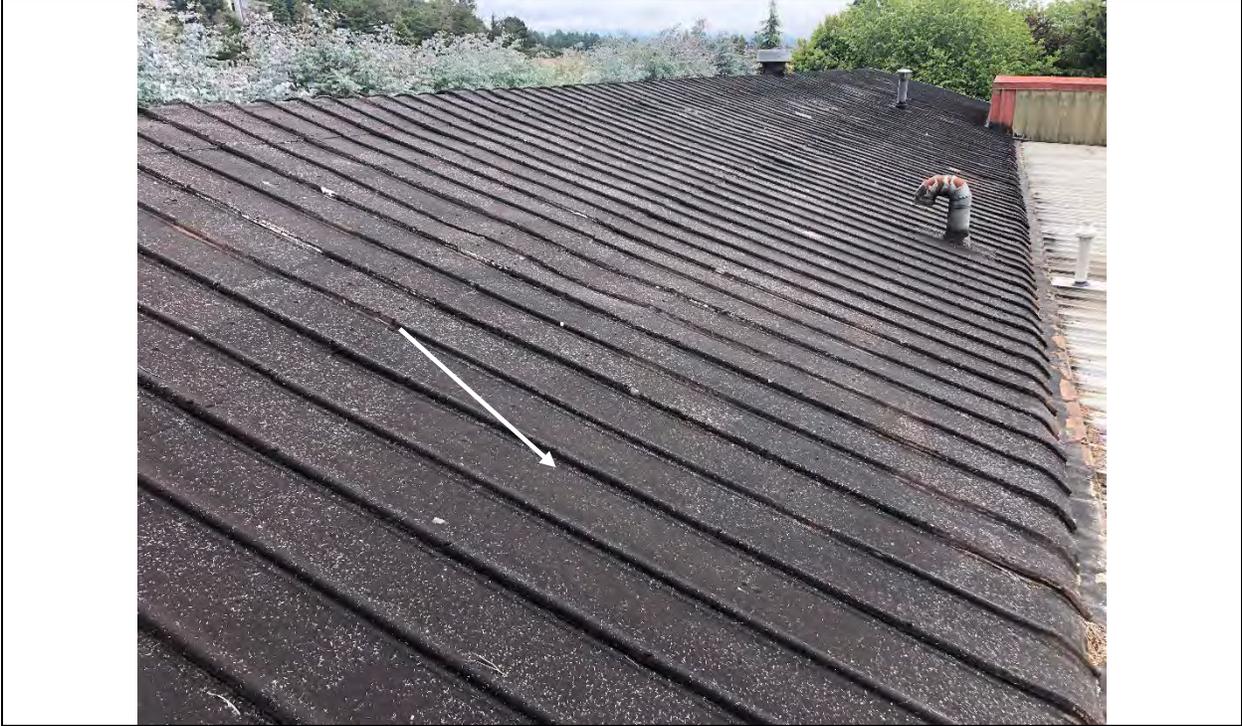
Photograph 5 – SCULPT Exterior – Bituminous roof coating (typical) reported to be ACM

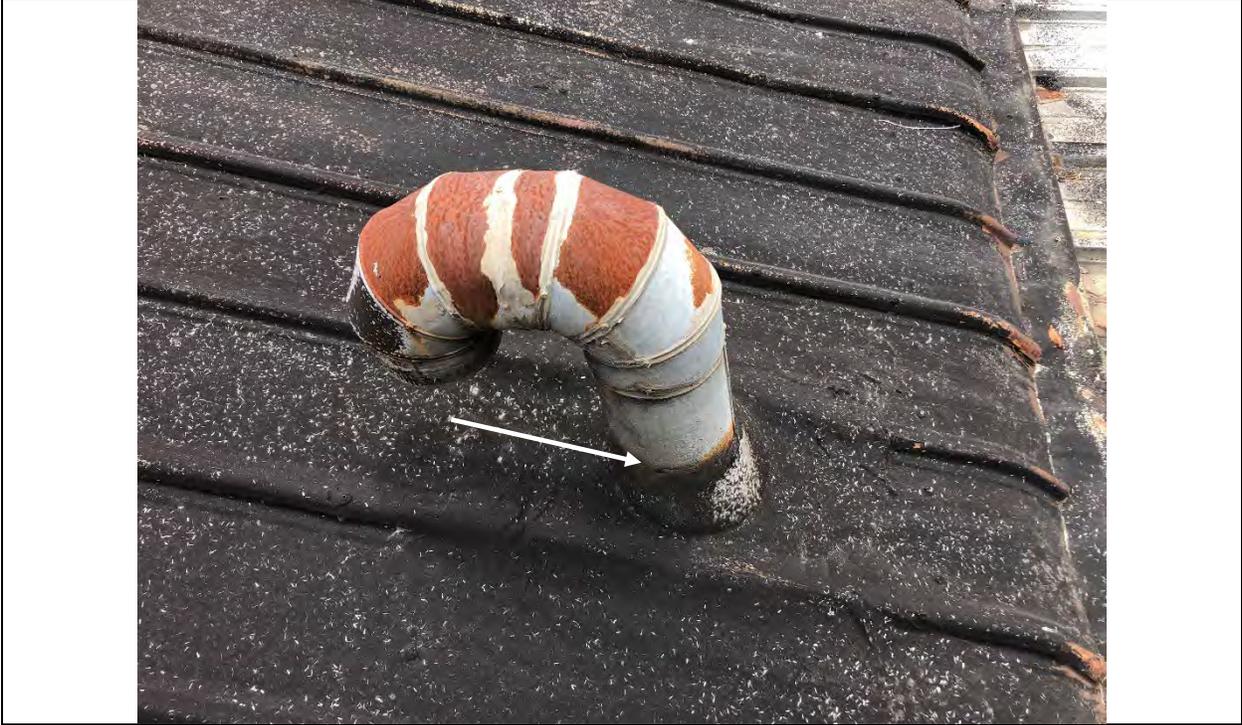
Photograph 6 – SCULPT Exterior – Roof mastic (typical) reported to be ACM

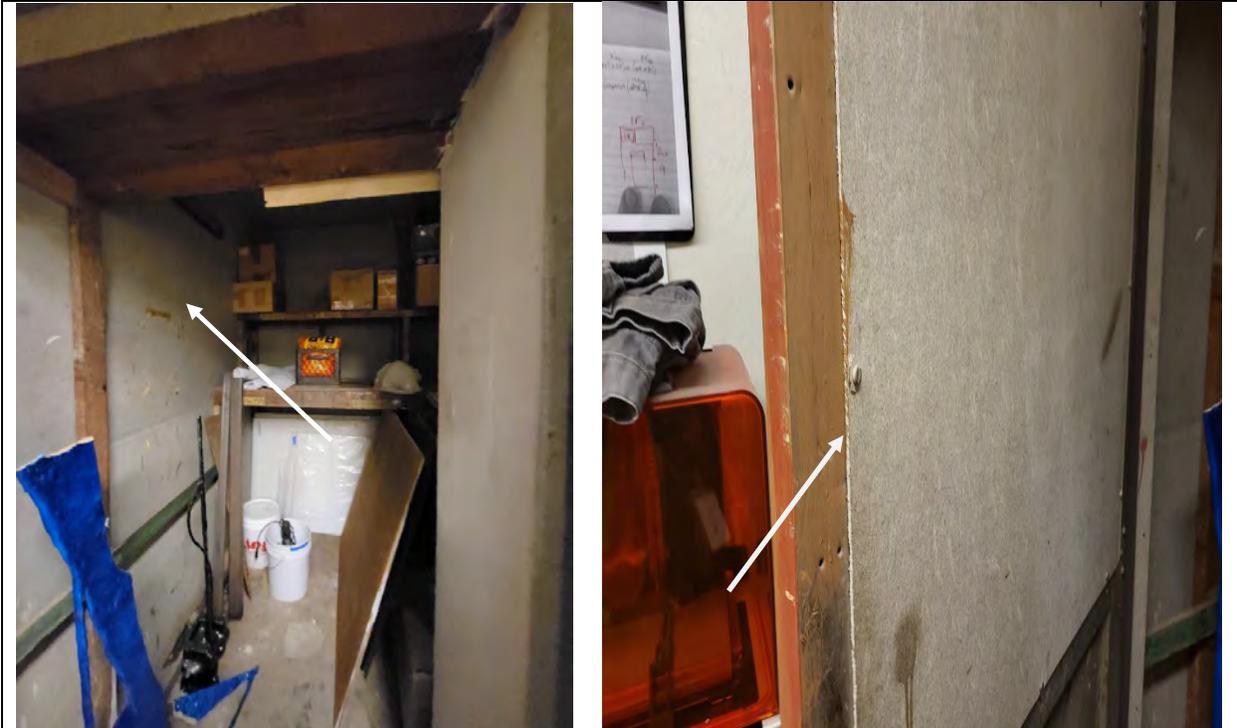
Photograph 7 – SCULPT Interior – Cementitious paneling (typical) reported to be ACM

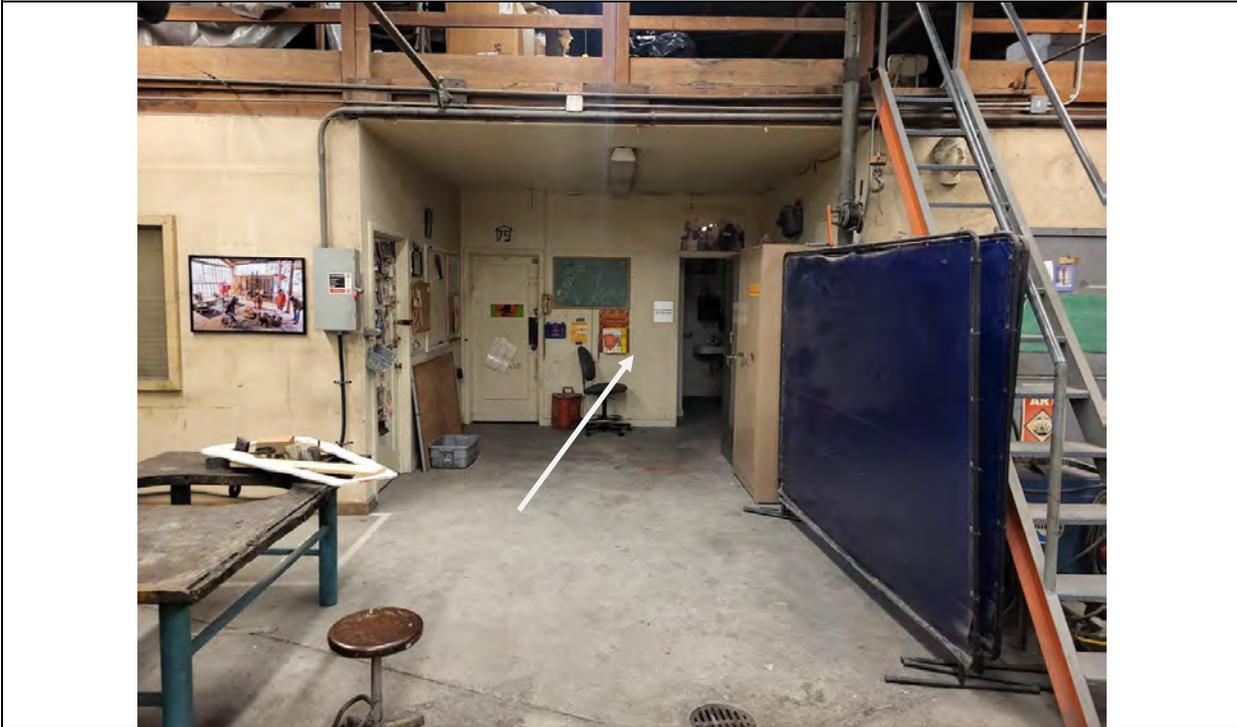
Photograph 8 – SCULPT Exterior – Drywall and joint compound (ACM) on walls and ceiling (typical)

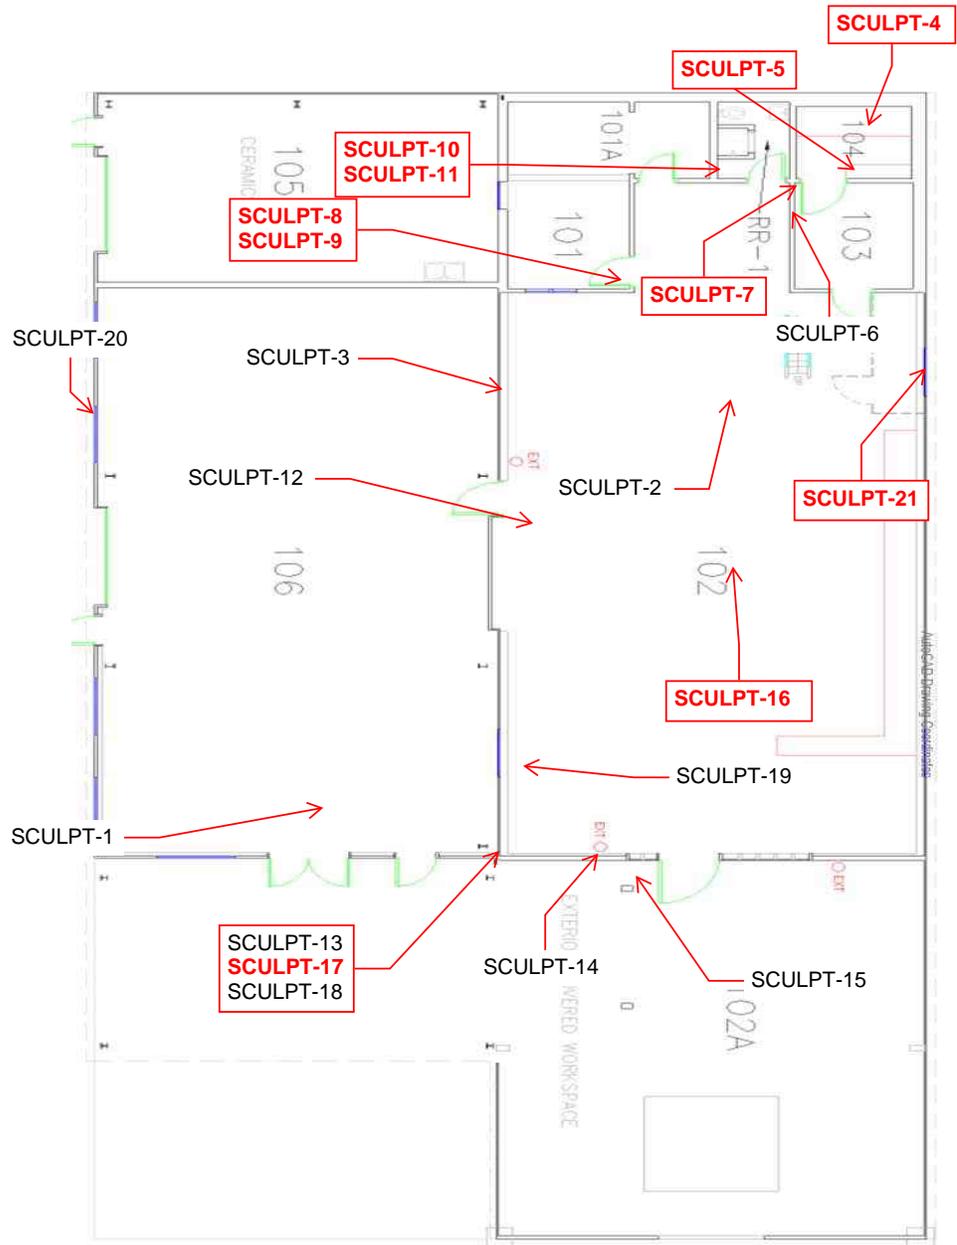
## Figure 1 - Sample Location Map

A total 21 suspect ACM samples were collected throughout the project site, some samples consisting of multiple layers of unique materials. The samples collected at the project site are listed in Table 1 (page 2). The locations of bulk samples collected at the project site are depicted on Figure 1 (Attachment B). The distribution of asbestos materials at the project site is depicted on Figure 2 (Attachment B).

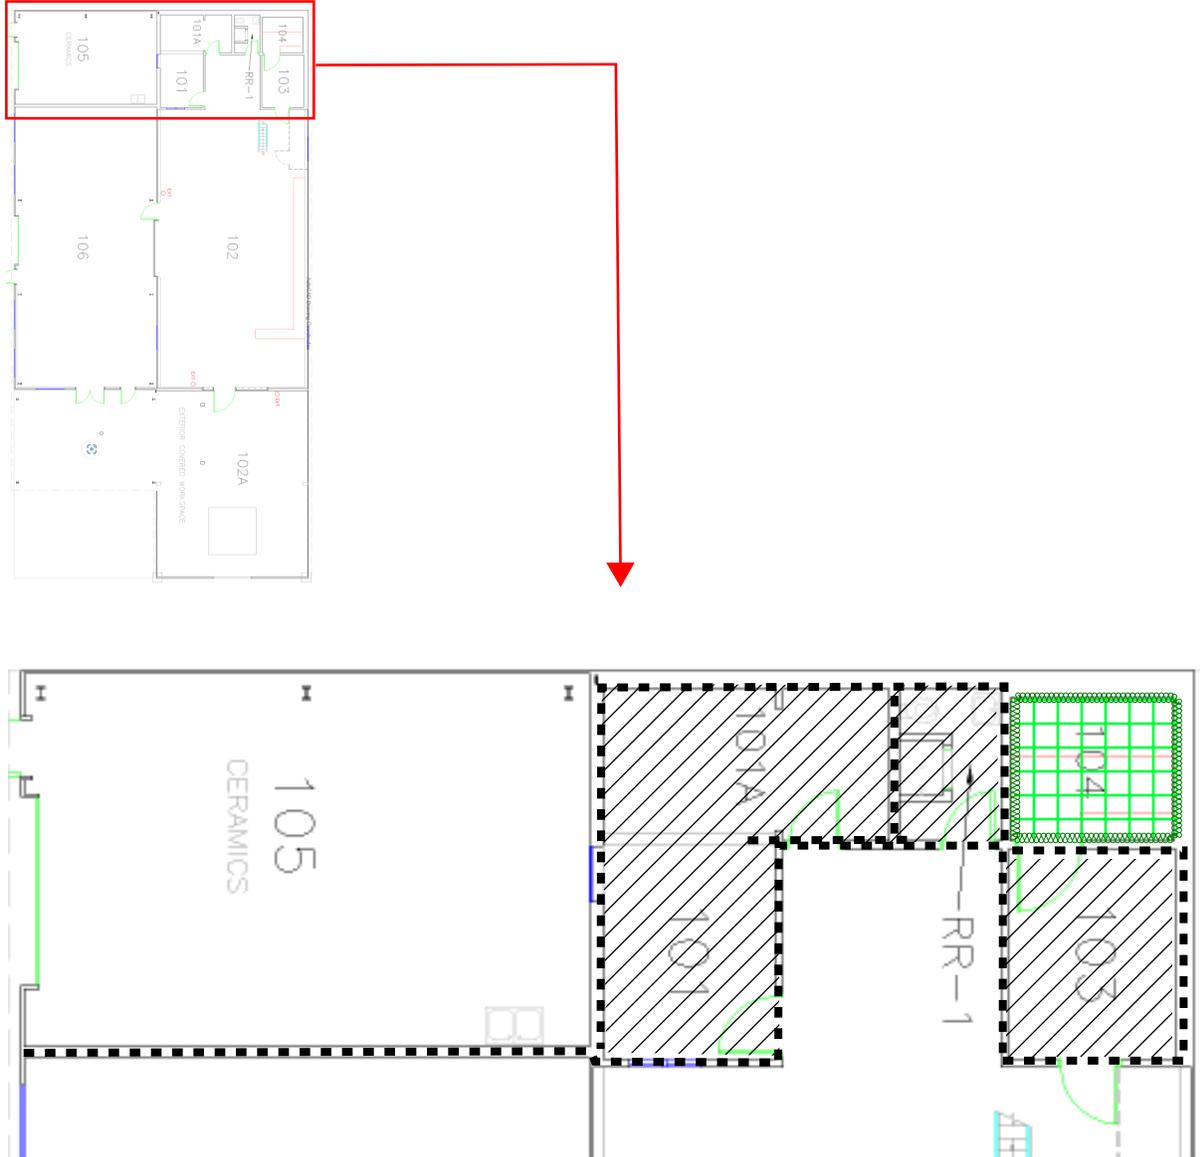
# Figure 2 - Distribution & Quantity Detail Sculpture Lab (75)

The approximate locations of the materials reported to contain asbestos are shown on Figure 2 (Attachment B). The analytical reports are attached (Attachment C).

As listed in Table 1, 10 of the samples collected from the project site were reported to contain asbestos. These samples represent six (6) homogeneous areas of material distributed throughout the SCULPT building as shown on Figure 2 (Attachment B). All other sampled materials analyzed via PLM were reported to be ND. See attached PLM laboratory analytical reports (Attachment C).

Materials reported to contain greater than 1% asbestos are classified as either ACM or Regulated ACM (RACM) depending on each material's physical characteristics. Material containing greater than 0.1% asbestos is designated by Cal/OSHA as Asbestos Containing Construction Material (ACCM). Any asbestos materials that may be disturbed by the project shall be removed by a licensed abatement contractor prior to other site work.

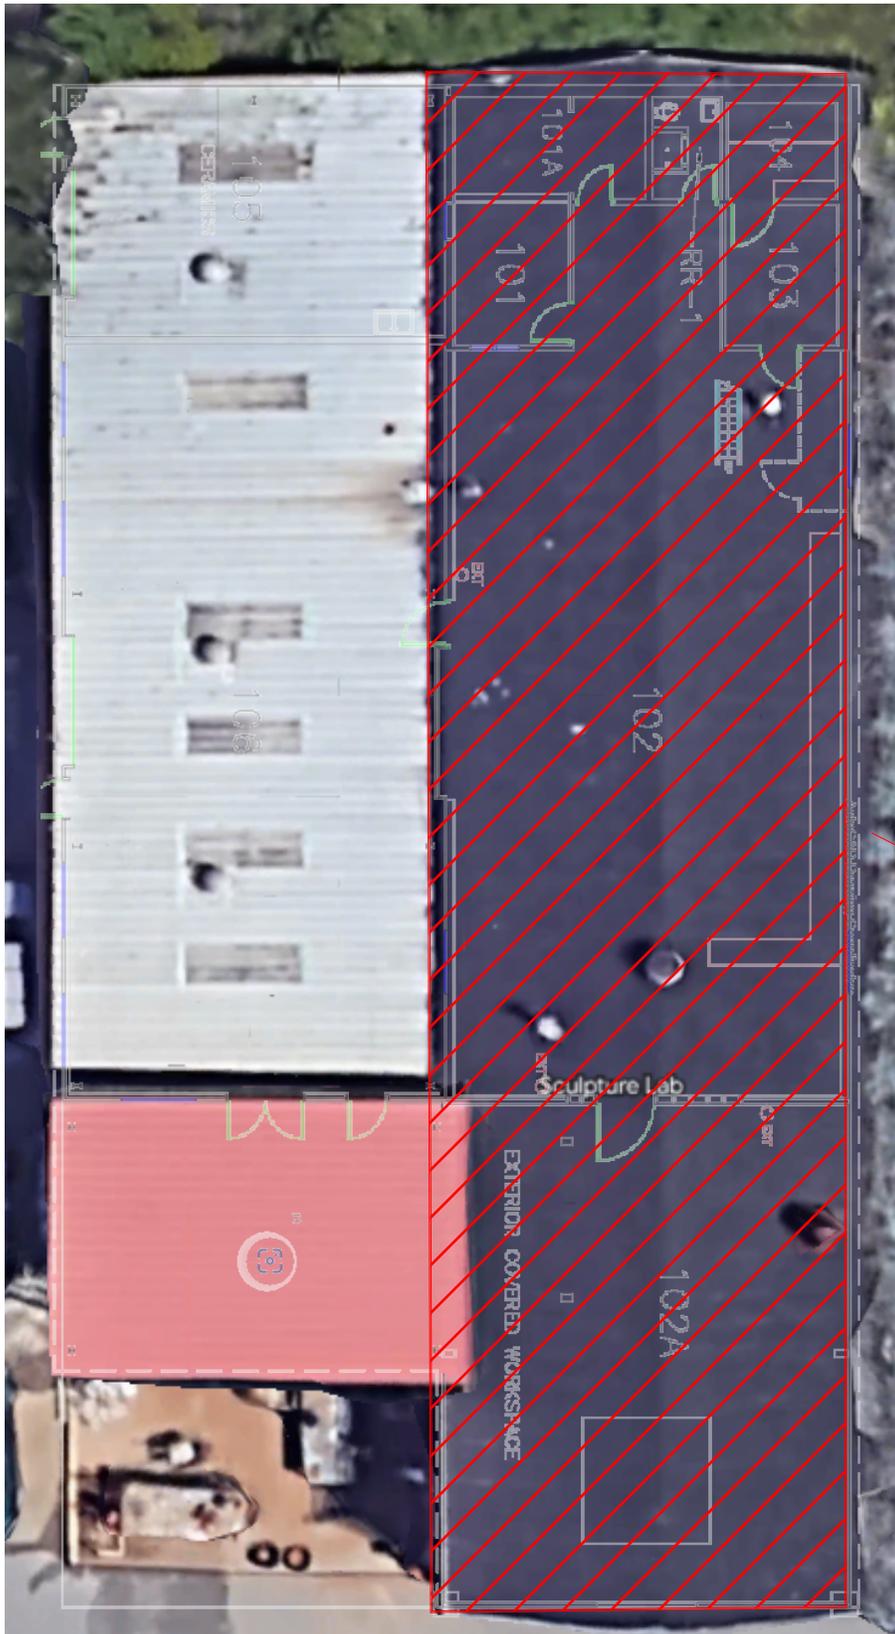
# Figure 2b - Distribution & Quantity Detail (cont.) Sculpture Lab (75)

Roof mastic reported to contain asbestos
