**HUMBOLDT STATE UNIVERSITY
JENKINS HALL**

SEISMIC EVALUATION

February 6, 2018 (DRAFT)

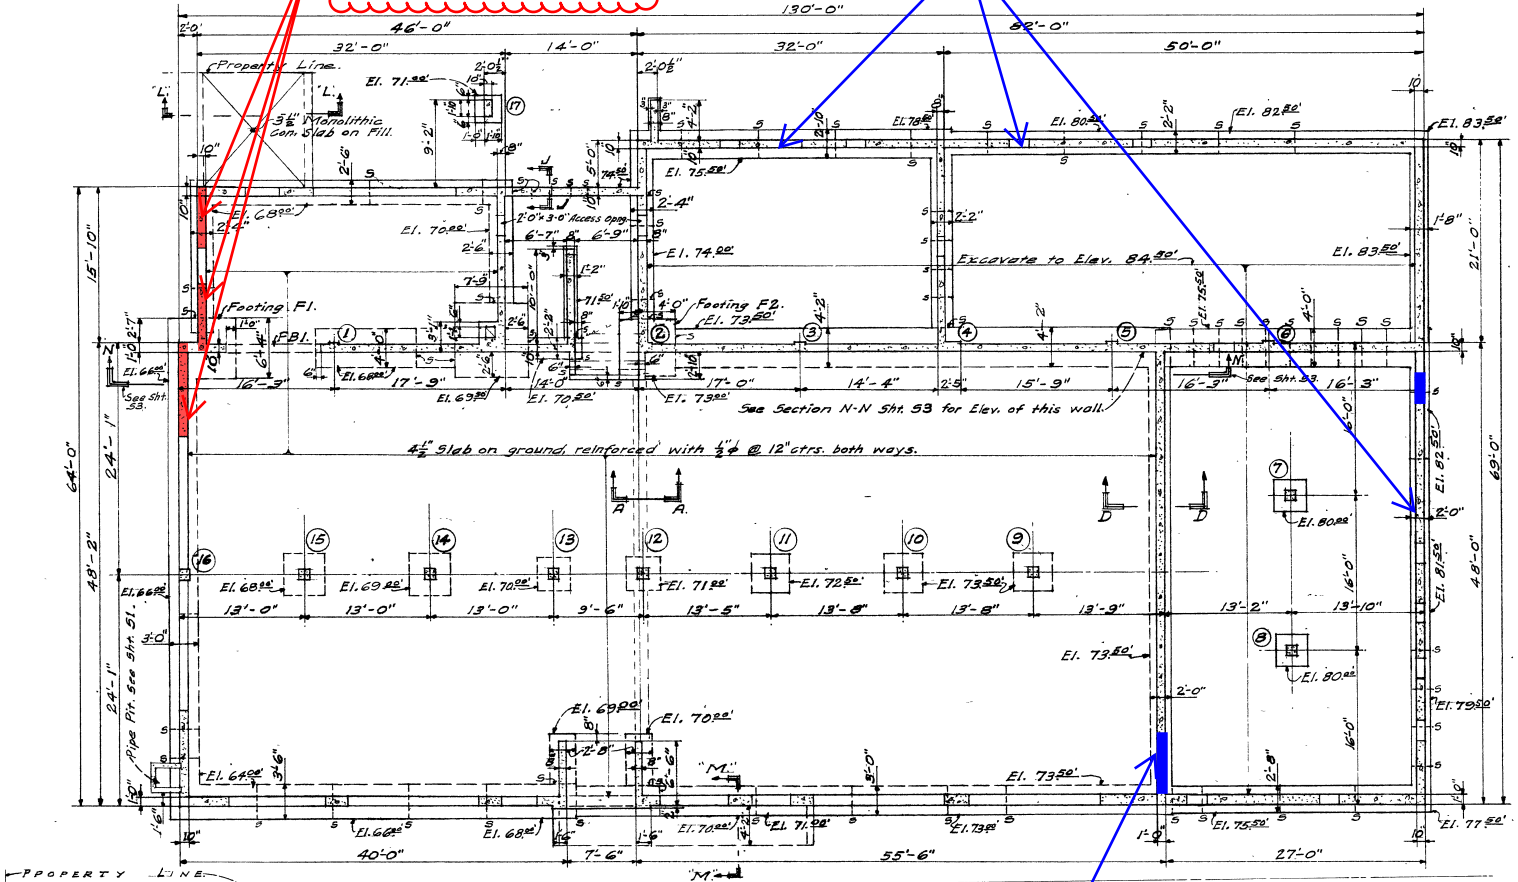
FIRST FLOOR

Additionally, TT notes HSU’s proposal to renovate the existing raised First Floor areas that were originally (per the original building drawings) intended to be unoccupied and backfilled with dirt. HSU’s concept renovation drawings note that these areas will require demolition and removal of “concrete steps, sections of slab and exposed concrete areas.” It should be noted that the majority of the exposed perimeter concrete steps are likely part of the perimeter building foundation, and cannot be demolished without significant shoring/underpinning operations, and reconstruction of the foundations at a lower elevation.

EXISTING STEPPED FOOTINGS
EXPOSED IN ROOMS PROPOSED FOR
RENOVATION: CANNOT DEMO
WITHOUT EXTENSIVE FOUNDATION
SHORING, UNDERPINNING AND
RECONSTRUCTION

WALL PIER DEFICIENCY:
INCREASE SIZE FOR
ADDED STRENGTH

compared with the north, south and east walls, where large portions of the First Floor walls are solid subgrade basement walls). While only marginally overstressed, this location is the weak link in the seismic force resisting system, and should be considered for retrofit. Retrofit may consist of infilling portions of windows to provide more shear wall length, and/or thickening of existing shear wall piers.

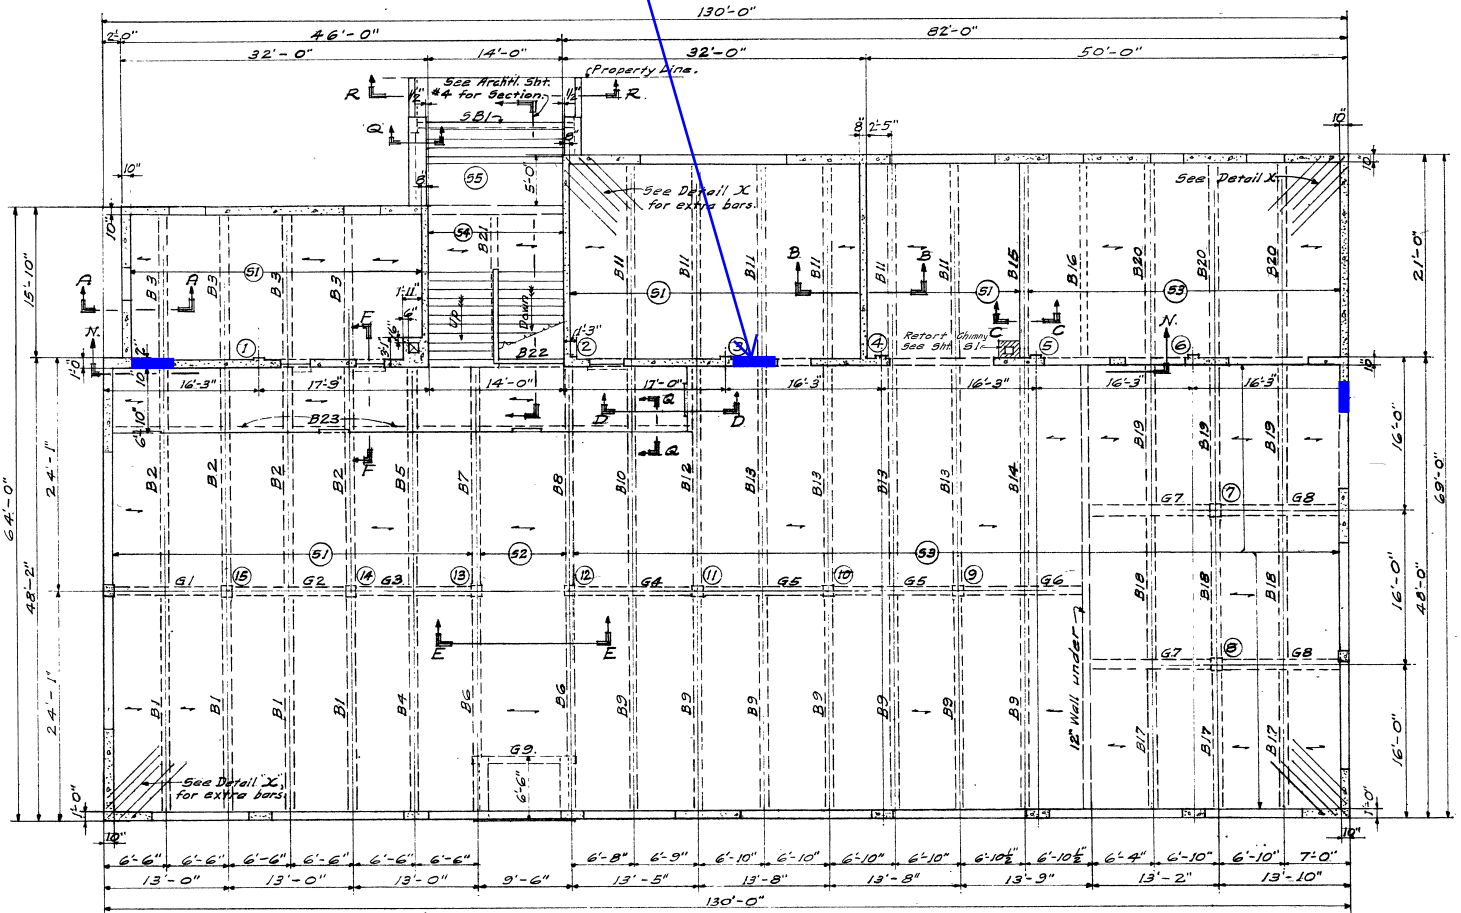
SECOND FLOOR

NO RETROFIT SCOPE AT THIS LEVEL

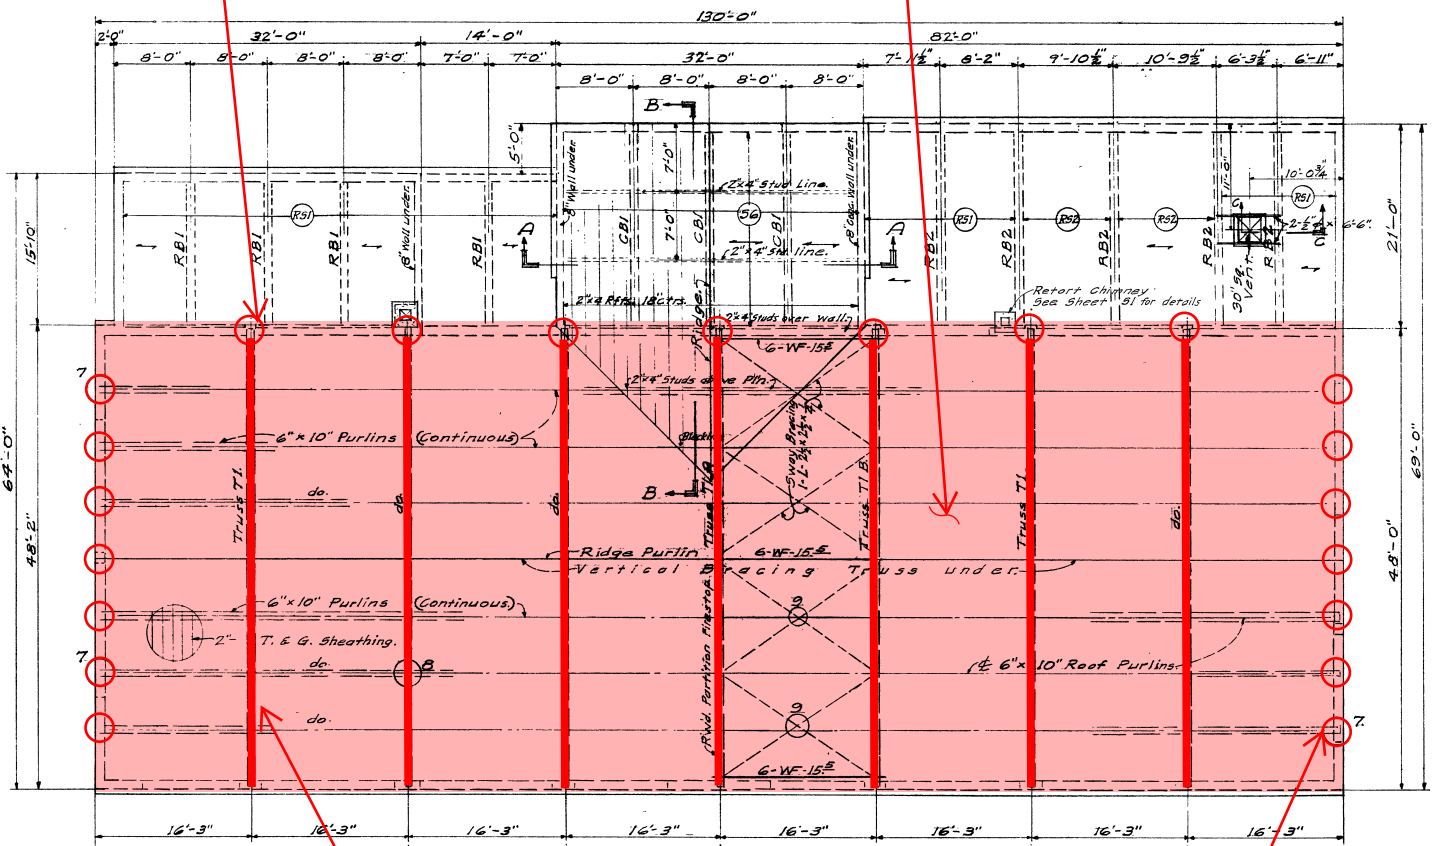
ROOF

- Wall-to-Roof Anchorage: During seismic events, heavy structural walls pull away from floor and roof diaphragms, and can be a potential collapse hazard if not adequately connected. This is a particular issue at flexible roof diaphragms (i.e. wood-framed or bare metal deck). For this building, the wall-to-roof anchorage connections are inadequate along the west and east building ends. Along the north and south sides of the building, the walls are well-anchored to the trusses, but the trusses are not adequately attached to the diaphragm. Both conditions should be prioritized for retrofit.

- Roof Diaphragm: Wood straight sheathing diaphragms have very low shear capacities, and are generally not used in modern seismic design; the diaphragm should be retrofitted by overlaying new plywood over the existing straight sheathing. Additionally, the wood and concrete diaphragms are not well tied together to transfer forces (primarily from the wood to concrete); new drag connections shall be provided.

DIAPHRAGM TIE DEFICIENCY:
PROVIDE NEW CONNECTIONS BETWEEN
WOOD AND CONCRETE DIAPHRAGMS,
TYP AT EACH TRUSS LOCATION

DIAPHRAGM DEFICIENCY:
STRENGTHEN DIAPHRAGM BY
PROVIDING NEW PLYWOOD
SHEATHING OVER EXISTING 2x
STRAIGHT SHEATHING

WALL ANCHORAGE DEFICIENCY:
STRENGTHEN CONNECTION OF WALL TO
PURLIN, TYP AT EAST AND WEST WALLS

WALL ANCHORAGE DEFICIENCY:
PROVIDE NEW BLOCKING TO CONNECT
DIAPHRAGM TO TRUSS, TYP AT EACH TRUSS
